NANTUCKET FACILITIES ASSESSMENT

Town of Nantucket, MA
16 Broad St.
Nantucket, MA

10 June 2015

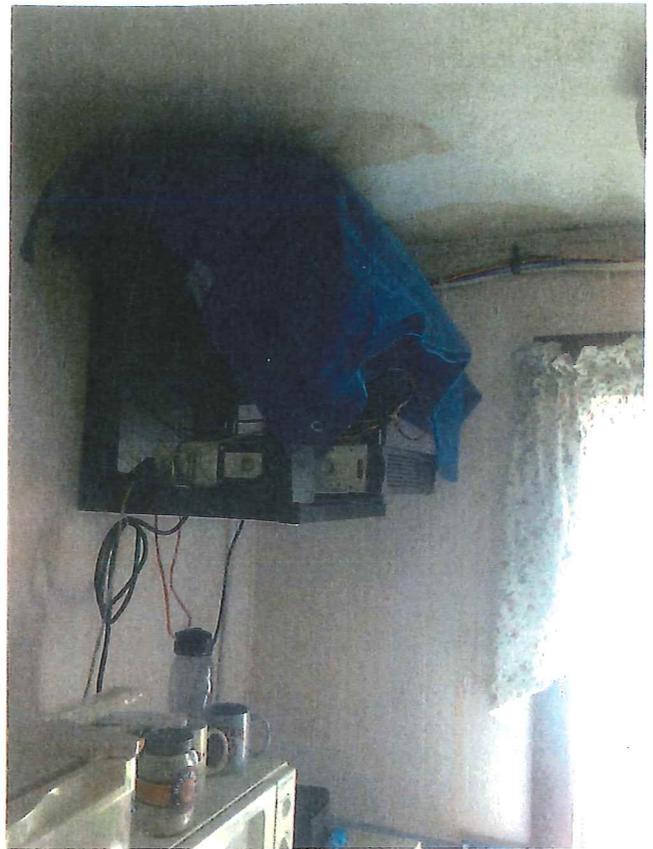
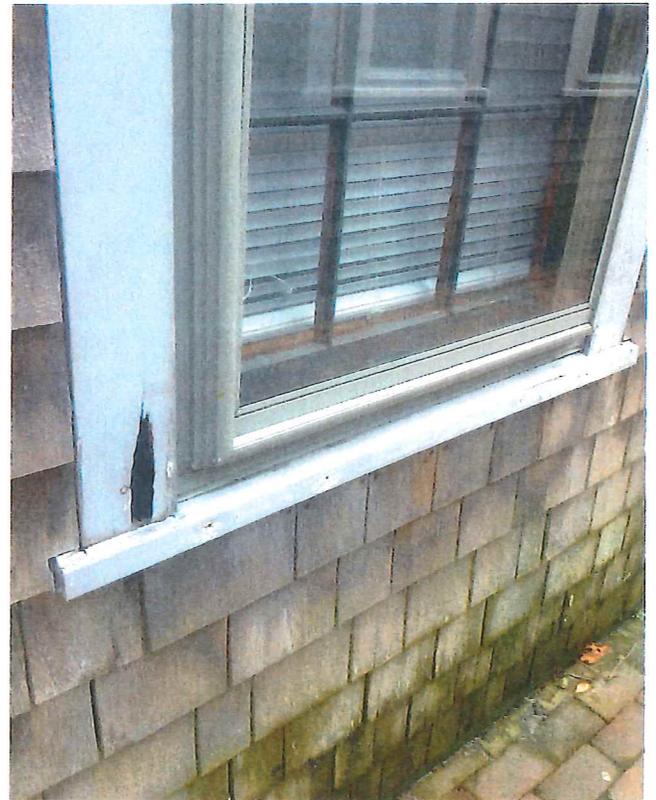
Wood framed two story building. Generally sound but showing signs of rot in various locations, especially at base of walls where water and dampness appear to be constantly present.

Asphalt shingles, wood gutters, plastic and metal rain leaders. There is an appreciable leak which is entering the interior of the building in the southeast corner. This has led someone to place a plastic tarp to protect the network server, battery backup unit, and alarm system electronics from water.

B1010 Floor Construction: Moisture, mildew, mold, and/or moss issues evident

B2010 Exterior Walls: Moisture, mildew, mold, and/or moss issues evident

B3010.10 Steep Slope Roofing: Active or inactive water infiltration evident

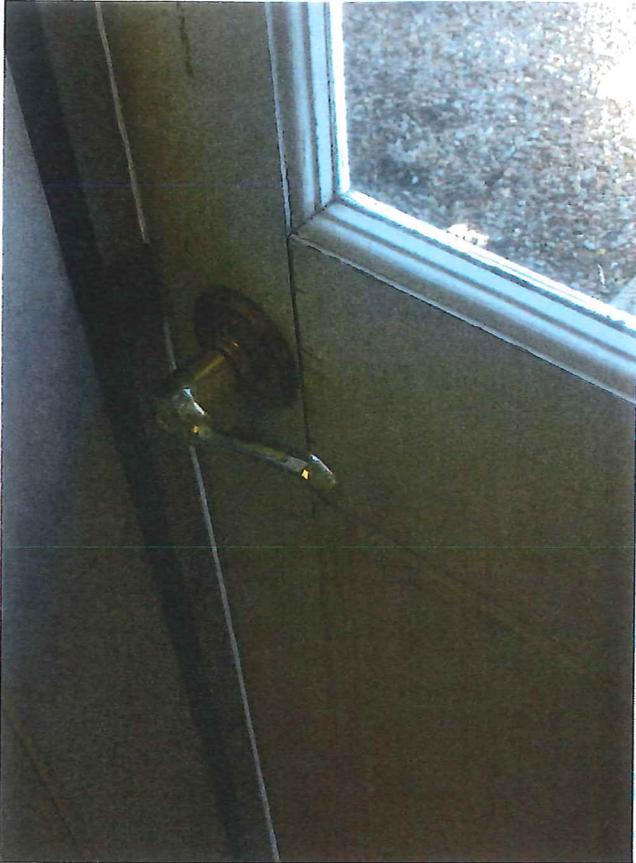
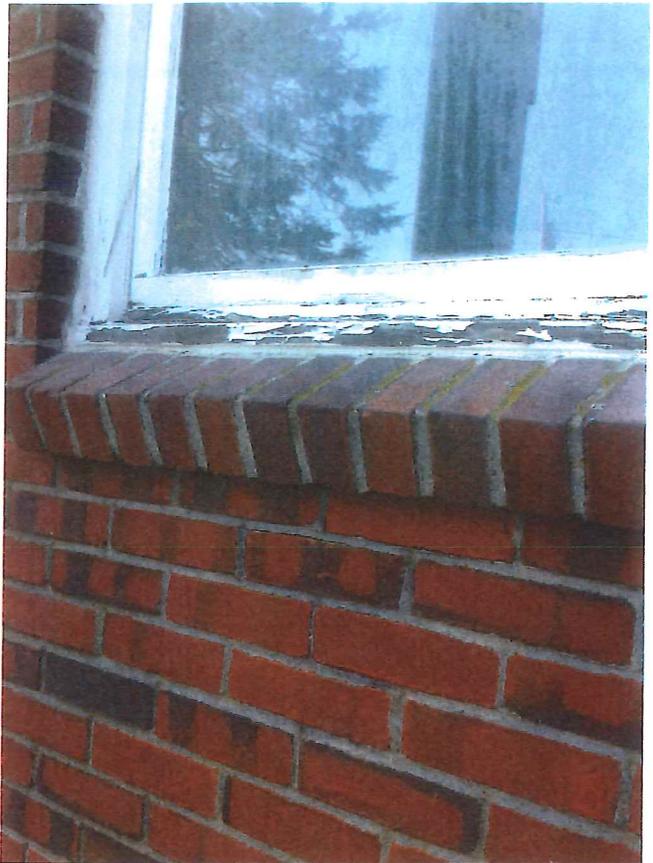
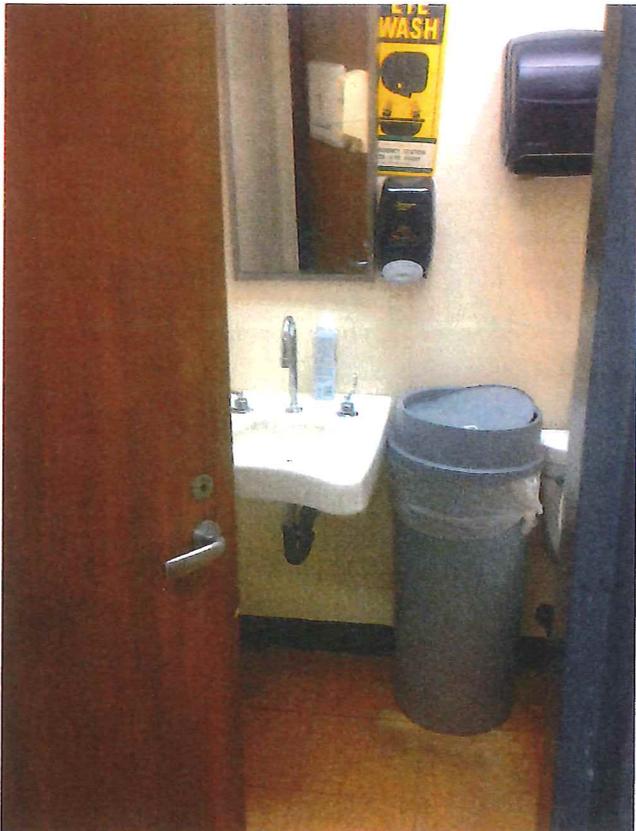
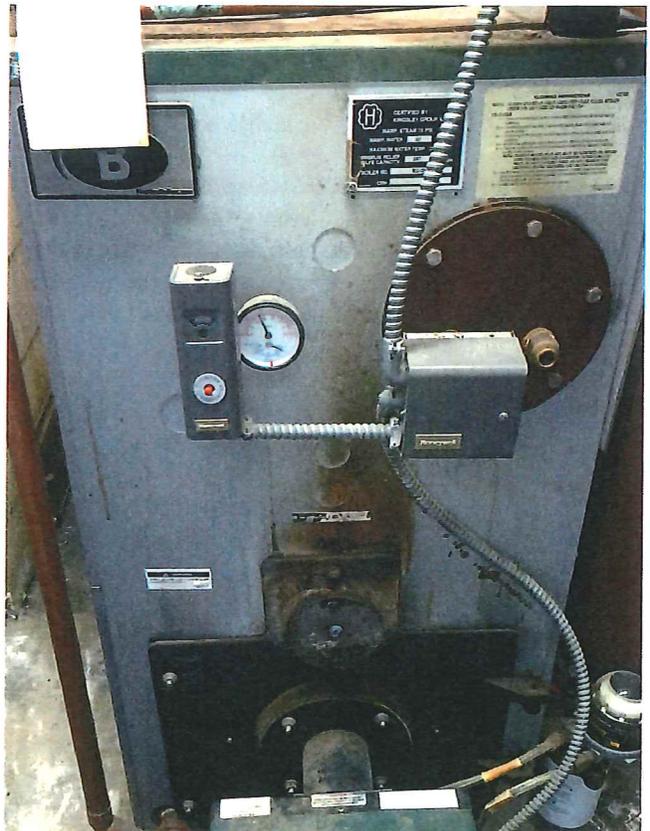
Two story, wood framed, slab on grade. Generally in fair condition with evidence of termite infestation and general deterioration.

The original Peerless oil fired boiler is rated 400 Mbh and (2) Taco hot water circulation pumps are beyond their useful life expectancy. In addition, the heating hot water distribution system, terminal components, ventilation and exhaust systems and controls should be replaced/upgraded.

B2010 Exterior Walls: System failure evident

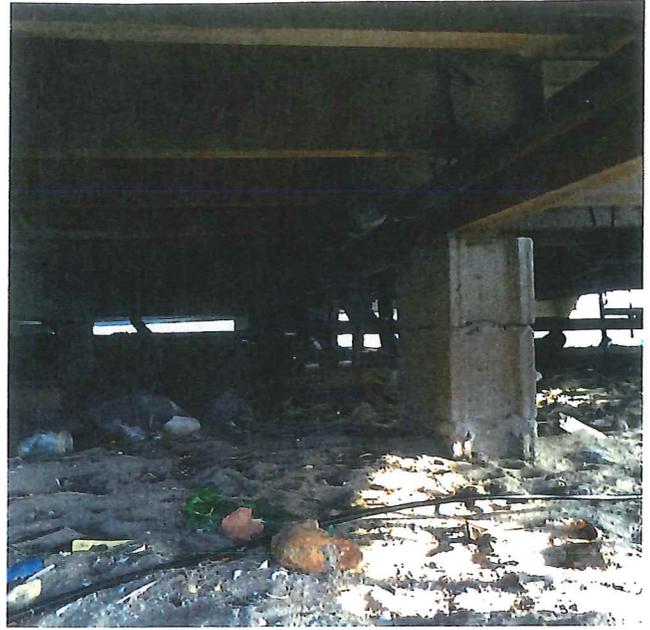
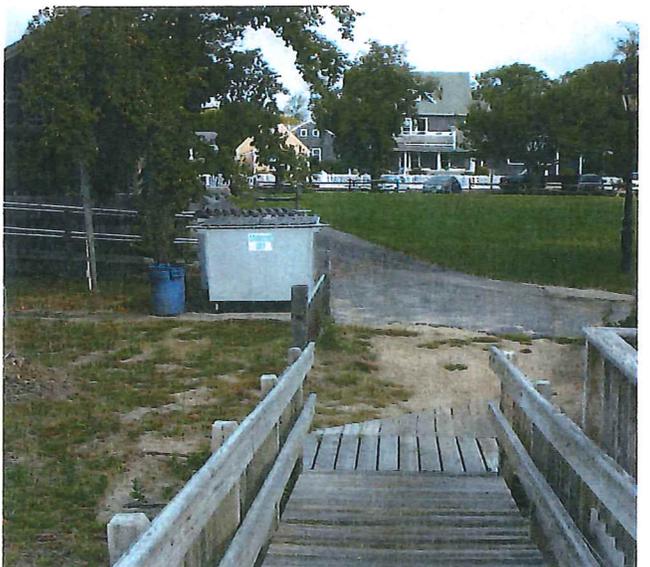
A1010 Standard Foundations: Load capacity issues evident

A1010 Standard Foundations: Settlement evident

B1010 Floor Construction: Load capacity issues evident

B1080 Stairs: Egress stair appears non-compliant with current regulatory standards due to width, winders, riser height and /or tread depth..

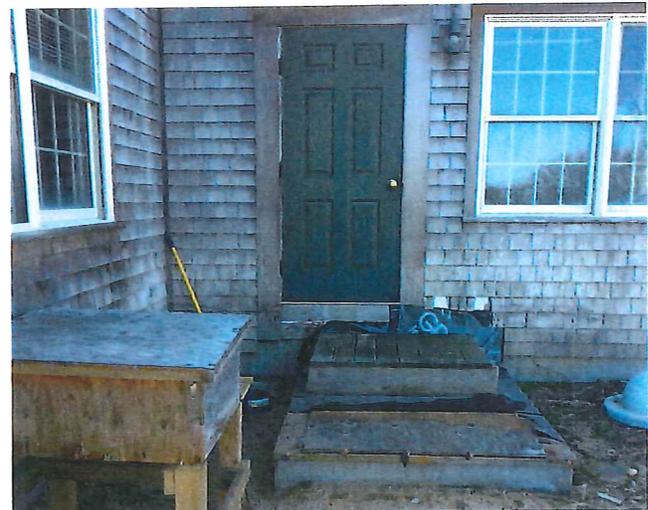
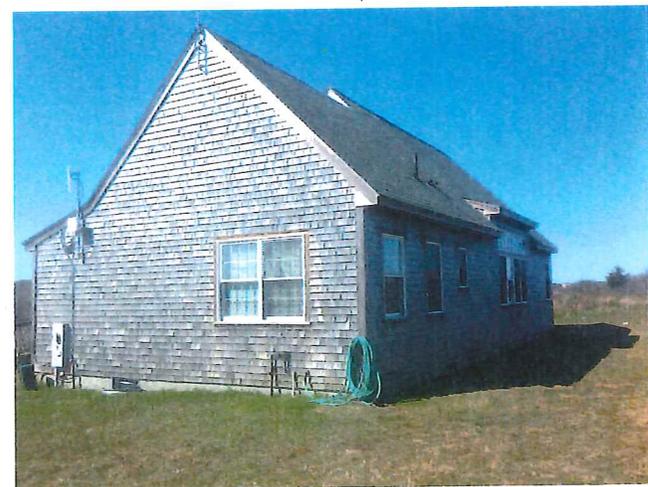
B3010.10 Steep Slope Roofing: Aging shingles, shakes, and/or tiles suggest new roof replacement
