SBPF Site Inspection Report/Log

Inspector: Ali Tepsurkayev

Date: 01/13/20 Time: 11:48 am Weather: Cloudy 43°F

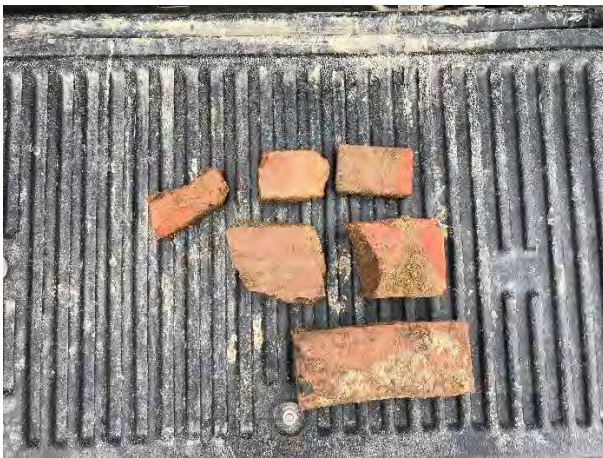
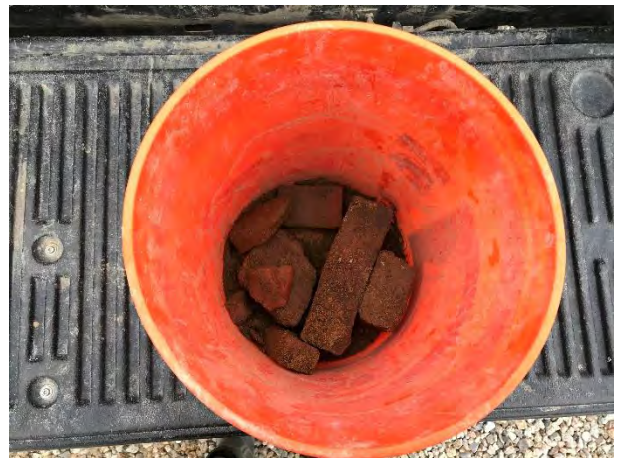
Site was in good condition. Lower geotubes significantly exposed along structure.

Collected several bricks. ~ 1 gallon.

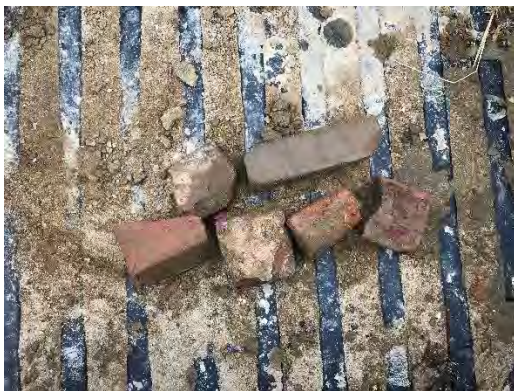
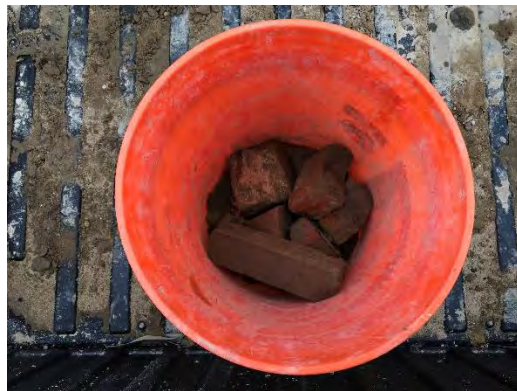
Site was in good condition. Lower geotubes partially exposed along no structure.

Collected several bricks. ~ 1 gallon.

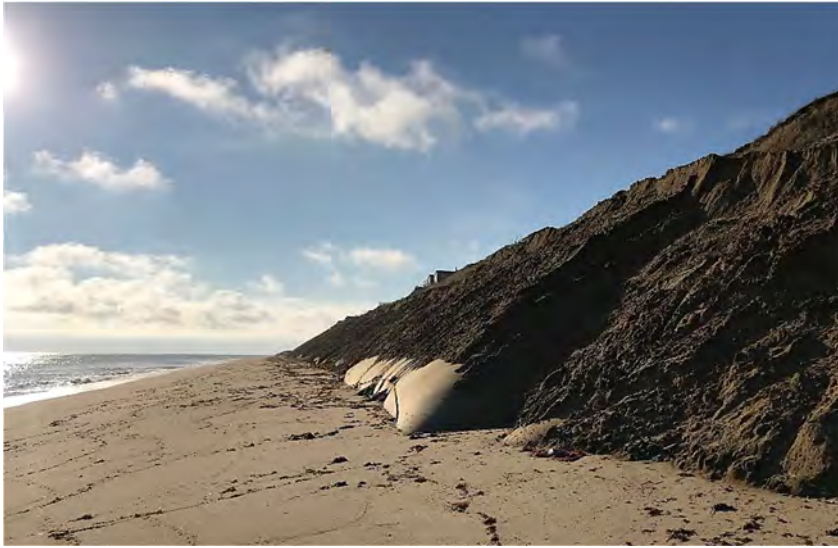
Site was in good condition. Lower geotubes partially exposed along no structure.

~ 340 feet.

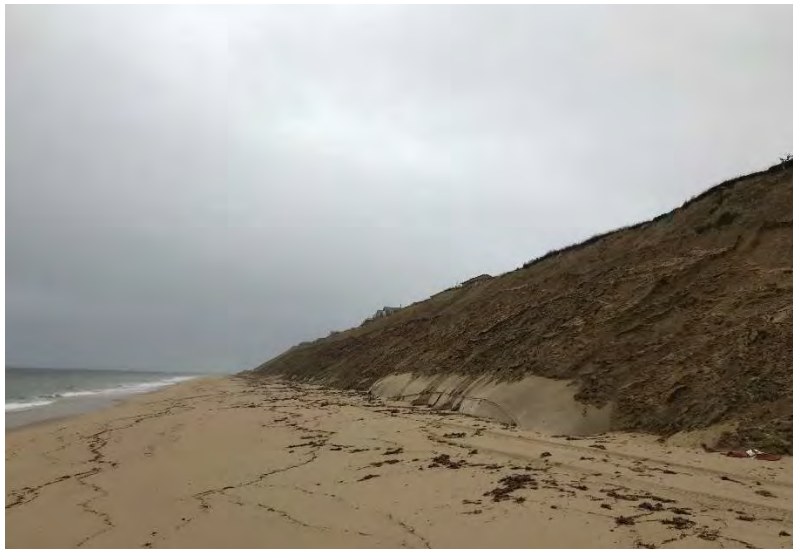
Site was in good condition. Lower geotubes partially exposed along no structure.

~ 340 feet. No changes

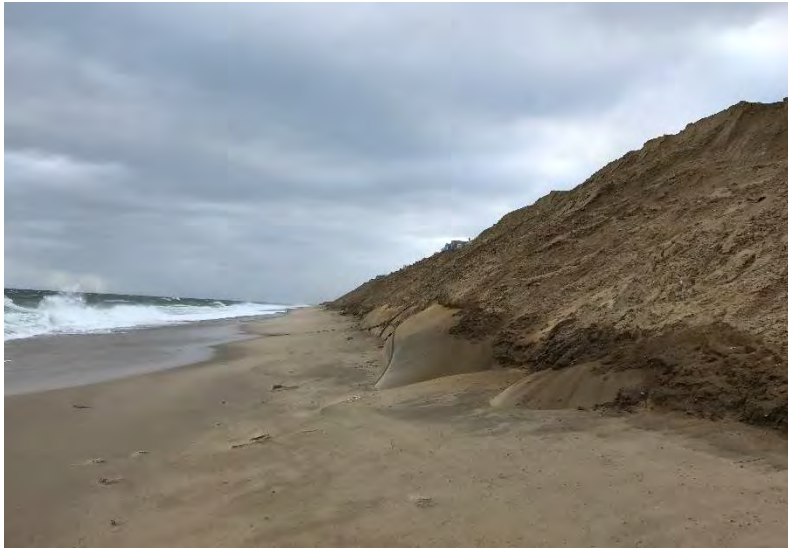
Site was in good condition. Lower geotubes partially exposed along no structure.

372 feet exposed.
