Children's Beach Stormwater Pumping Station Evaluation

Public Meeting

Town of Nantucket

March 14, 2019

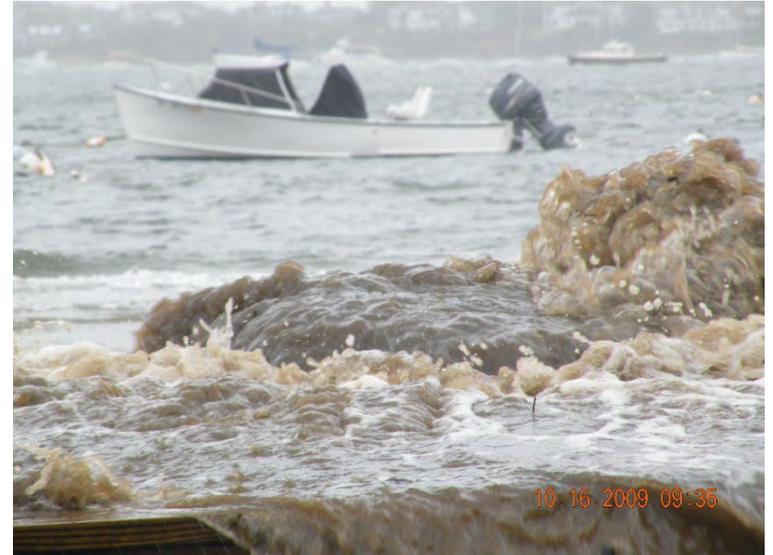
Background – Initial Pump Failure/Improvements

- Initial Failure Oct. 2009
- Hydraulic Evaluation 2011 Results
- Recommended 2011 Improvements
 - Improved Venting
 - Pump Repairs
 - VFDs

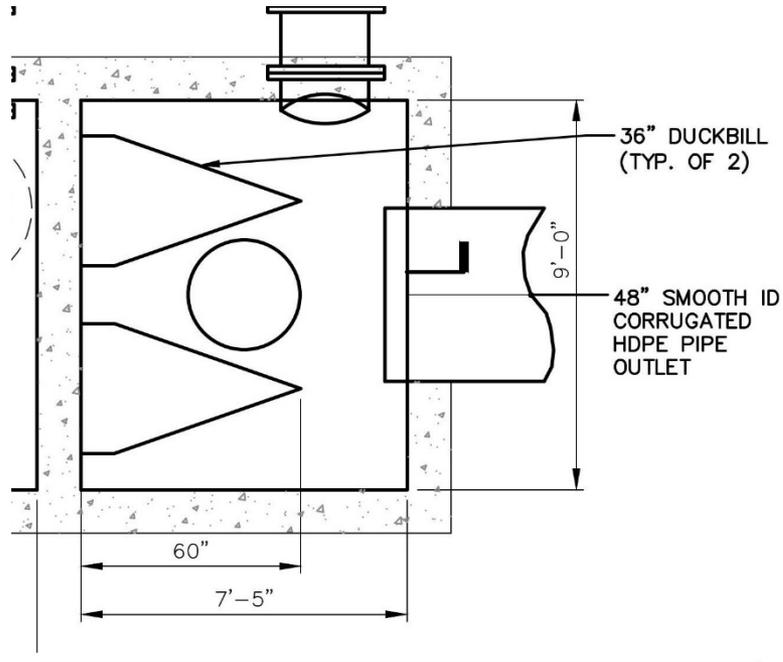
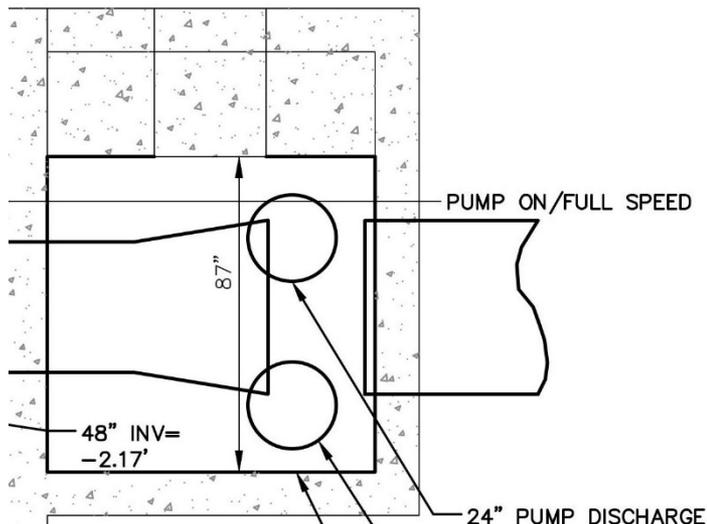
Existing Conditions - Discharge Chamber

- Congested
 - No Room for 24" Flap Valves
 - No room for 24" Duck Bill
 - Hydraulic interference

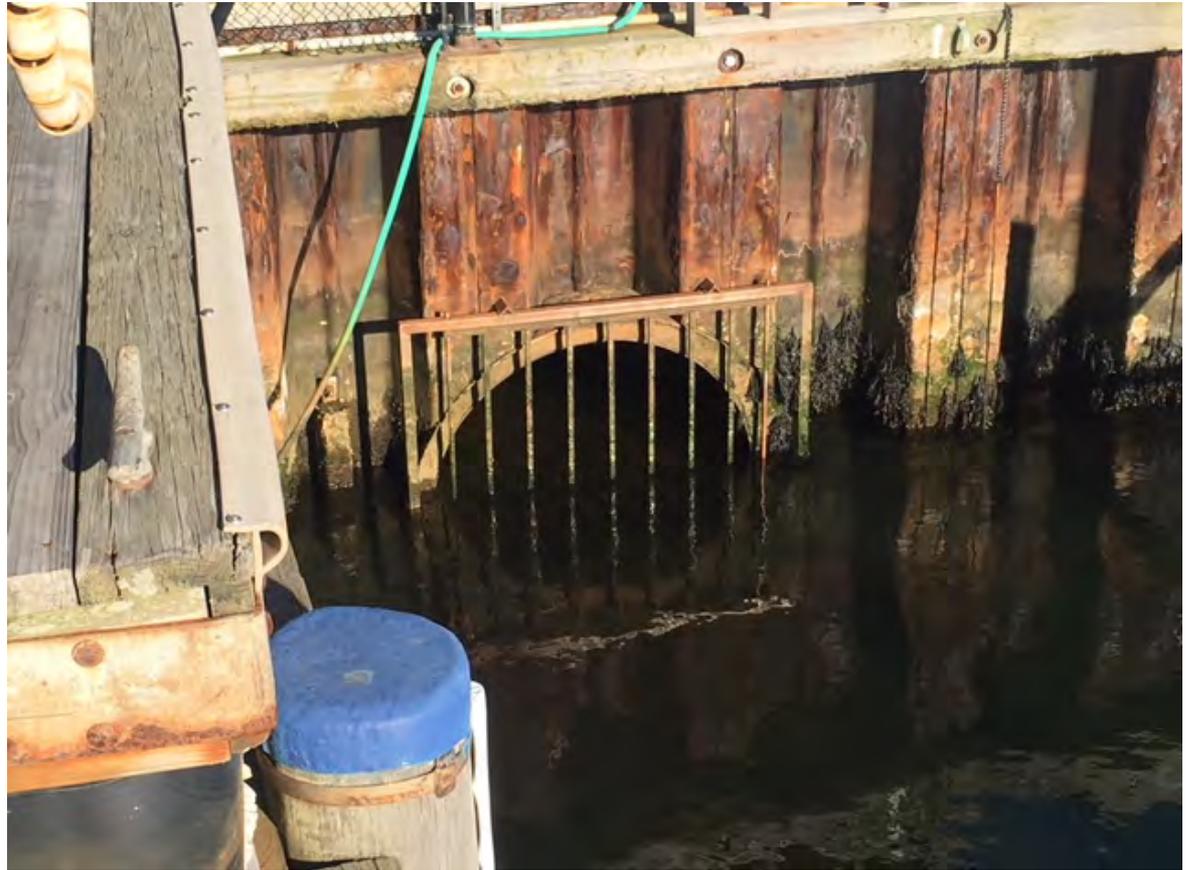
Existing Conditions - Outfall

- Note: No Outfall Check Valve

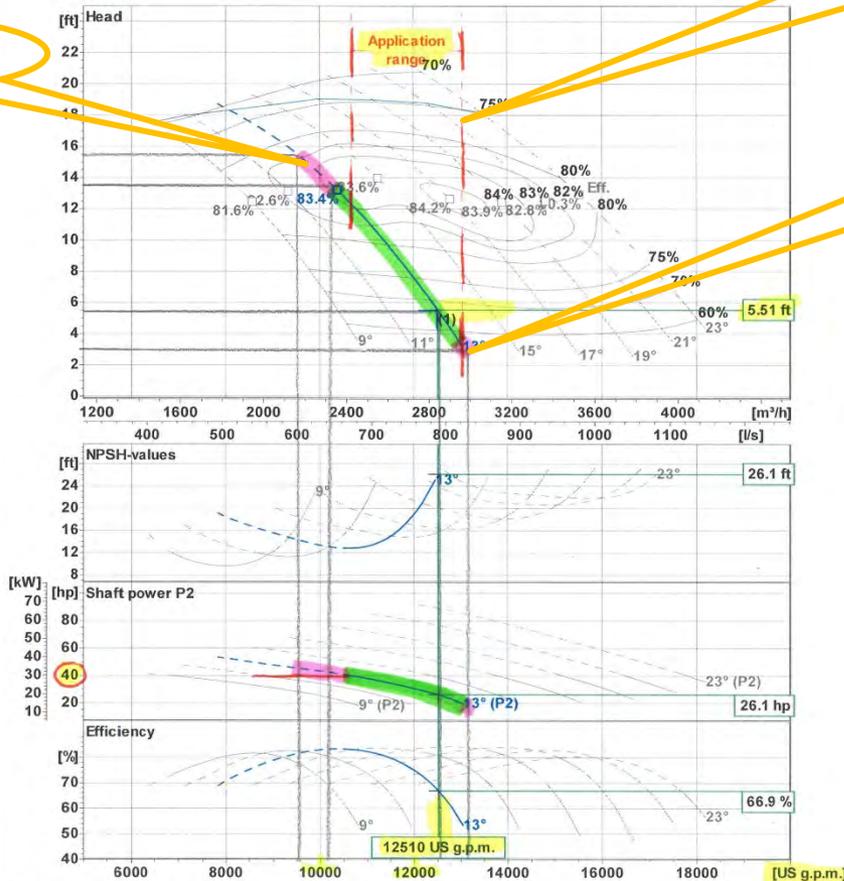
Performance curve

Motor Overload

Small Application Range

Excess Pump Loading

- Motors suffered damage due to overheating
 - Pumps called on to operate outside of the “Application Range”
 - *Left Side of Curve – Where Shaft Power Increases Above 40 HP*
 - 40 HP Motor size too small
 - *KSB recommends increasing motor size after determining hydraulic operating points*
 - Increase by 4 HP without VFD
 - Increase by additional 6 HP with VFD
 - For CBPS – Motor should be 50 HP

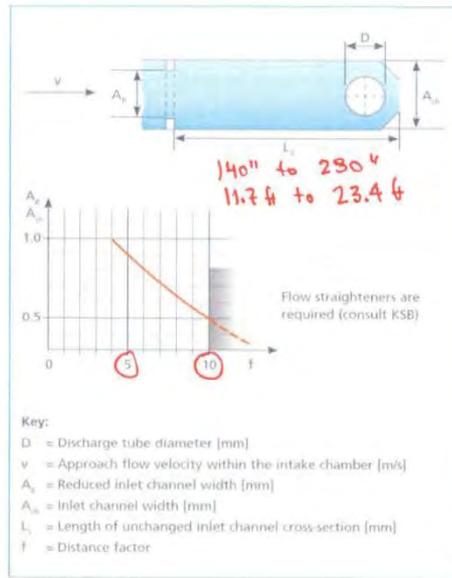
Fig. 27: Influence of cross-sectional constriction

**Minimum Wet Well Length
Approx. 18 FT for
Children's
Beach PS***
