Re: Harbor Master Building: Municipal Town Pier, 34 Washington Street  
Existing Conditions Report

Subject: Field Observations of Foundations and Structural Elements

Nantucket Marine Department  
Nantucket, MA  
Electrical Existing Conditions Systems Report  
J#839 024 00.00  
L#44349/Page 1/June 6, 2014

Nantucket Marine Department  
Nantucket, MA  
HVAC Existing Conditions Systems Report  
J#839 024 00.00  
L#44324/Page 1/June 6, 2014

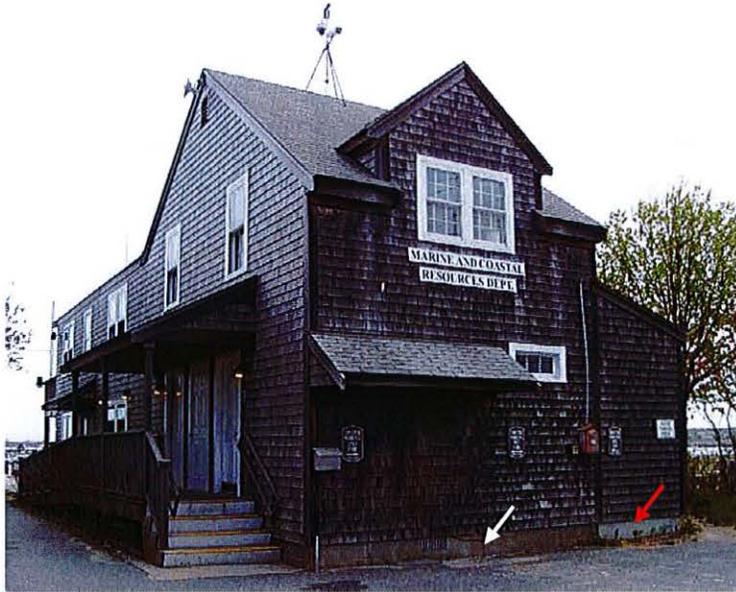
**PHOTOGRAPH 1**

- The building is a 2-story, wood-framed structure that consists of multiple sections that were constructed at different times (Photos 1 and 2).
- The foundation appears to consist of three separate sections, a concrete masonry unit (CMU) foundation nearest the street, and two sections of slab-on-grade with turned-down edges at the middle, right side, and back sections of the building (Photos 1, 3, 4, 5).

Front (called "west") and left (called "north") faces of building at 34 Washington Street, Nantucket, MA. White arrow shows concrete masonry unit (CMU) foundation beneath main portion of building; red arrow shows cast-in-place concrete foundation.

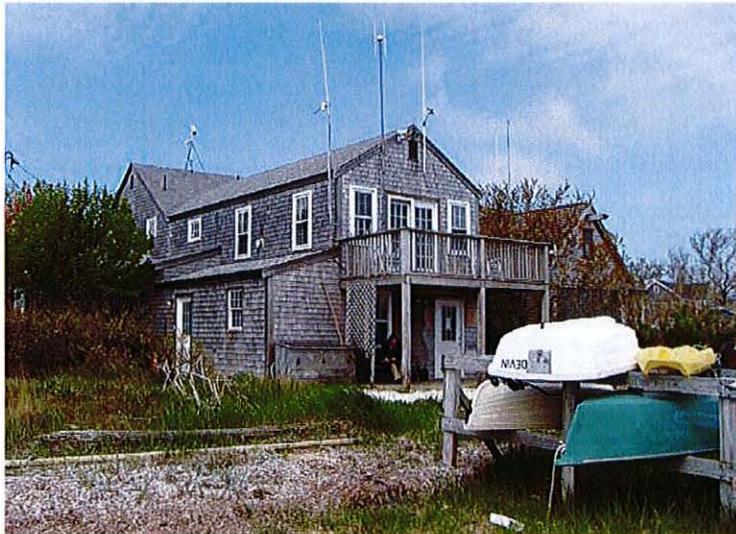
**PHOTOGRAPH 2**

Rear (called "east") and right (called "south") faces of building at 34 Washington Street, Nantucket, MA.

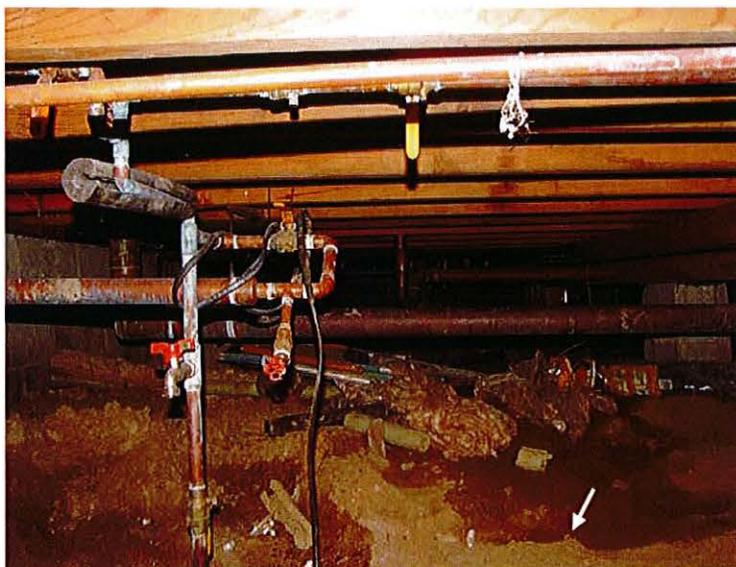
**PHOTOGRAPH 3**

- The observed portions of the CMU foundation beneath the west portion of the building are in fair condition, with some signs of weathered block and mortar. It appears that some sections of soil in the crawlspace beneath this portion of the building have apparently eroded (Photos 3 through 5). The 1<sup>st</sup> Floor framing in this section of the building is supported by a main carrying girder on intermittent CMU block piers. No connection hardware was observed between the piers and the girder (Photo 4), and no blocking was observed between floor joists. The soil along a portion of the southern foundation wall has apparently eroded (Photo 5). Anchorage between the foundation and framing could not be confirmed; I observed an approx. fifteen foot long section of wall at the east side of the crawlspace that did not appear to have any anchor bolts between the foundation and framing.

Looking west into crawlspace beneath west portion of building. Surface of soil in foreground (white arrow) is lower than in adjacent areas.

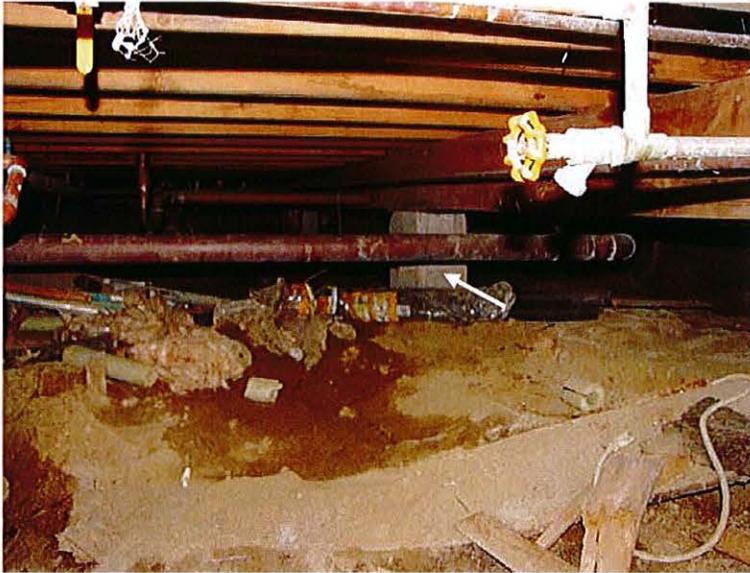
**PHOTOGRAPH 4**

Concrete masonry unit (CMU) "pier" is visible beneath main carrying beam in 1<sup>st</sup> Floor Framing. No anchorage is visible between beam and pier.

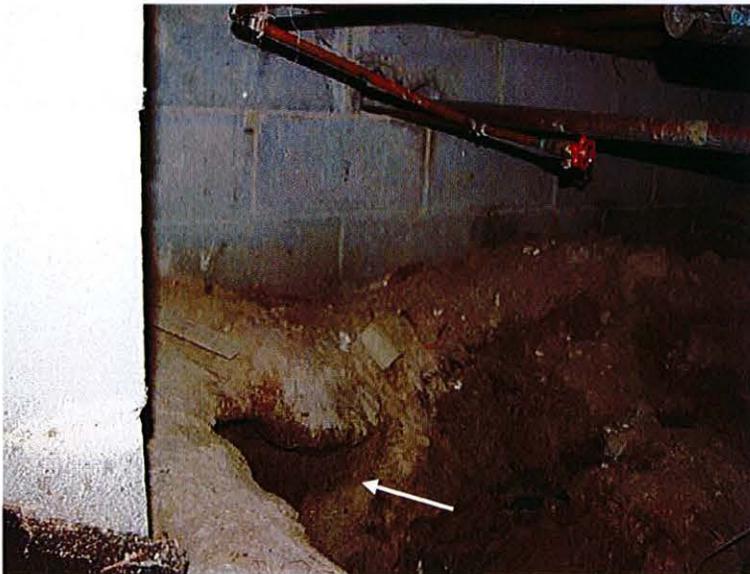
**PHOTOGRAPH 5**

CMU foundation wall along south side of crawl space. White arrow shows apparently eroded soil surface adjacent to wall. Foundation anchorage could not be confirmed. Looking along east foundation wall, no anchorage was visible within a distance of approx. fifteen feet.

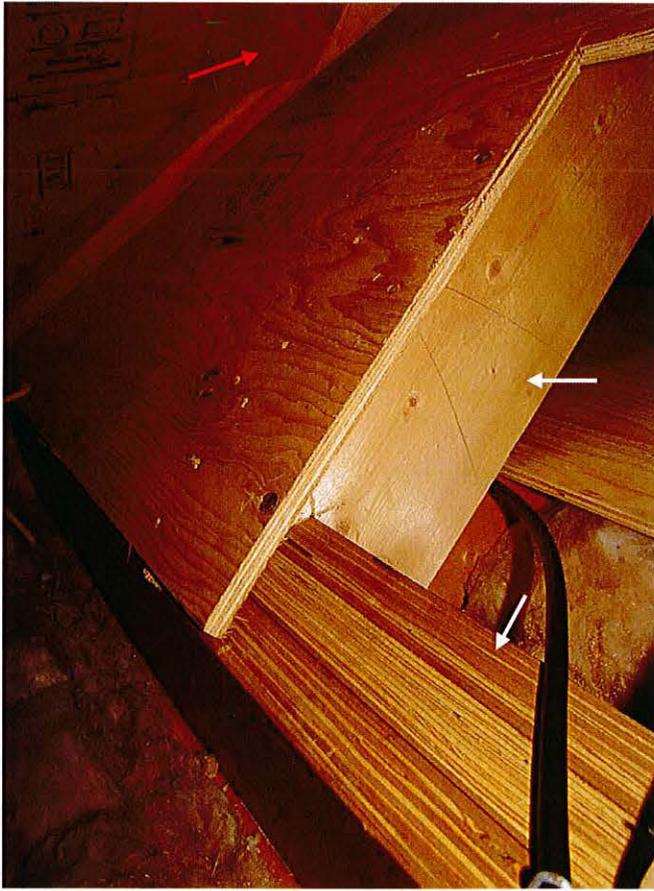
**PHOTOGRAPH 6**

- b. A portion of the roof over the middle section of the building is "over-framed" onto the main roof (Photo 6). The over-framed section does not appear to be strapped or otherwise detailed to resist uplift. Similar conditions are present at the over-framed roofs along the south side of the building (Photos 8 and 9).

Main roof framing for front (west) section of framing consisting of 2x10 rafters supported by a laminated veneer lumber (LVL) beam (white arrows). The rafters are "flush-framed" into the side of the LVL beam, with a small portion of the rafter left intact on top. No connection hardware was observed. Red arrow shows roof of middle section of building "over-framed" onto main roof framing.

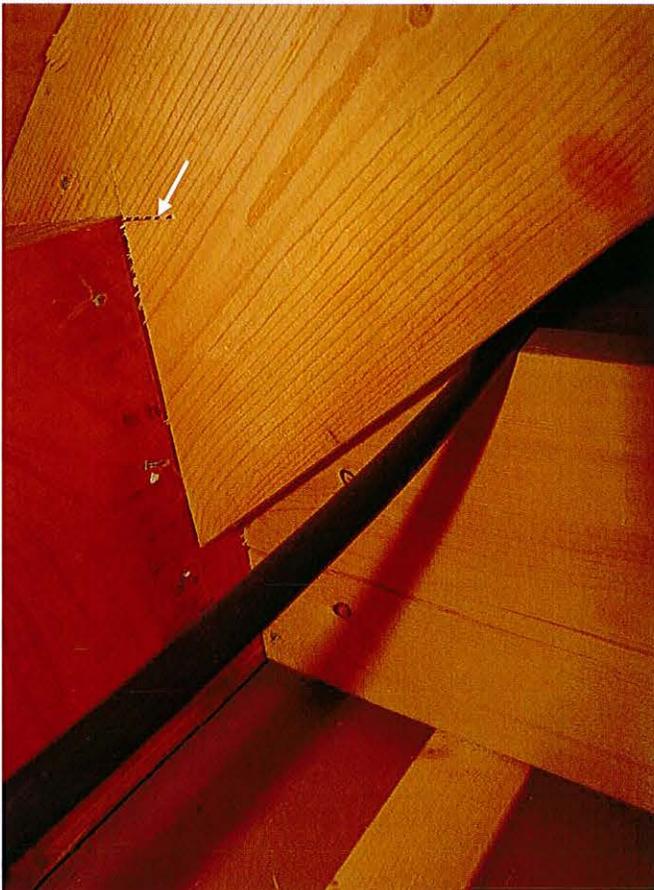
**PHOTOGRAPH 7**

Main roof rafter framing into side of LVL support beam without connector hardware. White arrow shows typical "overcut" condition at main roof rafter cuts.

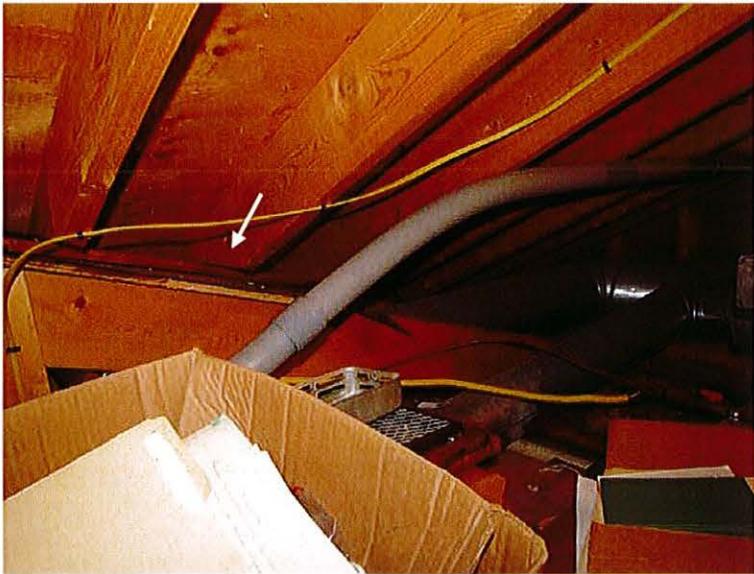
**PHOTOGRAPH 8**  
Typical overframed roof framing.

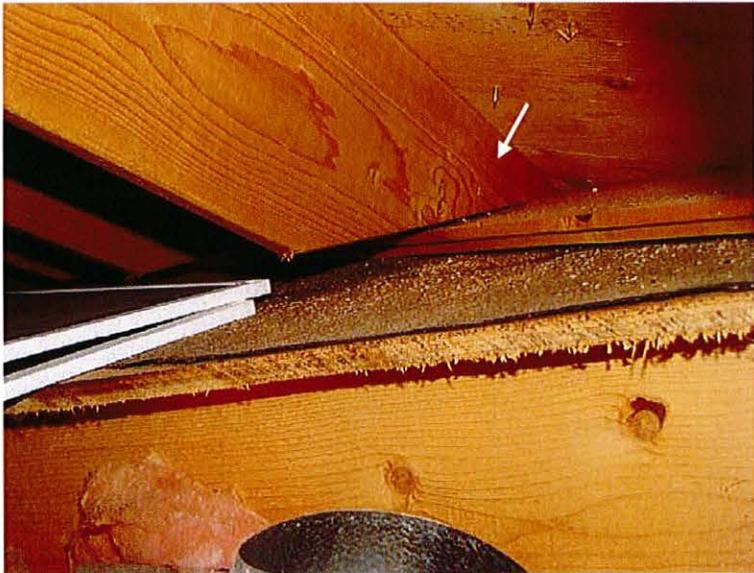
**PHOTOGRAPH 9**  
Typical overframed roof conditions showing minimal bearing area and no hold-downs or other connection hardware.

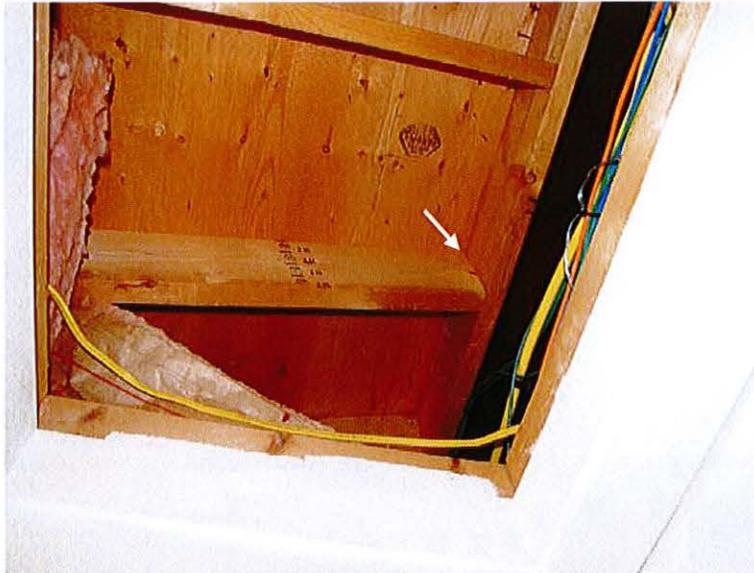
**PHOTOGRAPH 10**  
Typical framing conditions at "shed roof" on right (south) side of building. No connection hardware is visible between ledger and rafters. Very few nails were visible connecting the ledger to the exterior wall.

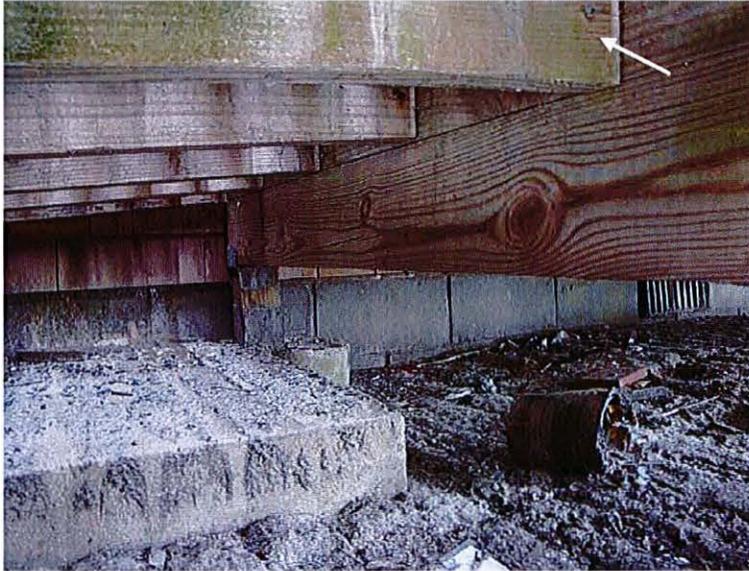
**PHOTOGRAPH 11**

- The ramp / deck framing on the north side of the building is supported by intermittent concrete "sonotube" foundations. At some locations, the joists are "flush-framed" to the supporting girders, but no connection hardware is present (Photo 11). Two of the observed support posts are misaligned with the supporting sonotubes, leaving less than 1/2" of the post bearing on the supporting concrete (Photo 12).

Wood joist framing at ramp on north side of building. No hardware connectors are present at flush-framed joists (white arrow). Post supporting end of girder bears partly on sonotube, partly on concrete pad. Post connector does not fit completely onto post.

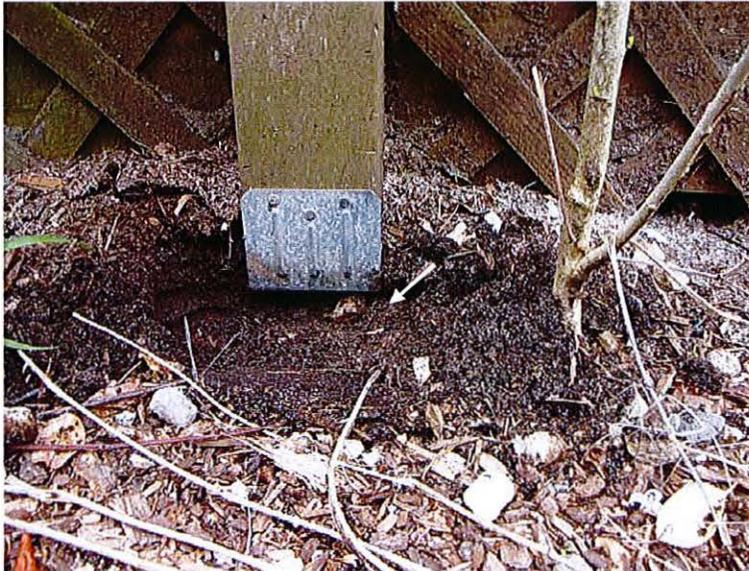
**PHOTOGRAPH 12**

Typical condition, observed ramp support posts do not bear on sonotube foundations.

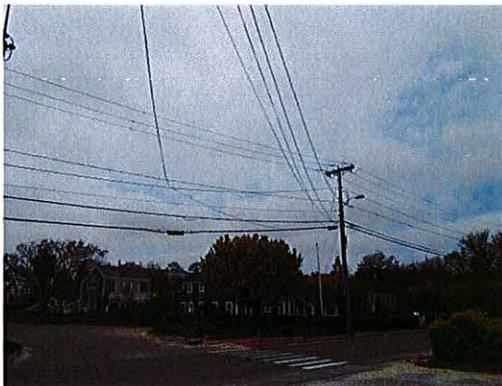
*Overhead Service Conductors*

The electrical service is derived from a utility pole on Washington Street on the opposite side of the road of the Building. The service comes overhead to a utility pole on the property, then underground and feeds two utility company meters, meter numbers 064008264 and 07208738. Meter 07208738 connects to the main distribution panel rated at 120/240V, 200 Ampere, 22 KAIC. The two meters and the main distribution panel are mounted exterior to the building on a wooden stand. The second meter may serve the dock power and lighting, this could not be determined at the time of the site visit. The equipment is beginning to show signs of deterioration due to weather conditions.

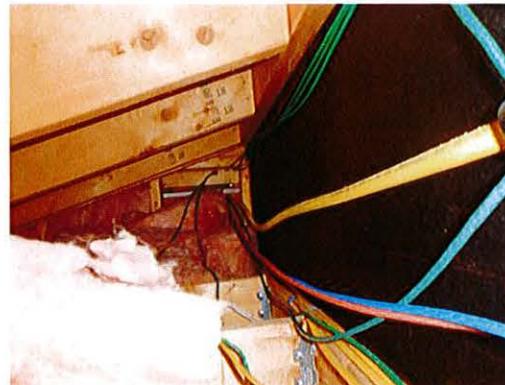
*Romex Wiring*

All wiring throughout the building is type NM cable “Romex” and is in violation of the NEC. NM type cable is not allowed in commercial buildings. There seems to be an adequate amount of receptacles where needed. There is an abundance of surface mounted raceways installed in renovated spaces; other wiring is run in the crawl space and within the eaves of the attic space.

Existing Romex wiring should be removed and replaced with MC type cable to comply with NEC.

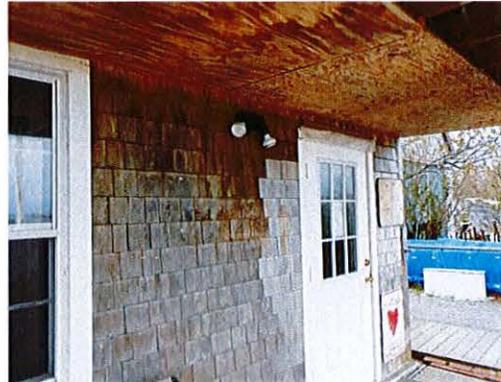
*Exterior Flood Lights*

Lighting consists of surface mounted fluorescent wrap around fixtures, recessed compact fluorescent fixtures in the Public Restrooms and wall mounted compact fluorescent sconces in the Stairwell. Lighting control is via local line voltage switches. Exterior lighting consists of HID flood lights. Interior lighting is in fair condition and the exterior lighting is in poor condition.

Occupancy sensors should be installed throughout the building to comply with the energy code. A timeclock and photocell should control the exterior lighting. Exterior light fixtures should be replaced with dark sky compliant LED fixtures.

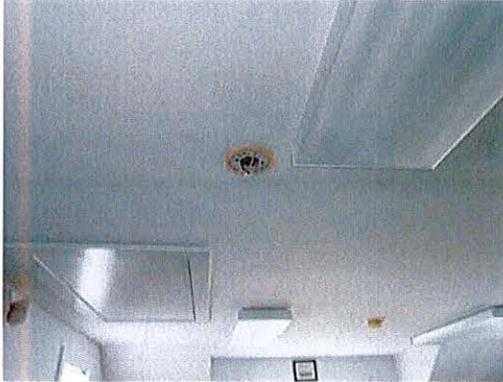
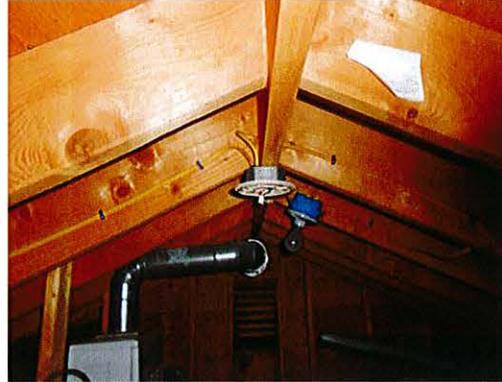
*Removed Device*

The fire alarm system consists of a Fire Lite MS-4 conventional 4-zone panel. The panel was normal and no troubles were present at the time of inspection. Detection devices consist of local smokes and C.O. detector laid out for a residential occupancy. System devices consist of heat detectors. No pull stations were noted during the visit. The A/V devices were located in the Public Restrooms and were in poor condition. A number of local 120V smokes have been removed, most likely due to false alarms.

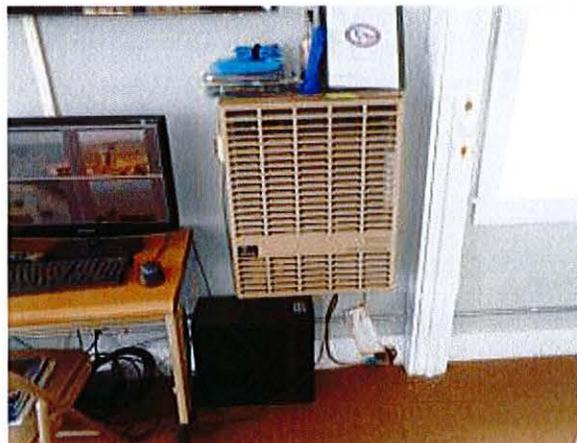
*Harbor Master's Office – Propane Fired Heating Unit*

The Harbor Master's office is heated by a wall mounted propane fired unit heater (manufactured by Empire). The unit heater and associated thermostat appear to be in poor condition.

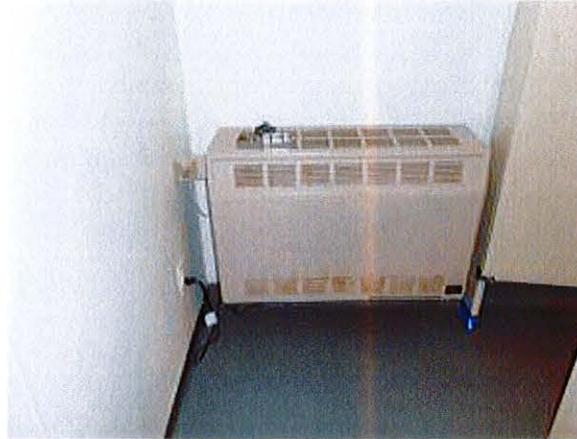
*Restroom Heating Unit (Typical of 2)*

Each of the restrooms are heated by propane fired unit heaters (manufactured by Empire) which appear to be in poor condition.

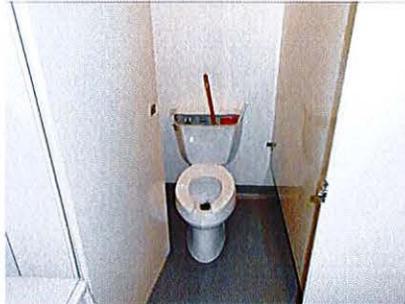
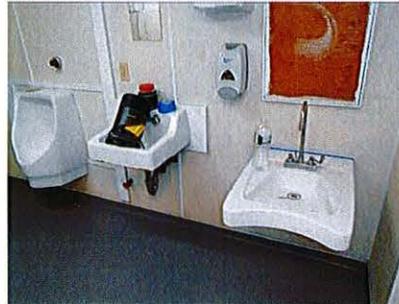
*Typical bathroom fixtures*

In general the plumbing fixtures do not meet accessibility standards. Installation of all new high efficiency fixtures are recommended.

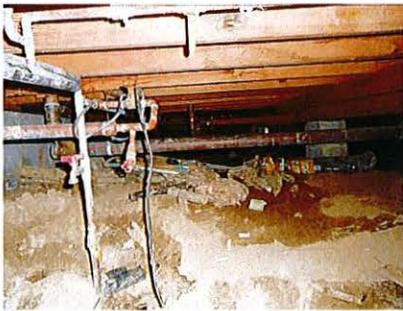
*Typical domestic water piping in crawl space*

The majority of the domestic distribution piping is located in the building crawl space. The crawl space allow for minimal accessibility for maintenance. Piping is copper tubing with sweat joints. The majority of the piping is not insulated. There are signs of corrosion at pipe joints and valves. Due to the lack of accessibility, a major renovation should include all new domestic water piping.
