TOWN OF NANTUCKET

Town of Nantucket
Capital Program Committee
www.nantucket-ma.gov

MINUTES

2015 NANTUCKET FACILITIES ASSESSMENT

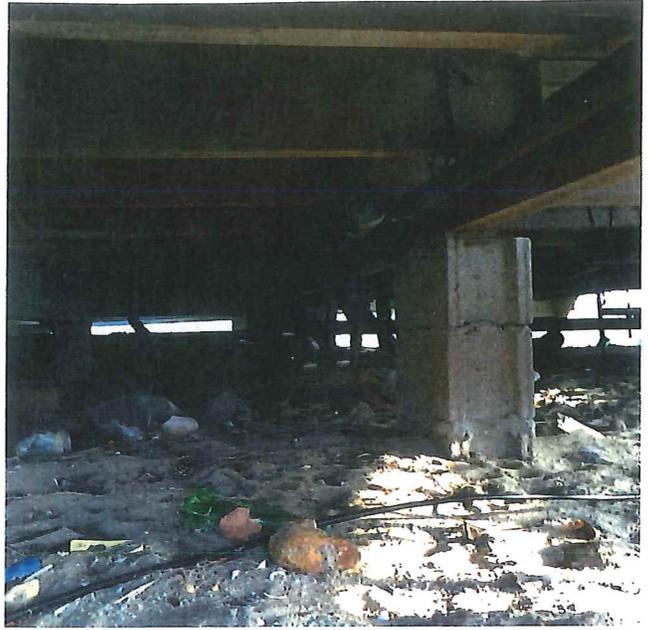
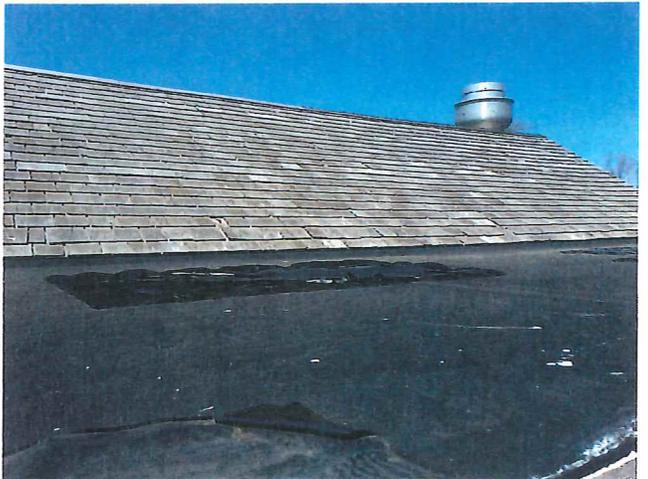
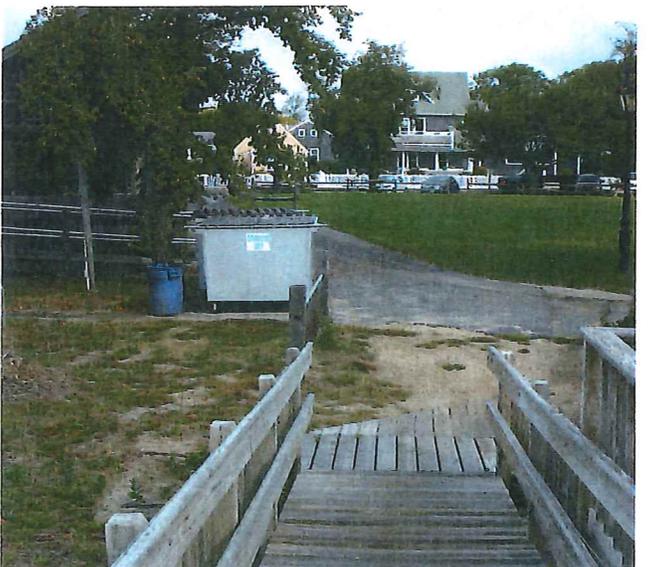
B1010 Floor Construction: Load capacity issues evident

B1080 Stairs: Egress stair appears non-compliant with current regulatory standards due to width, winders, riser height and /or tread depth..

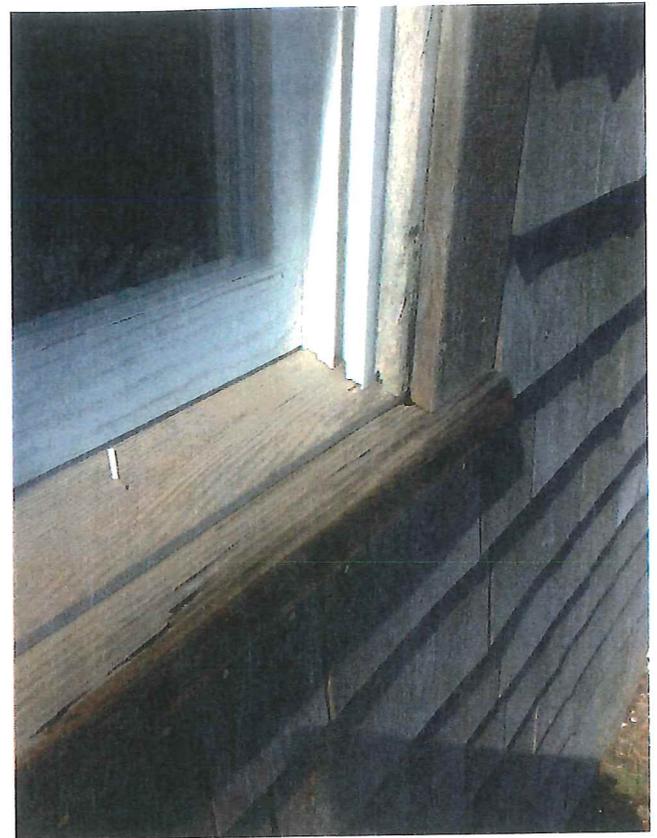
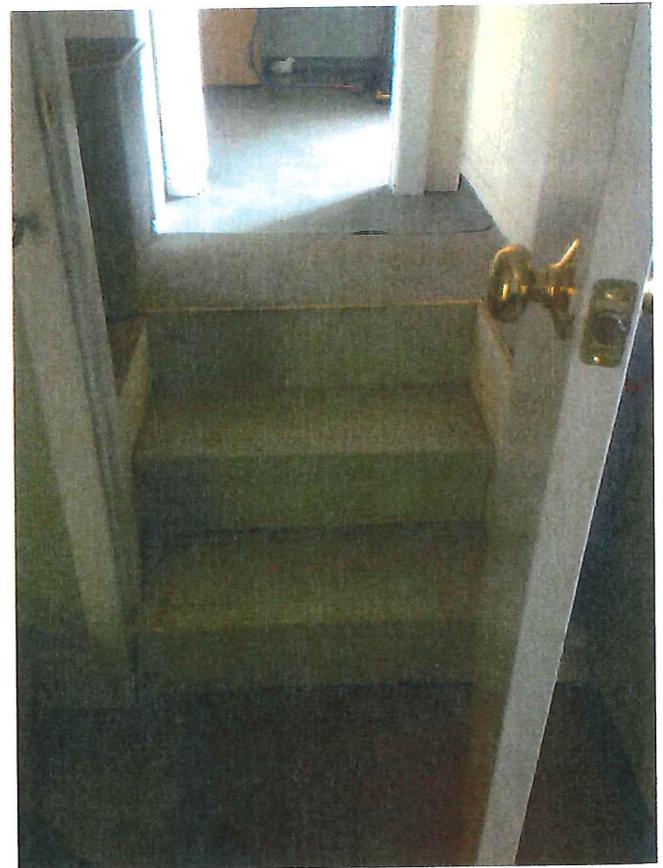
B2010 Exterior Walls: Moisture, mildew, mold, and/or moss issues evident

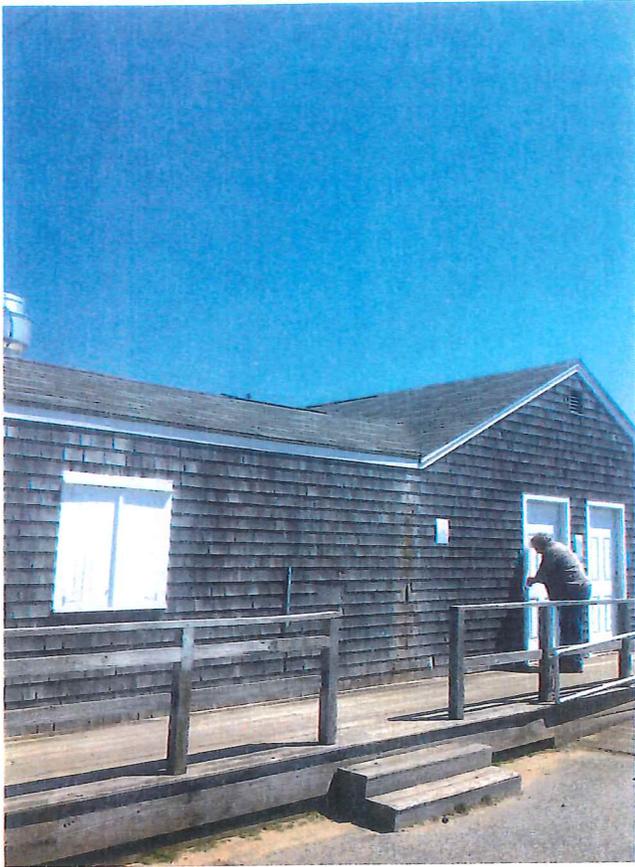
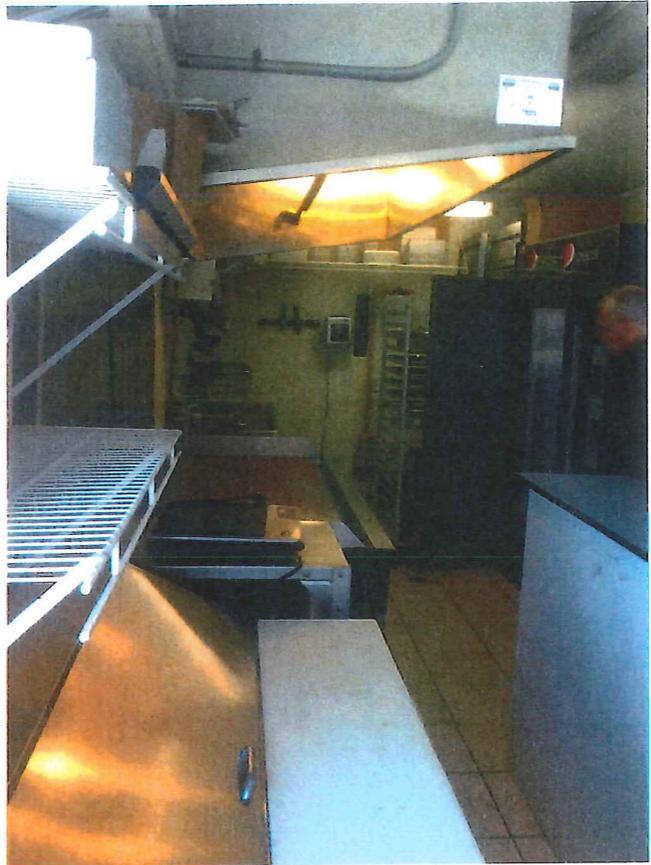
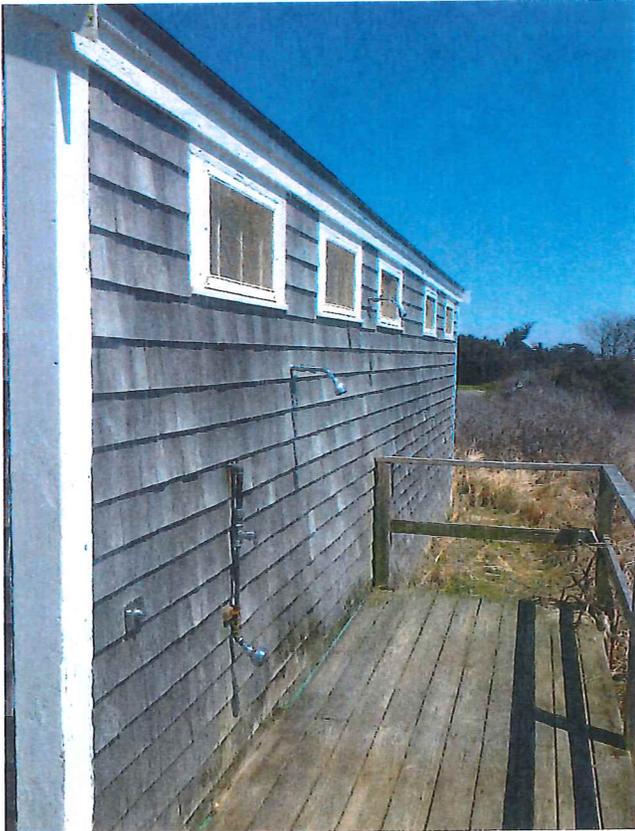
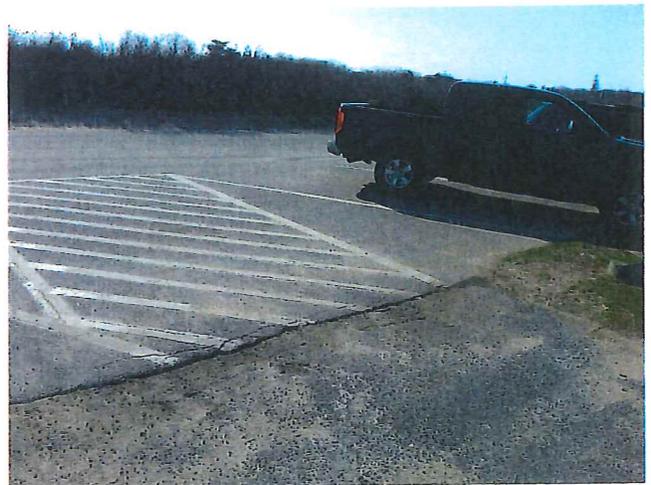
B3010.10 Steep Slope Roofing: Aging shingles, shakes, and/or tiles suggest new roof replacement

B1080.50 Stair Railings: Height lower than 42", is ladder type and/or baluster spacing exceed 4"
