# WPA Form 3 – Notice of Intent

Stabilization of roadway and utilities in the public layout of Baxter Road.

BAXTER ROAD  
NANTUCKET, MASSACHUSETTS

EXISTING CONDITIONS - TEMPORARY SLOPE STABILIZATION  
 BAXTER ROAD  
 SLOPE STABILIZATION  
 NANTUCKET, MASSACHUSETTS

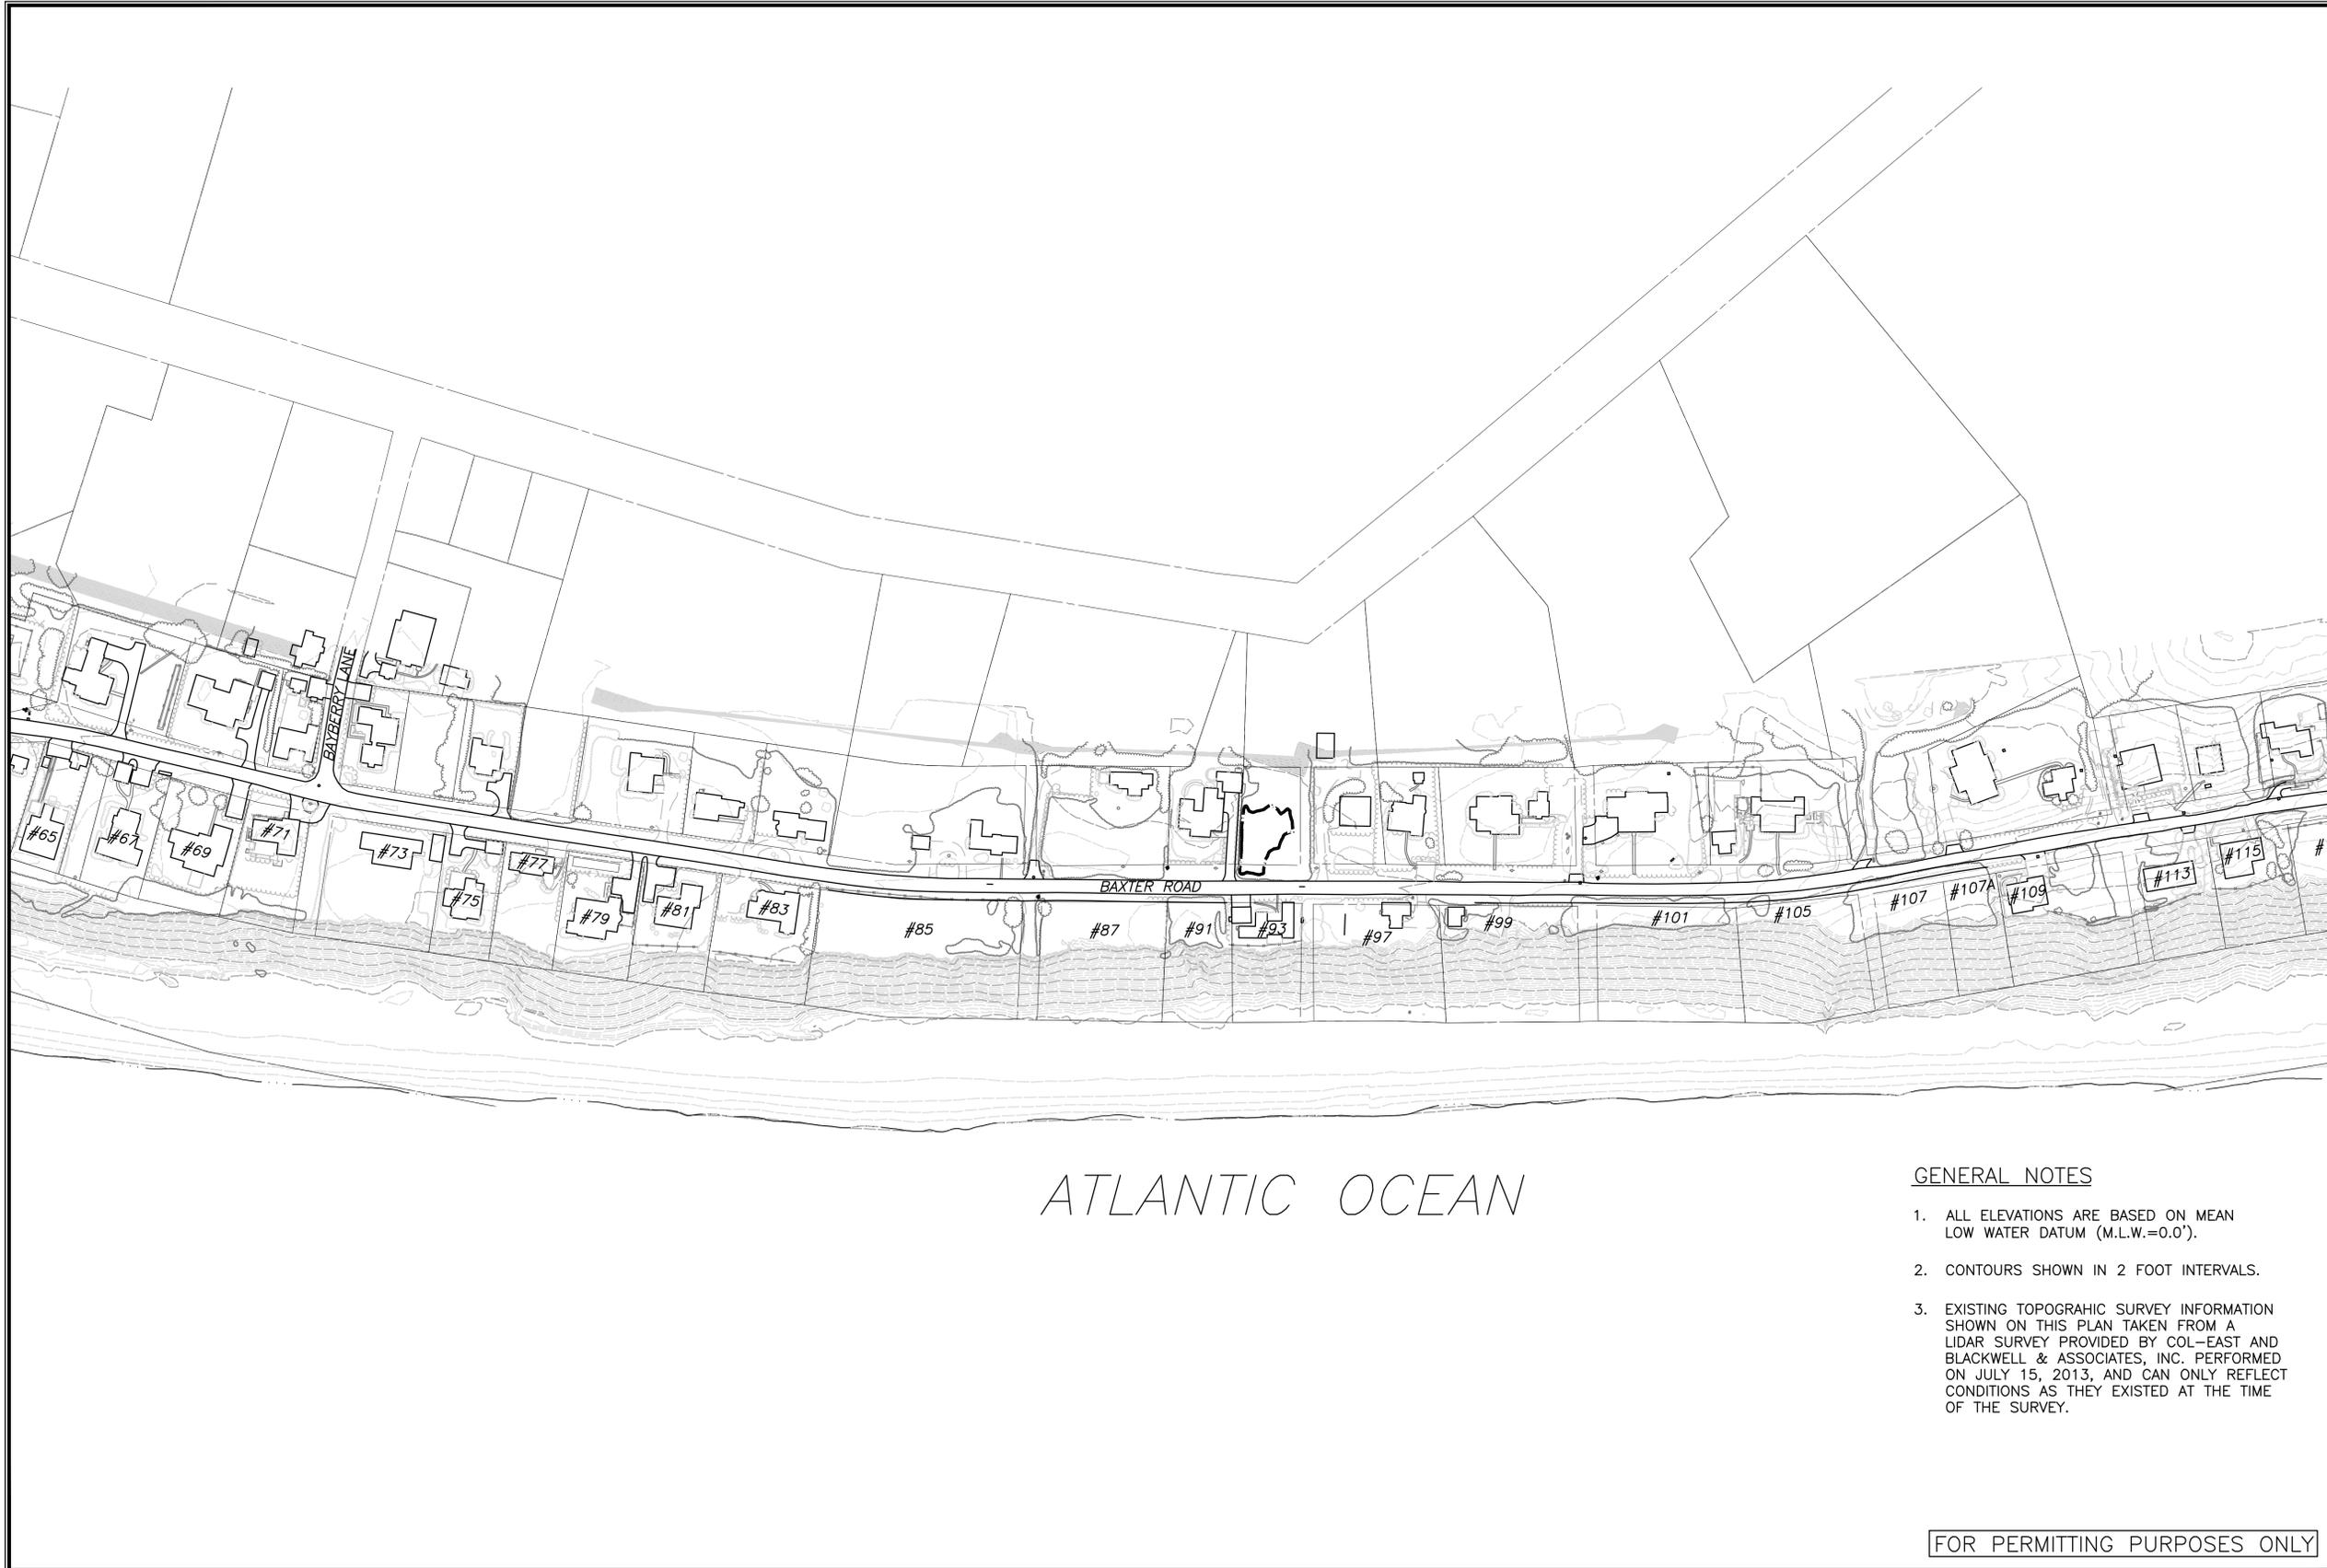
RSD	SMW	
DESIGNED	DRAWN	CHECKED
SCALE		
1" = 200'		
DATE		
OCT. 25, 2013		
PROJECT NO.		
2967-11		
SHEET NO.		
2 OF 9

1. ALL ELEVATIONS ARE BASED ON MEAN LOW WATER DATUM (M.L.W.=0.0').
2. CONTOURS SHOWN IN 2 FOOT INTERVALS.
3. EXISTING TOPOGRAPHIC SURVEY INFORMATION SHOWN ON THIS PLAN TAKEN FROM A LIDAR SURVEY PROVIDED BY COL-EAST AND BLACKWELL & ASSOCIATES, INC. PERFORMED ON JULY 15, 2013, AND CAN ONLY REFLECT CONDITIONS AS THEY EXISTED AT THE TIME OF THE SURVEY.

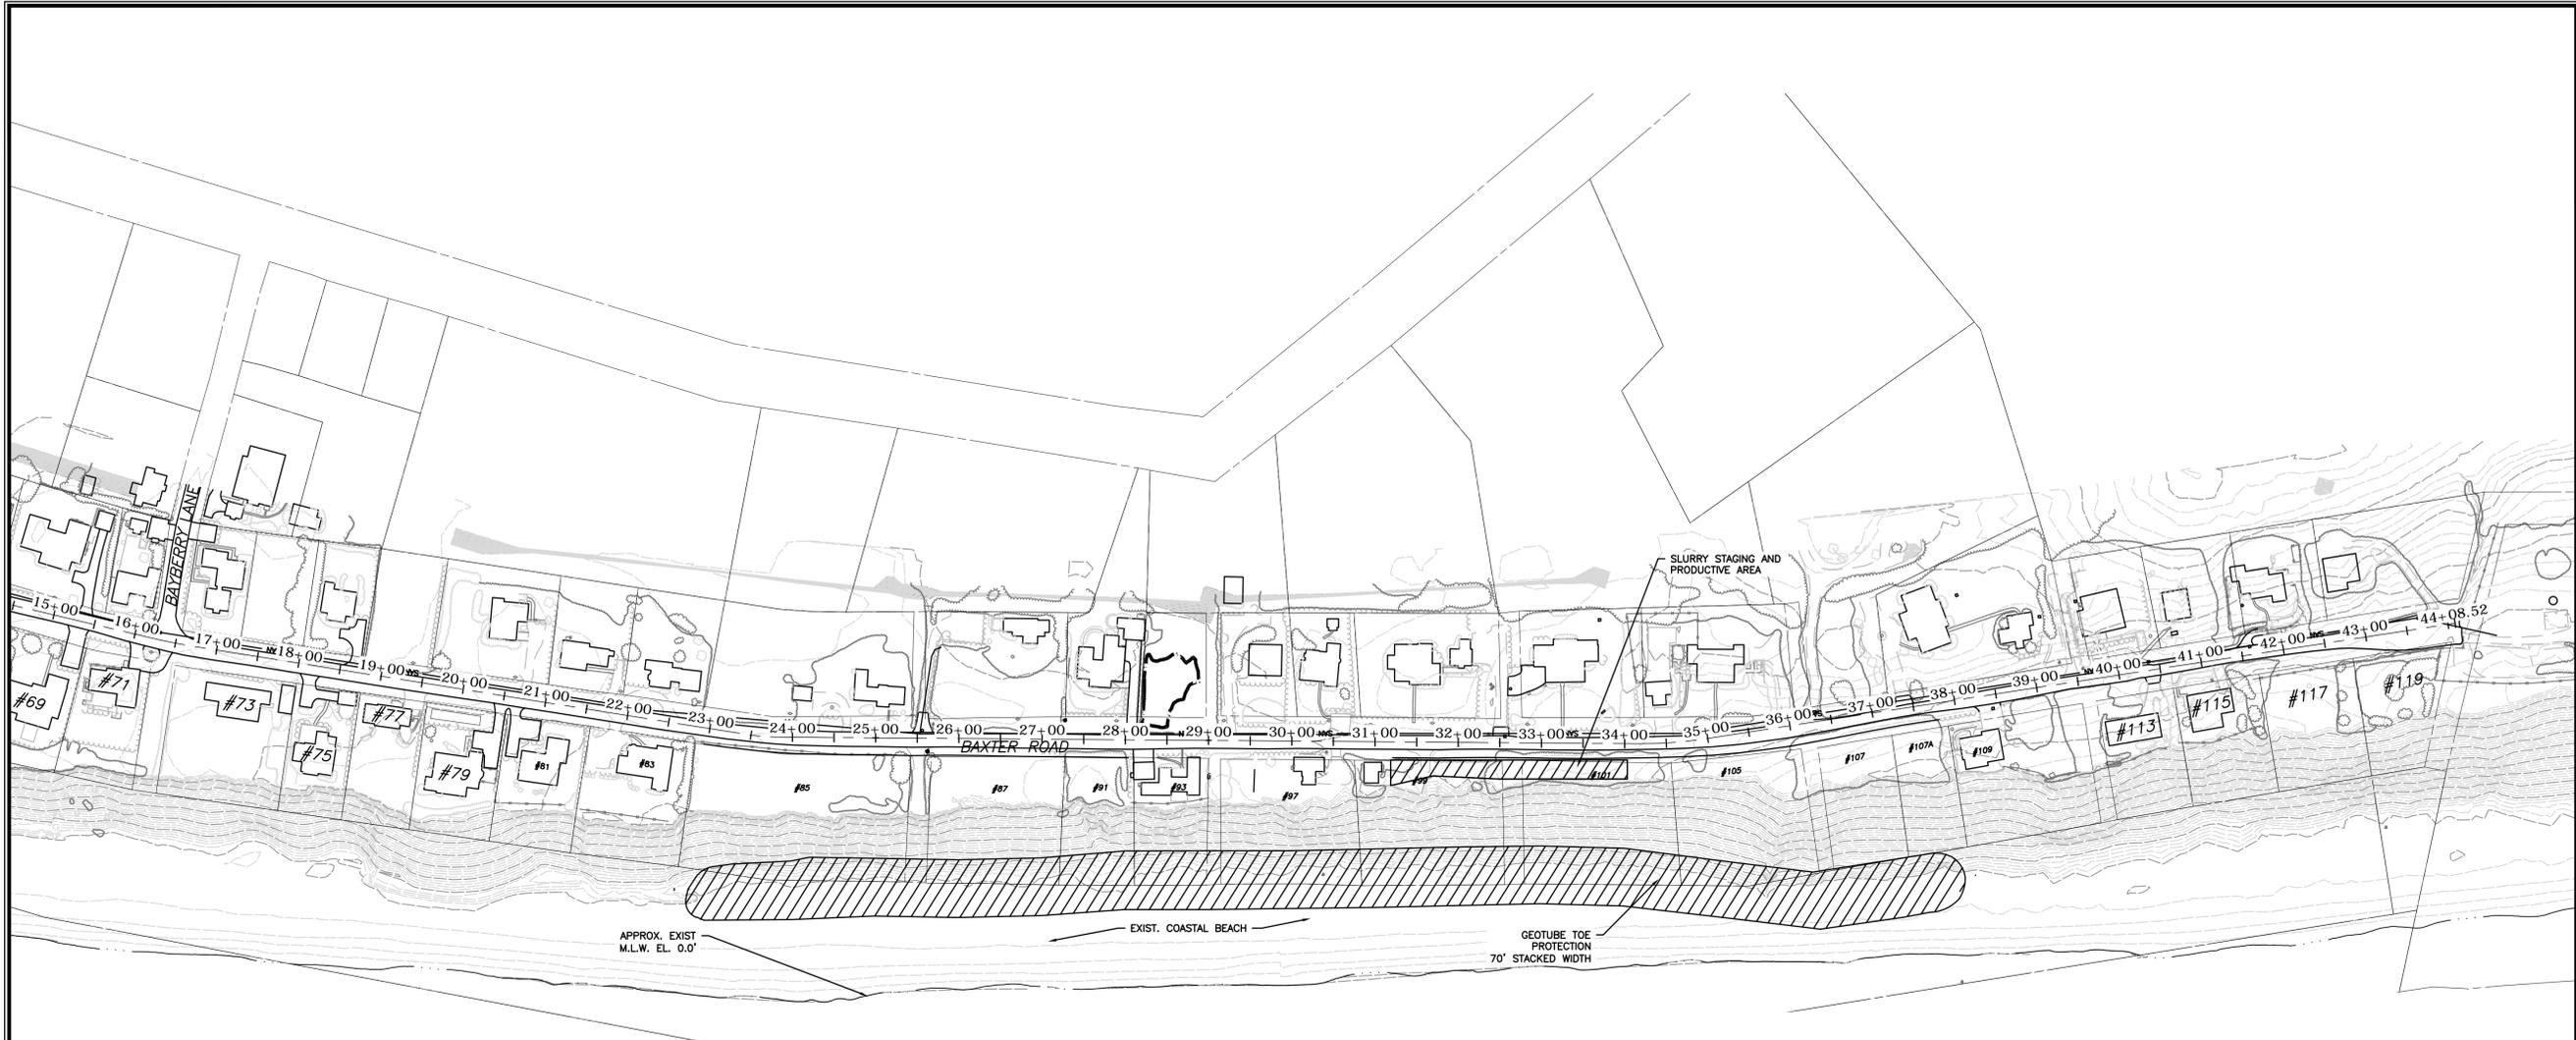
RSD	SMW	---
DESIGNED	DRAWN	CHECKED
SCALE 1" = 200'		
DATE OCT. 25, 2013		
PROJECT NO. 2967-11		
SHEET NO. 3 OF 9

NOTE:  
 LENGTH = 1,500 LF  
 AREA OF IMPACT = 105,320 SF

- ALL ELEVATIONS ARE BASED ON MEAN LOW WATER DATUM (M.L.W.=0.0').
- CONTOURS SHOWN IN 2 FOOT INTERVALS.
- EXISTING TOPOGRAPHIC SURVEY INFORMATION SHOWN ON THIS PLAN TAKEN FROM A LIDAR SURVEY PROVIDED BY COL-EAST AND BLACKWELL & ASSOCIATES, INC. PERFORMED ON JULY 15, 2013, AND CAN ONLY REFLECT CONDITIONS AS THEY EXISTED AT THE TIME OF THE SURVEY.
- LIMITS OF SAND COVER OVER THE GEOTEXTILE TUBES NOT SHOWN FOR CLARITY. FOR LIMITS SEE TYPICAL SECTION ON SHEET 4 AND CROSS SECTIONS SHEETS 5 THRU 9.
- GEOTUBE LIMITS, ELEVATIONS AND SLOPE IS BASED ON DESIGN PROVIDED BY MACAFFERI AND OCEAN & COASTAL CONSULTANTS.

The application consists of placing approximately 1,500 linear feet of geotubes extending from 85 Baxter Road to 107a Baxter Road. While initial application materials proposed two distinct sections of tubes only at the locations where roadway failure appears imminent and where no structures currently exist, the issue of flanking cannot be resolved in the gap area between the two systems. Therefore, the application materials request a continuous run of geotube from 85 Baxter Road to 107a Baxter Road.

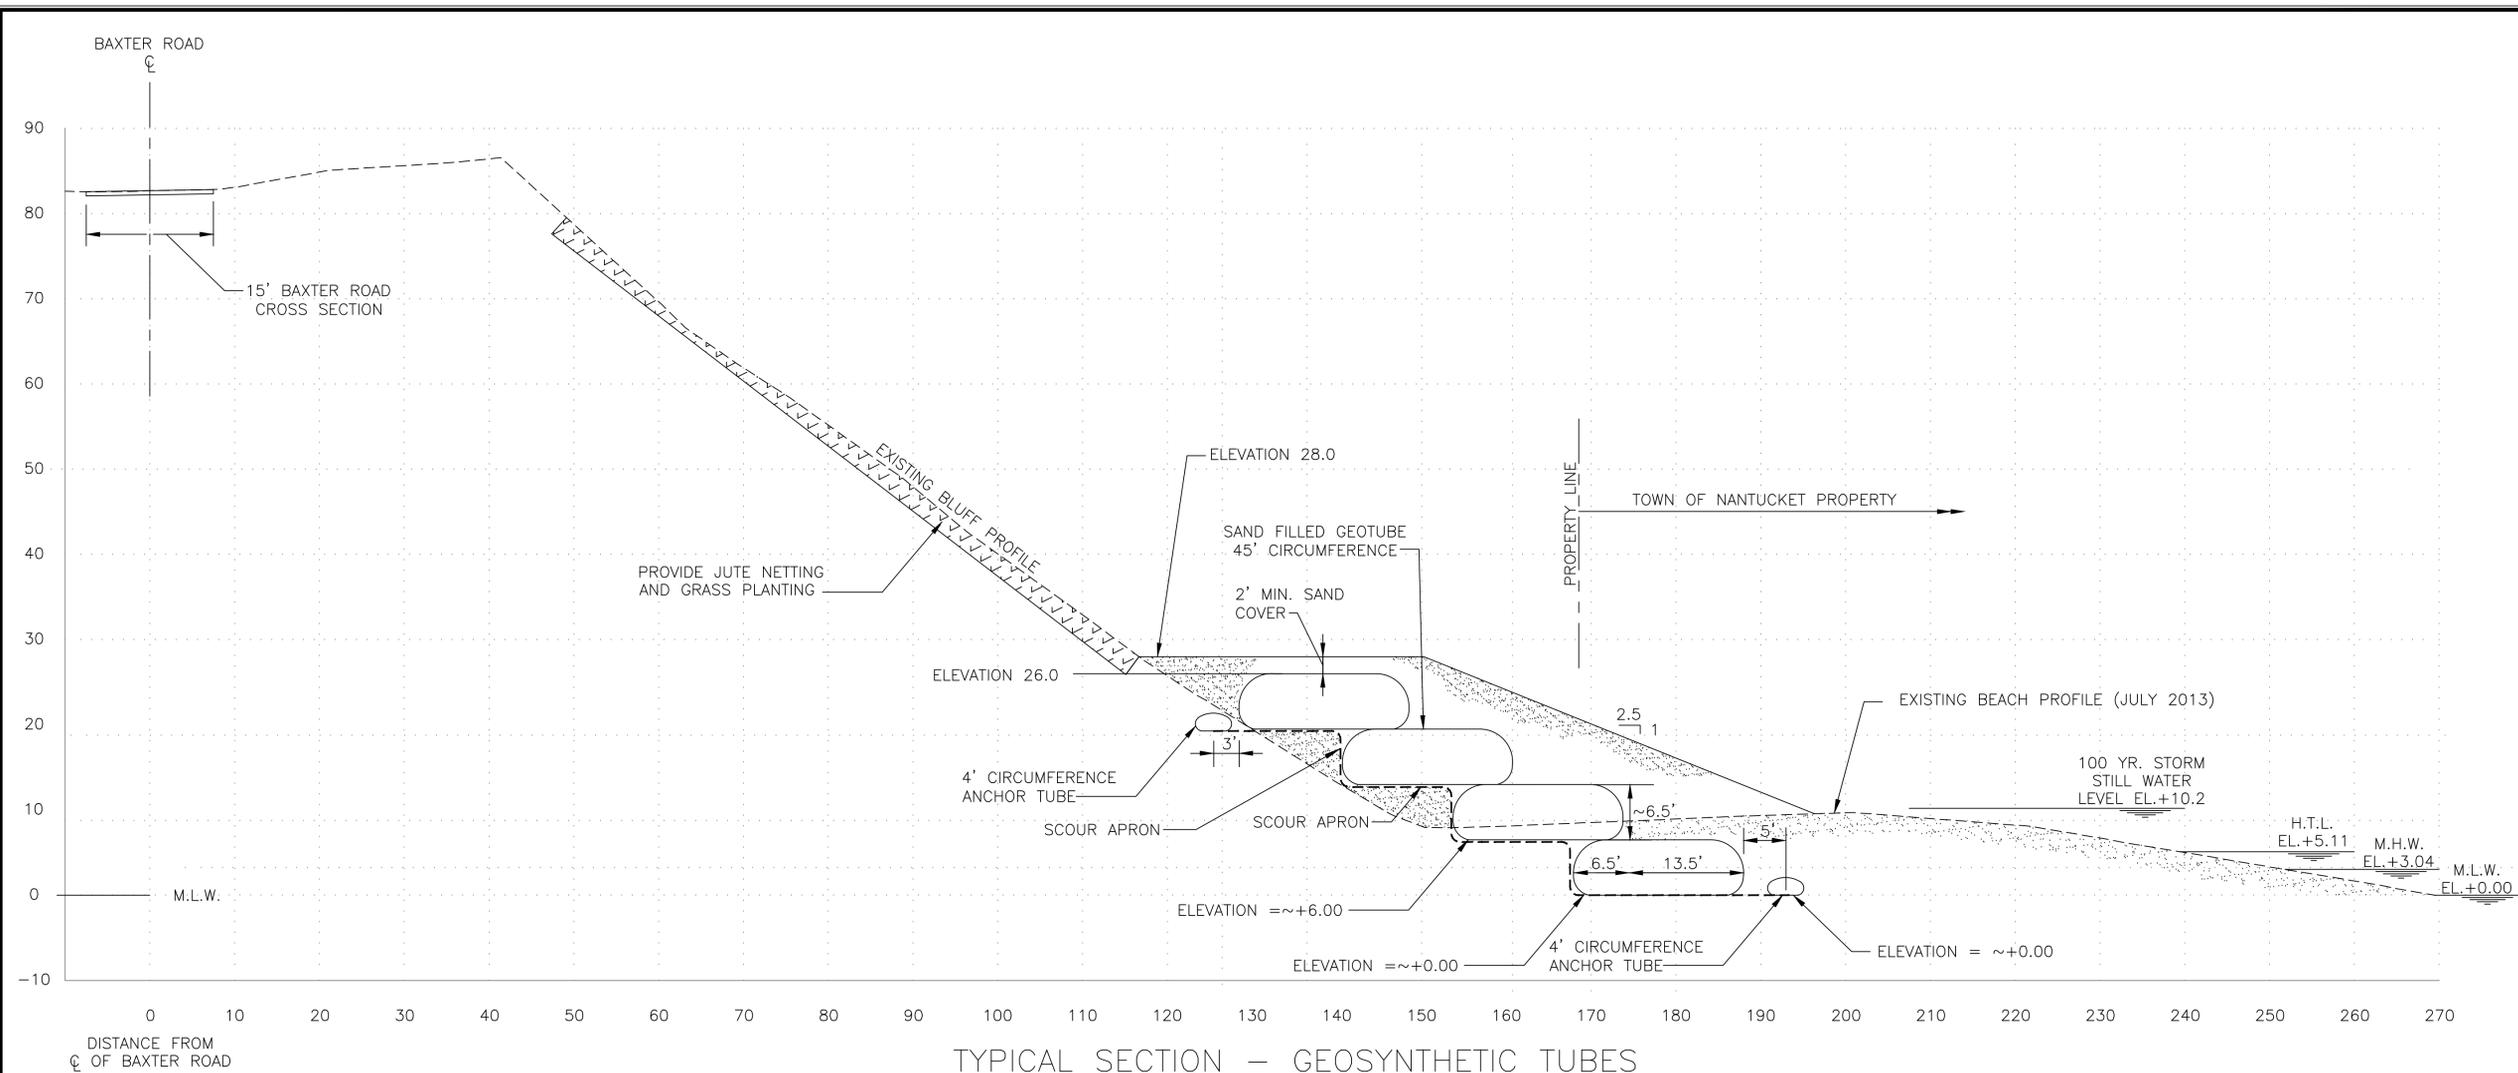
DESIGNED	SMW	---
DRAWN	---	---
CHECKED	---	---
SCALE HOR: 1" = 20' VERT: 1" = 20'		
DATE OCT. 25, 2013		
PROJECT NO. 2967-11		
SHEET NO. 4 OF 9

TYPICAL SECTION – GEOSYNTHETIC TUBES

6. SCOUR APRON SHALL BE APPROXIMATELY 60' WIDE SO AS TO EXTEND ALONG THE BOTTOM CONTOUR OF STACKED GEOTEXTILE TUBE CONFIGURATION.
7. SAND BACKFILL SHALL BE PLACED IN 12" LIFTS AND COMPACTED PRIOR TO PLACEMENT OF UPPER GEOTEXTILE TUBE LAYER, SO AS TO PROVIDE A FLAT STABLE BENCH FOUNDATION FOR THE GEOTEXTILE TUBE INSTALLATION.

- Geotube Alternative 3 – Four-Geotextile-Tube Configuration: The preferred alternative for toe stabilization and proposed in this request is the placement of four 45-foot diameter geotubes, with the bottom tube buried in the beach to elevation 0.0 MLW and the top tube set at elevation 26.0 MLW. The bottom tube and scour apron are buried to mitigate for localized toe scour that will inevitably occur at the base of the structure. The U.S. Army Corps of Engineers (USACE) recommends designing for a scour depth of 1.5 times wave height. The 1% annual chance breaking wave height at the structure toe is estimated at five feet. Using the USACE guidelines, the predicted scour depth may be up to 7.5 feet. This is approximately equal to the 0.0 MLW elevation selected for the base.

1. The existing beach within the footprint of the bottom geotube and scour apron layer will be graded to elevation 0.0 MLW and to achieve a maximum 1.5% slope in any direction. Given the variations in the beach profile, this will require varying amounts of excavation along the beach as noted in the cross sections shown on the project plans.

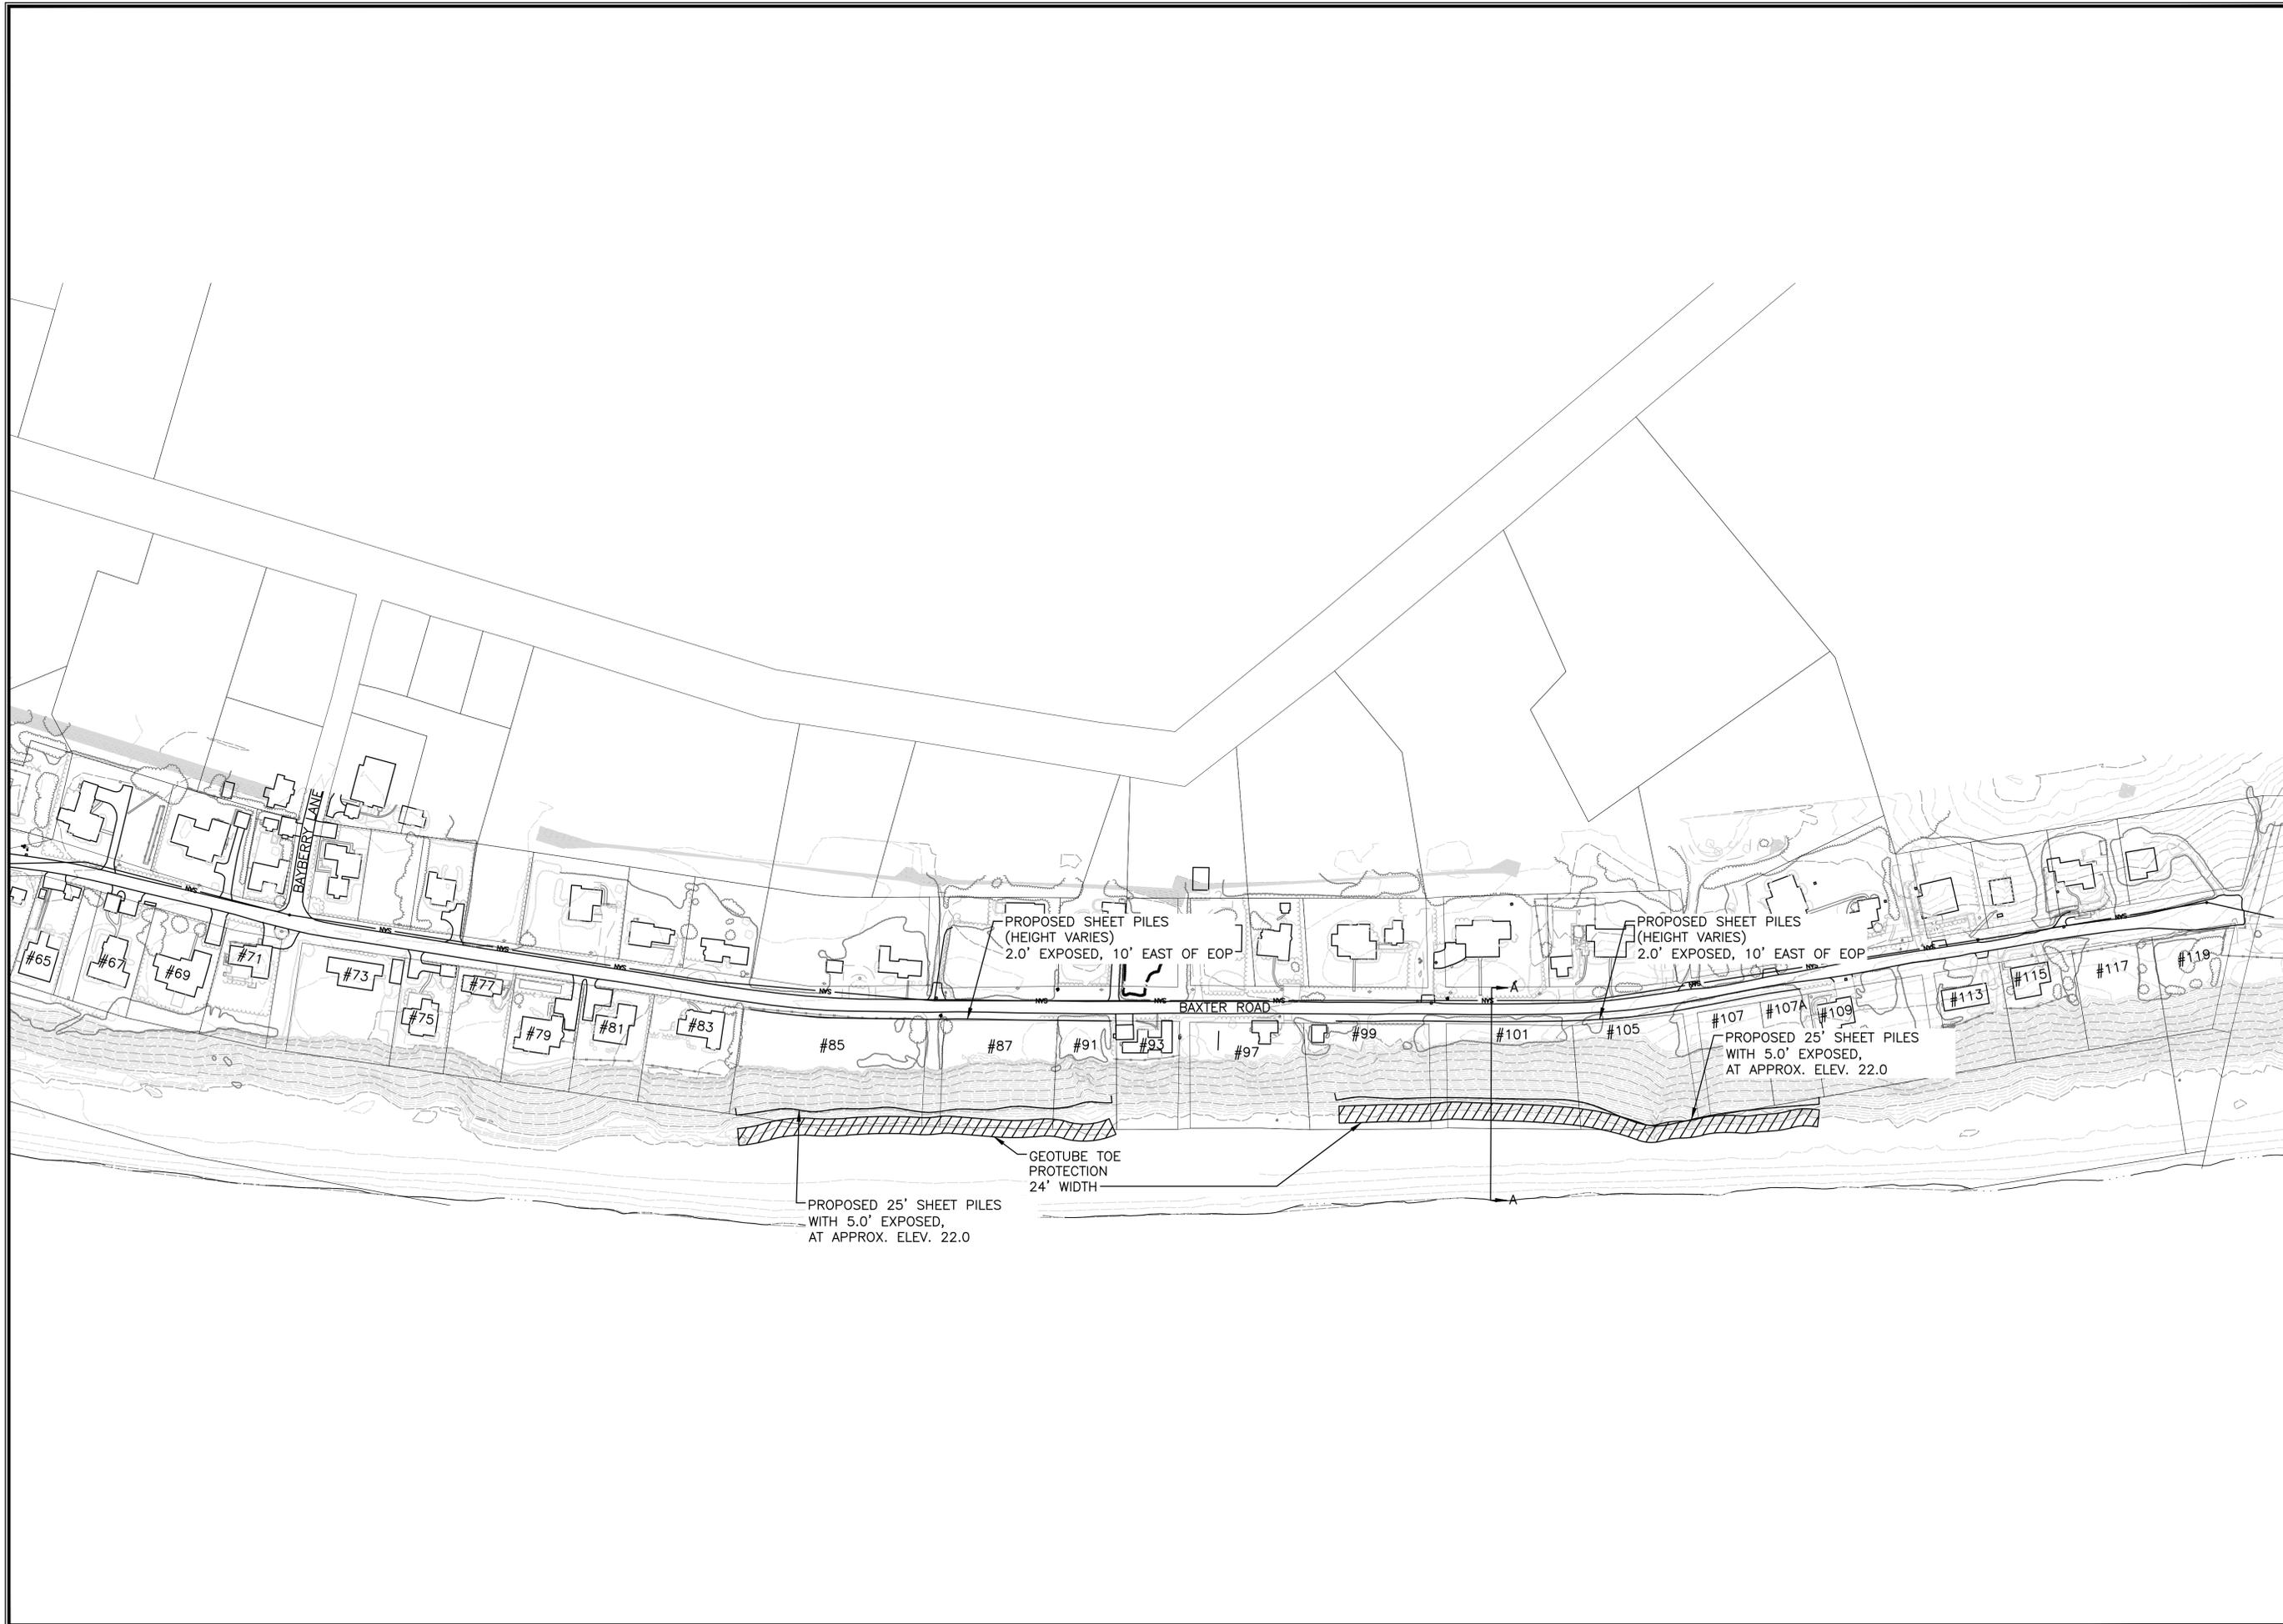
RSD DESIGNED	SW DRAWN	-- CHECKED
SCALE 1" = 100'		
DATE SEPT. 27, 2013		
PROJECT NO. 2967-11		
SHEET NO. 1 OF 6		
SHEET NAME

**PLAN VIEW - SLOPE STABILIZATION ALTERNATIVES**  
**BAXTER ROAD**  
**SLOPE STABILIZATION**  
 NANTUCKET, MASSACHUSETTS

Per request of the town of Nantucket, Milone & MacBroom, Inc. has evaluated potential methods of stabilizing Baxter Road to protect access to private residences and existing sewer and water utilities located beneath the roadway. As noted on our memorandum of September 24, 2013 the goal of this current effort is to maintain vehicular access and utility service to the residential properties on Baxter Road from Bayberry Lane north to the Sankaty Head Lighthouse. The project limits evaluated by MMI are limited to those areas where Baxter Road appears in imminent danger of failure from bank failure. Specifically, our project area extends from 85 to 91 Baxter Road and from 99 to 107.

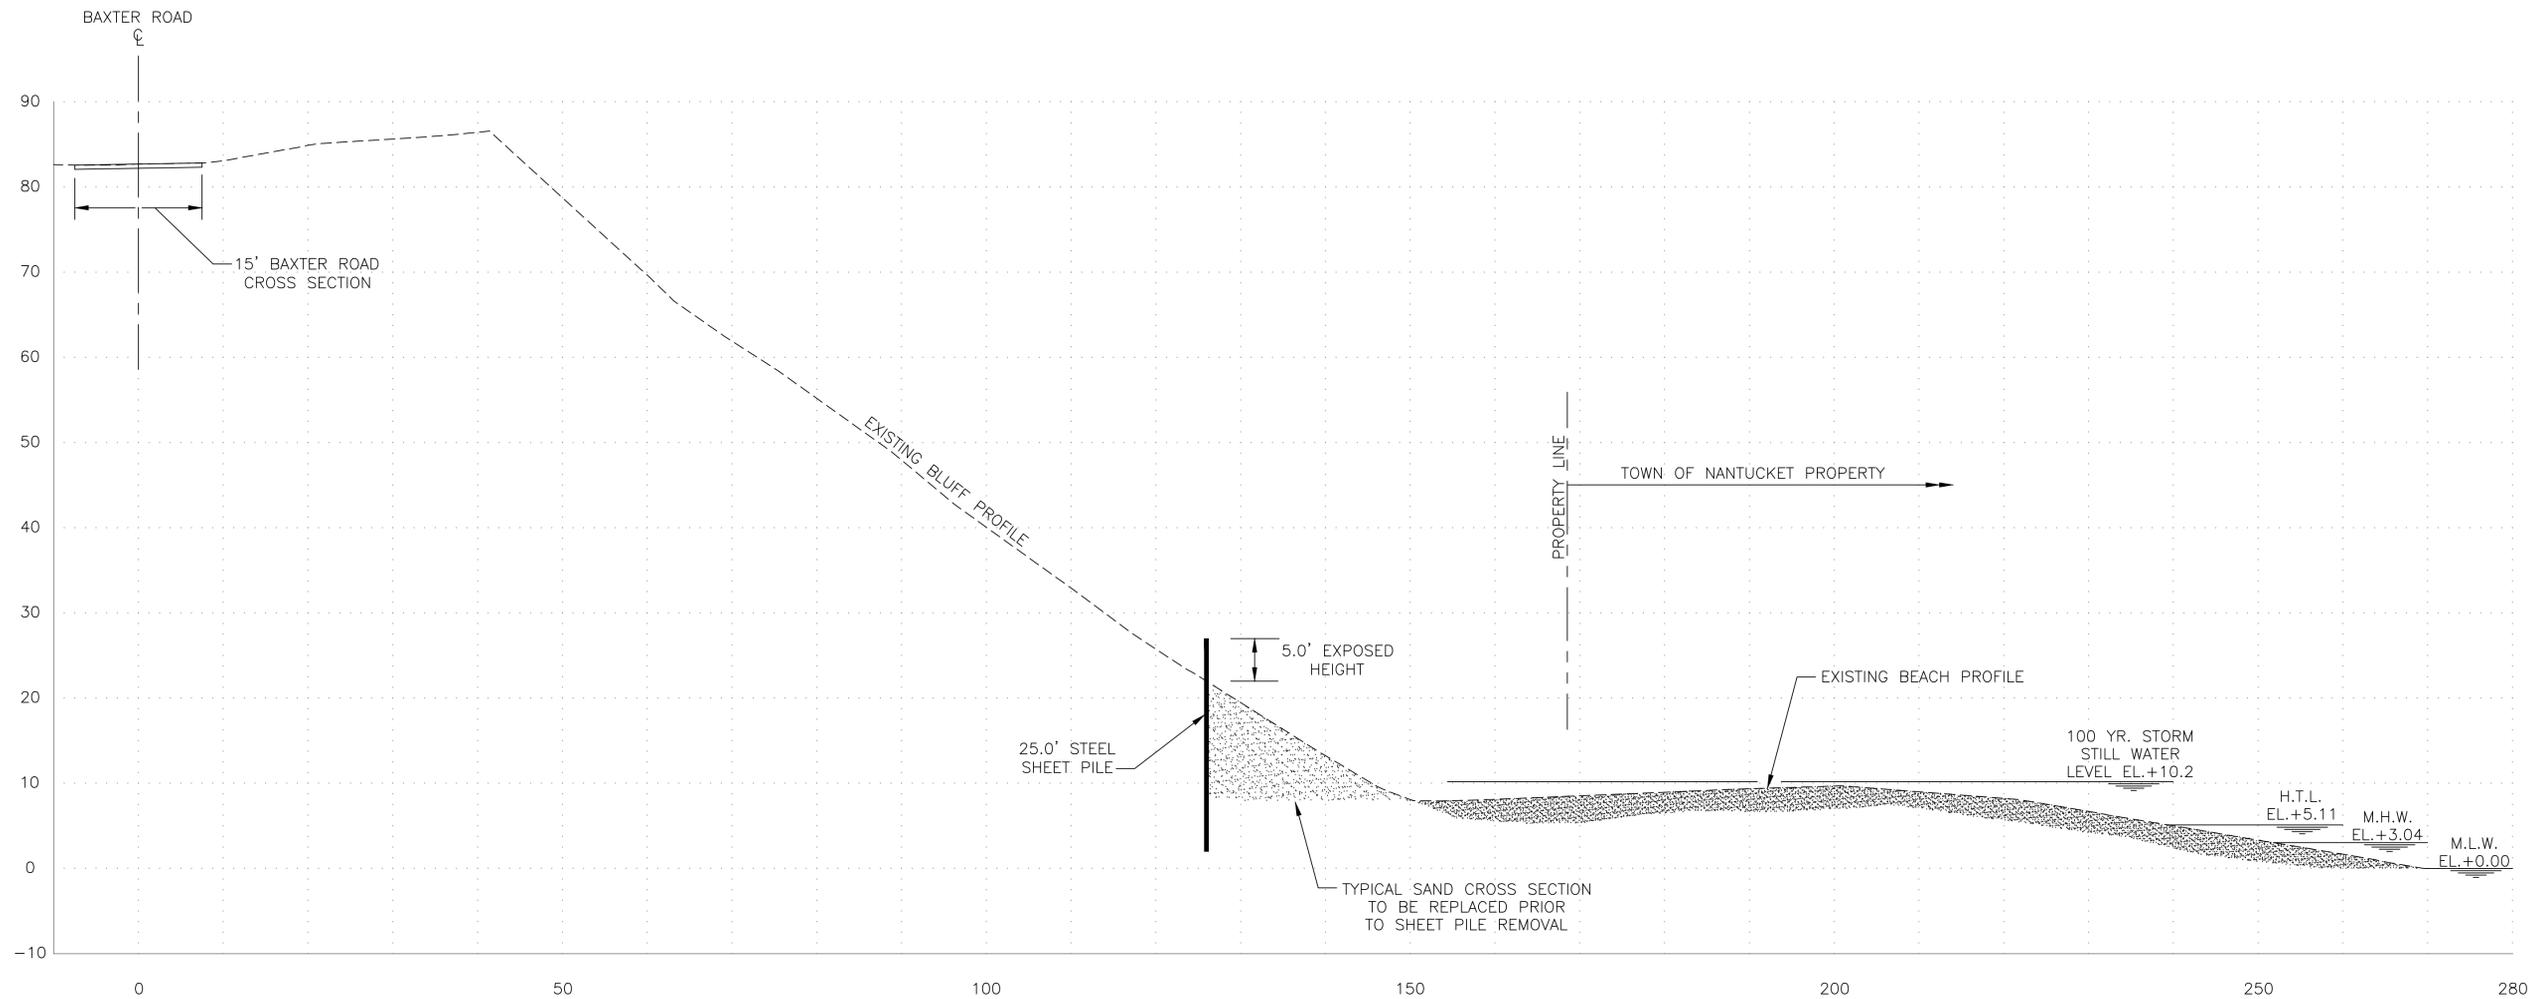
RSD DESIGNED	SW DRAWN	-- CHECKED
SCALE 1" = 10'		
DATE SEPT. 27, 2013		
PROJECT NO. 2967-11		
SHEET NO. 3 OF 6

SECTION A-A: ALTERNATIVE 1

STABILIZATION ALTERNATIVE	DESCRIPTION	ALTERNATIVE ADVANTAGES	ALTERNATIVE DISADVANTAGES	APPROXIMATE CONSTRUCTION ESTIMATE	APPROXIMATE CONSTRUCTION DURATION
ALTERNATIVE #1 STEEL SHEET PILES	SHEET PILES DRIVEN AT TOE OF SLOPE, AT APPROXIMATE ELEVATION 22.0. PILES TO BE 25.0' LONG WITH 5.0' LEFT EXPOSED	<p>SHEETING PROVIDES SOLID PROTECTION FROM UNDERMINING AND EROSION OF TOE THROUGH WAVE ACTION DURING STORMS.</p> <p>PILES INSTALLED IN SAND LENS AT TOE OF SLOPE MORE EASILY INSTALLED. SOIL COMPOSITION REQUIRES LESS IMPACT OR VIBRATION TO REACH DESIRED INSTALLATION DEPTH.</p> <p>INSTALLATION FROM BEACH PROVIDES RESULTS IN FEWER DISRUPTIONS TO BAXTER ROAD VEHICLE TRAFFIC AND LOCAL RESIDENTS.</p>	<p>STEEL SHEETING IS A FORM OF HARD ARMORING EROSION PROTECTION.</p> <p>WAVE REFLECTION MAY BECOME A CONCERN IF THE SAND IN FRONT OF THE SHEETING ERODES.</p> <p>ANY SAND WHICH ERODES FROM IN FRONT OF THE SHEETING WILL NEED TO BE REPLENISHED PRIOR TO REMOVAL OF SHEETING.</p> <p>SAND MAY NEED TO BE REPLENISHED EACH SPRING.</p> <p>CRANE AND OTHER EQUIPMENT WILL REQUIRE ADDITIONAL MOBILIZATION TO REMOVE PILES.</p> <p>MATERIAL/EQUIPMENT WILL NEED TO BE BARGED TO SHORE.</p> <p>ANGER OF FLANKING AT ENDS.</p>	<p><u>SHEET PILE ESTIMATE</u> APPROXIMATE TOTAL SHEET PILE WALL LENGTH = 1,270 FT</p> <p>TYPICAL DRIVEN DEPTH = 25.0 FT</p> <p>UNIT PRICE = \$50/SF</p> <p>INSTALLED SHEETING COST = \$1,587,500</p> <p><u>SAND REPLENISHMENT ESTIMATE</u> TOTAL REPLENISHMENT VOLUME = 6,600 CY</p> <p>UNIT PRICE = \$50/CY</p> <p>SAND REPLENISHMENT COST = \$330,000 (PER APPLICATION)</p> <p>TOTAL ESTIMATED COST = <u>\$1,917,500</u></p>	<p>ESTIMATED DAILY OUTPUT = 1000 SF PER 8 HOUR DAY</p> <p>TOTAL BURIED SHEETING SQUARE FOOTAGE = 28,575 SF</p> <p>ESTIMATED CONSTRUCTION DURATION = <u>29 WORK DAYS</u></p>

This alternate would entail driving steel sheet piling along the toe of the bluff for a distance of approximately 1720 feet, essentially through the project sections defined above, and to a depth of approximately 20 feet. The sheet piling would serve to protect the toe of slope from erosion due to wave action. To maintain this system, sand may have to be replaced along the waterward face of sheeting periodically as erosion occurs. Construction would result in steel sheeting being visible from the existing ground surface to elevation 22.0, with an average exposed height of five feet. Not only would this create less than desirable aesthetics, the sheeting would create an unnatural physical barrier paralleling the shoreline. The bulkhead would likely be capped with poured-in-place concrete. This option, focusing on

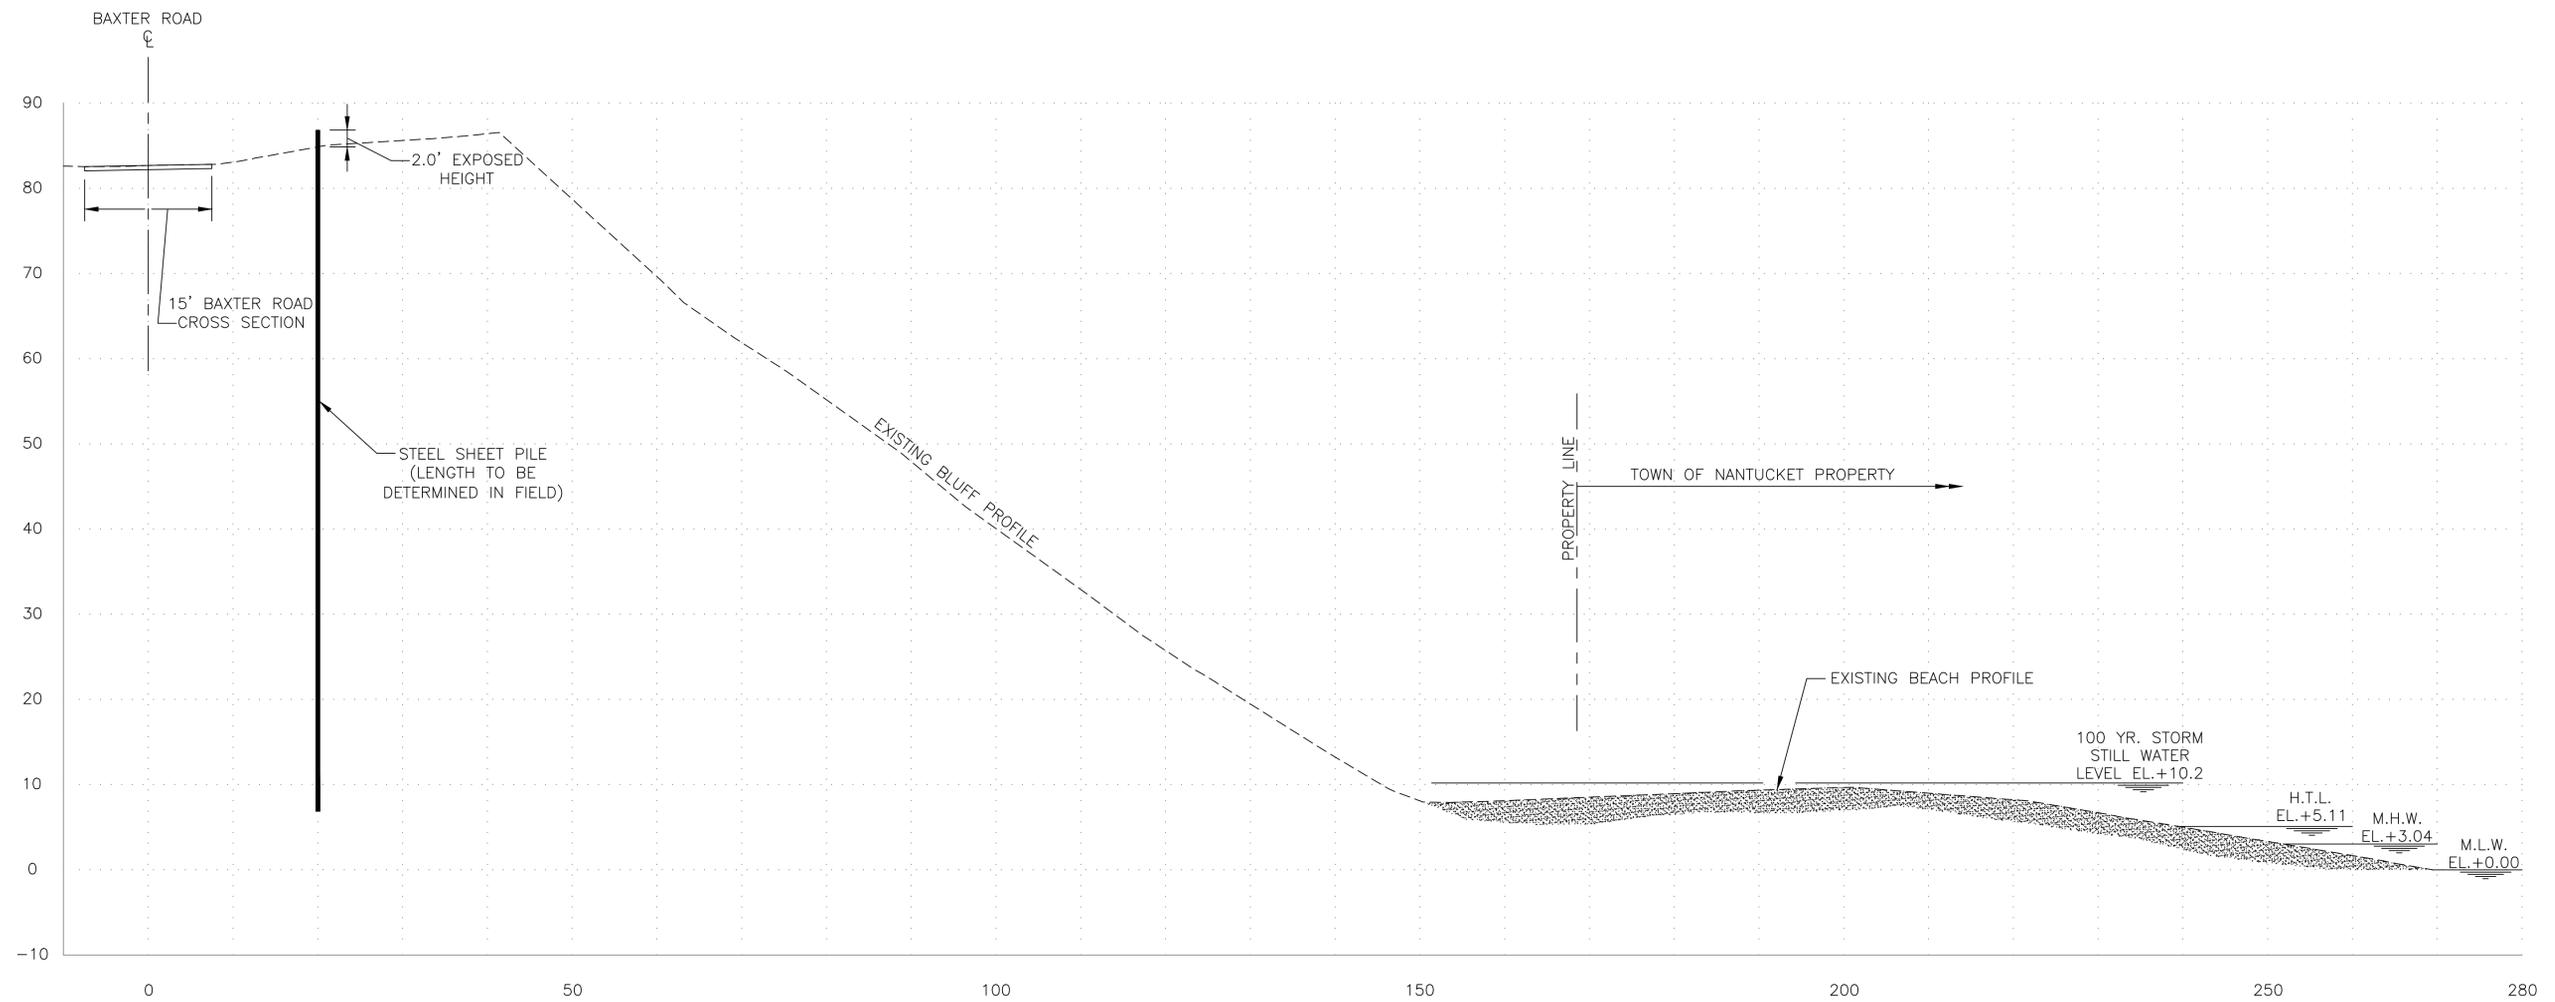
RSD DESIGNED	SW DRAWN	-- CHECKED
SCALE 1" = 10'		
DATE SEPT. 27, 2013		
PROJECT NO. 2967-11		
SHEET NO. 4 OF 6

SECTION A-A: ALTERNATIVE 2

STABILIZATION ALTERNATIVE	DESCRIPTION	ALTERNATIVE ADVANTAGES	ALTERNATIVE DISADVANTAGES	APPROXIMATE CONSTRUCTION ESTIMATE	APPROXIMATE CONSTRUCTION DURATION
ALTERNATIVE #2 STEEL SHEET PILES	SHEET PILES DRIVEN AT THE TOP OF SCONSET BLUFF, APPROXIMATELY 10' EAST OF THE EASTERN EDGE OF BAXTER ROAD.	SHEETING CAN BE INSTALLED FROM THE TOP OF THE BLUFF, ELIMINATING THE NEED TO BARGE EQUIPMENT ONTO THE BEACH. SHEETING SHOULD PREVENT SUDDEN CATASTROPHIC COLLAPSE OF BAXTER ROAD AND EXISTING UTILITIES SHOULD THE BLUFF ERODE AND RETREAT TOWARDS THE ROADWAY.	TO PREVENT GLOBAL FAILURE OF THE SLOPE PILES WILL NEED TO HAVE A LENGTH OF 80 FT OR MORE. INSTALLATION IS IN CLOSE PROXIMITY TO RESIDENCES. DUE TO THE DENSE SOIL COMPOSITION AT THE TOP OF THE BLUFF THE SHEET PILES WILL NEED TO BE HAMMERED INTO THE GROUND. THIS INSTALLATION TECHNIQUE WILL BE DISRUPTIVE TO RESIDENTS. DRIVING OF PILES IN CLOSE PROXIMITY TO EXISTING WATER MAIN ALONG BAXTER ROAD COULD CREATE UNSEEN DAMAGE AND/OR LEAKS. SHEET PILE INSTALLATION AT TOP OF BLUFF DOES NOT PREVENT/RETARD EROSION AT THE TOE OF THE SLOPE. IF THE SLOPE FAILS UP TO THE SHEET PILES FUTURE REMOVAL MAY BECOME DIFFICULT/IMPOSSIBLE. CRANE WILL NEED TO BE INSTALLED WITHIN BAXTER ROAD, BLOCKING ACCESS TO AREAS TO THE NORTH.	SHEET PILE ESTIMATE APPROXIMATE TOTAL SHEET PILE WALL LENGTH = 1,160 FT TYPICAL DRIVEN DEPTH = 80 FT UNIT PRICE = \$50/SF INSTALLED SHEETING COST = \$4,640,000 TOTAL ESTIMATED COST = <u>\$4,640,000</u>	ESTIMATED DAILY OUTPUT = 750 SF PER 8 HOUR DAY TOTAL BURIED SHEETING SQUARE FOOTAGE = 92,800 SF ESTIMATED CONSTRUCTION DURATION = <u>124 WORK DAYS</u>

The second alternative would involve driving steel sheet piling along the edge of Baxter Road, or the edge of the town-owned roadway right-of-way, generally to the limits described above. The intent is to protect the town-owned infrastructure, rather than address toe failure. The premise behind this alternative is that the sheet piling would support the roadway in the event of a total or partial but significant slope failure. Theoretically this alternative is viable, however considering the practicality of construction and geotechnical limitations of the area, several issues suggest that driving sheeting along the roadway is not feasible. First, the sheets would be very long and difficult to drive through the thick glacial till layer. Additionally, a substantial tieback system would be required, extending under the street and likely conflicting with utilities. The depth of the sheets would be determined, in part, by the assumed retained height based on some failure scenario. Accommodating a complete slope failure would be largely infeasible, and planning for a partial failure would be difficult given the nature of the sandy soil layer along the toe of slope and difficulty in establishing slope stability in conjunction with the sheet piling. Finally, while this alternative attempts to protect the roadway and related infrastructure, it affords no protection for the privately owned properties. For these reasons, this alternative has been deemed infeasible.
