# WPA Form 3 – Notice of Intent

Stabilization of roadway and utilities in the public layout of Baxter Road.

BAXTER ROAD  
NANTUCKET, MASSACHUSETTS

EXISTING CONDITIONS - TEMPORARY SLOPE STABILIZATION  
 BAXTER ROAD  
 SLOPE STABILIZATION  
 NANTUCKET, MASSACHUSETTS

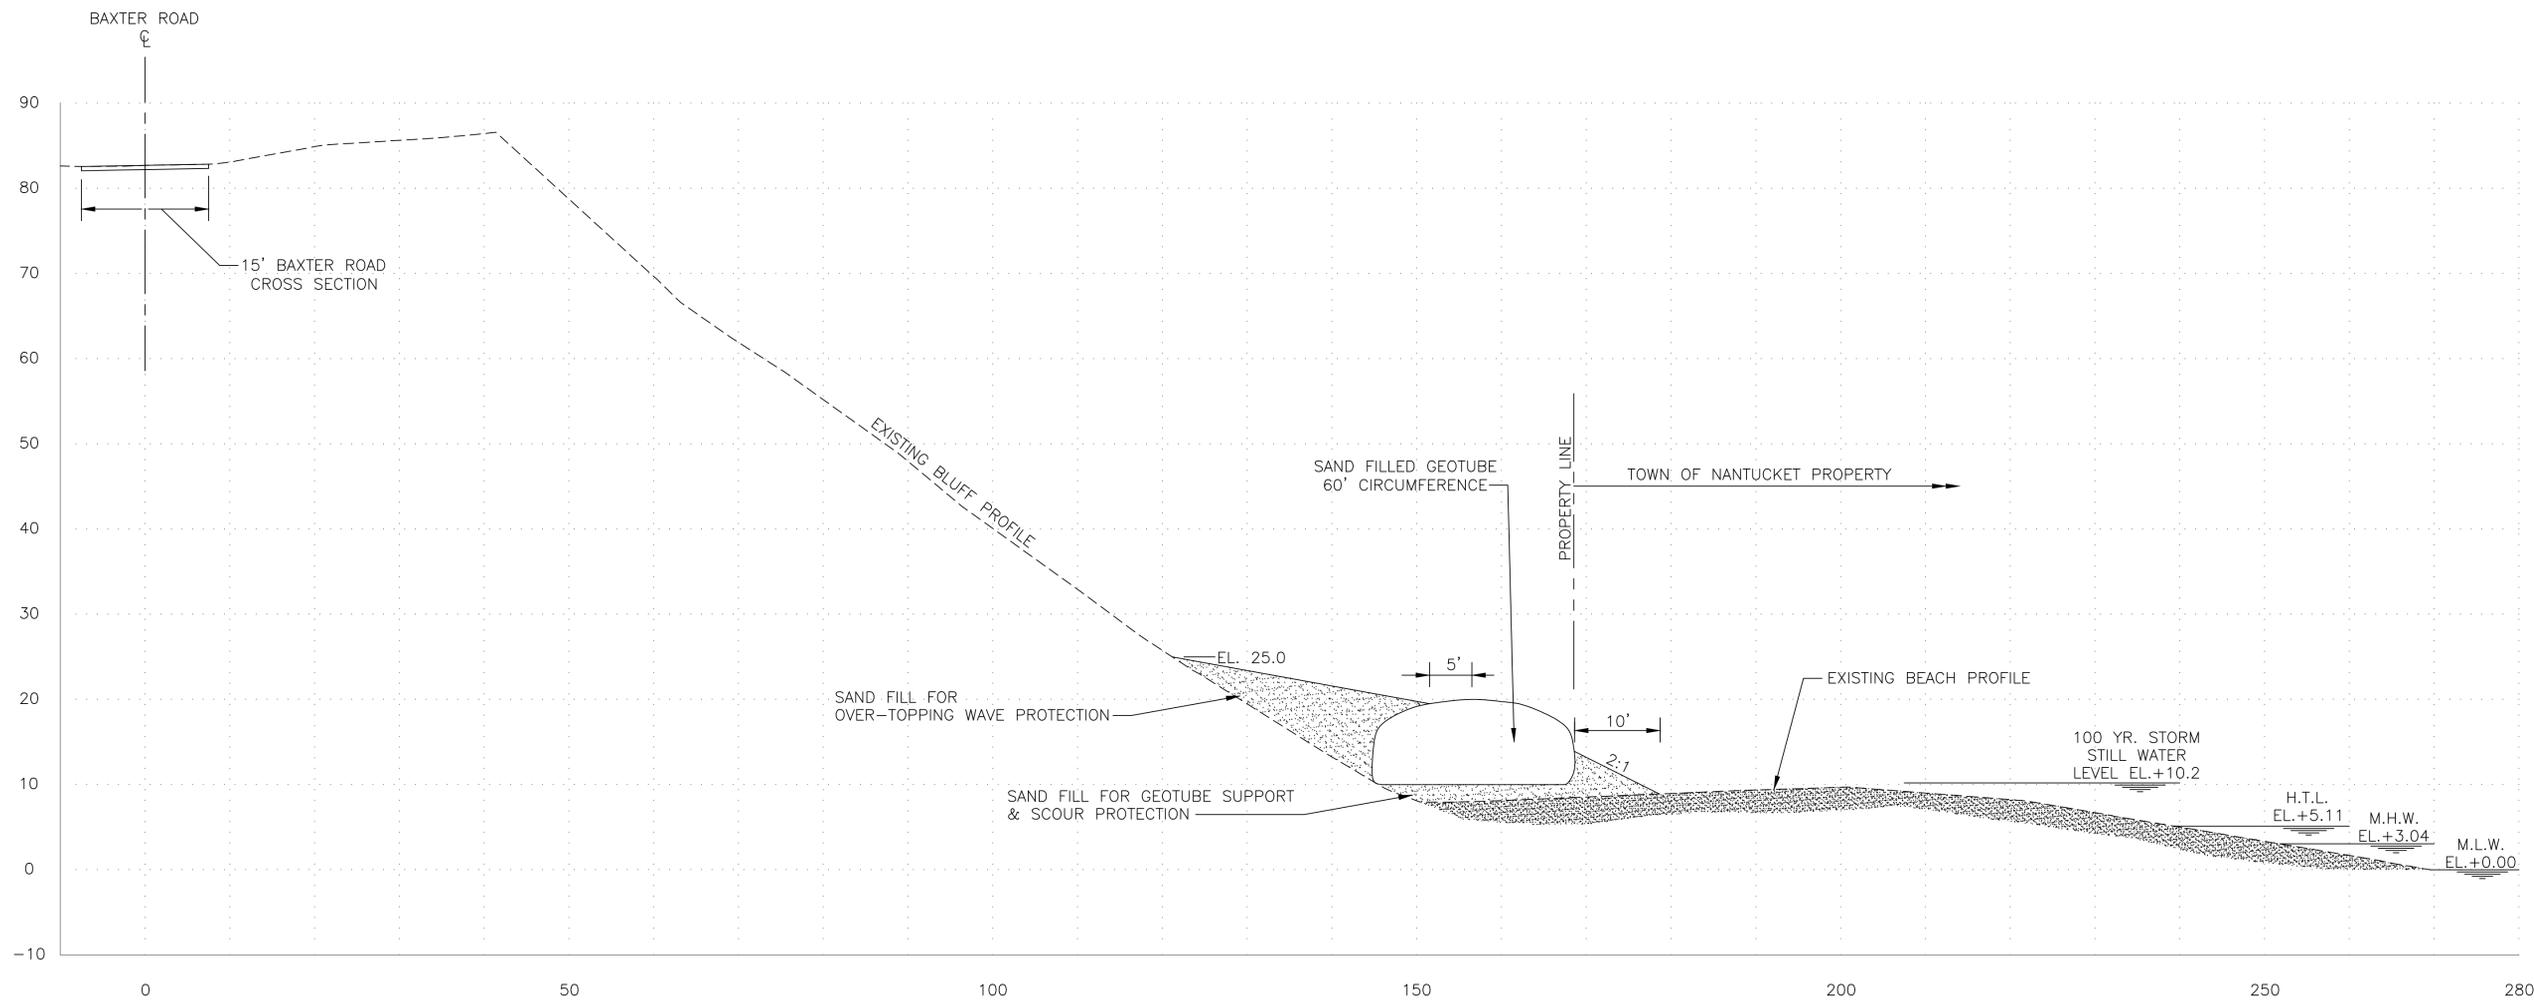
RSD DESIGNED	SW DRAWN	-- CHECKED
SCALE 1" = 10'		
DATE SEPT. 27, 2013		
PROJECT NO. 2967-11		
SHEET NO. 5 OF 6

SECTION A-A: ALTERNATIVE 3

STABILIZATION ALTERNATIVE	DESCRIPTION	ALTERNATIVE ADVANTAGES	ALTERNATIVE DISADVANTAGES	APPROXIMATE CONSTRUCTION ESTIMATE	APPROXIMATE CONSTRUCTION DURATION
ALTERNATIVE #3 SAND-FILLED GEOTUBES	LARGE GEOTEXTILE TUBE FILLED WITH SAND. INSTALLED AT TOE OF SLOPE TO PROTECT AGAINST UNDERMINING OF SAND TOE.	<p>INSTALLATION MATERIAL (OTHER THAN GEOTUBE) IS AVAILABLE ON ISLAND.</p> <p>INSTALLATION CAN BE COMPLETED WITH A RELATIVELY SMALL WORK CREW IN A VERY SHORT TIMEFRAME IN A COST-EFFECTIVE MANNER.</p> <p>TOE SCOUR IS PREVENTED BY THE ADDITION OF A GEOTEXTILE FABRIC WING WHICH IS PART OF THE GEOTUBE SYSTEM.</p> <p>REMOVAL OF GEOTUBE AT COMPLETION OF TEMPORARY STABILIZATION REQUIRES ONLY THE REMOVAL OF GEOTEXTILE FABRIC. SAND FILLING COULD REMAIN ON BEACH, IF DESIRED, WHICH COULD BE USED FOR FUTURE REPLENISHMENT.</p>	<p>GEOTEXTILE FABRIC COULD BE TORN BY LARGE DEBRIS CONTAINED WITHIN STORM WAVES.</p> <p>SAND BACKFILL MAY NEED TO BE REPLENISHED AFTER EACH STORM SEASON.</p> <p>SAND DELIVERY SYSTEM AT TOP OF BLUFF (CRANE W/HOPPER, CONVEYOR BELT, ETC.) COULD BE DISRUPTIVE TO RESIDENTS.</p> <p>DANGER OF FLANKING AT ENDS OF GEOTUBE.</p>	<p><u>GEOTUBE ESTIMATE</u> APPROXIMATE TOTAL GEOTUBE LENGTH = 1,220 FT UNIT PRICE = \$560/LF INSTALLED GEOTUBE COST = \$683,200</p> <p>SAND BACKFILL ESTIMATE TOTAL BACKFILL VOLUME = 4,300 CY UNIT PRICE = \$50/CY SAND BACKFILL COST = \$215,000</p> <p>TOTAL ESTIMATED COST = <u>\$898,200</u></p>	<p>ESTIMATED DAILY OUTPUT = 150 FT PER 8 HOUR DAY APPROXIMATE TOTAL GEOTUBE LENGTH = 1,220 SF</p> <p>ESTIMATED CONSTRUCTION DURATION = <u>9 WORK DAYS</u></p>

This alternative entails placement of sand-filled geotextile tubes along the toe of slope to provide temporary protection from wave and tidal action. This alternative is largely constructible, the sand fill is readily available, and the option presents a cost effective, short term solution for protecting the toe of slope within the town's study area. In protecting the slope, this treatment may result in short-term slope stabilization. It is critical to understand, however, that these structures could be overtopped and/or undermined even with detailed design consideration. Failure of the geotubes could result in failure of Baxter Road and we cannot predict when this may occur. While these measures are considered temporary, the installation of geotextile tubes can be expected to retard slope failure and can be designed to prevent slope failure from normal tidal events. While there would be some impact to aesthetics, we would anticipate this alternative can be permitted locally, given its temporary nature. For these reasons this alternative is deemed a viable option for the short-term.

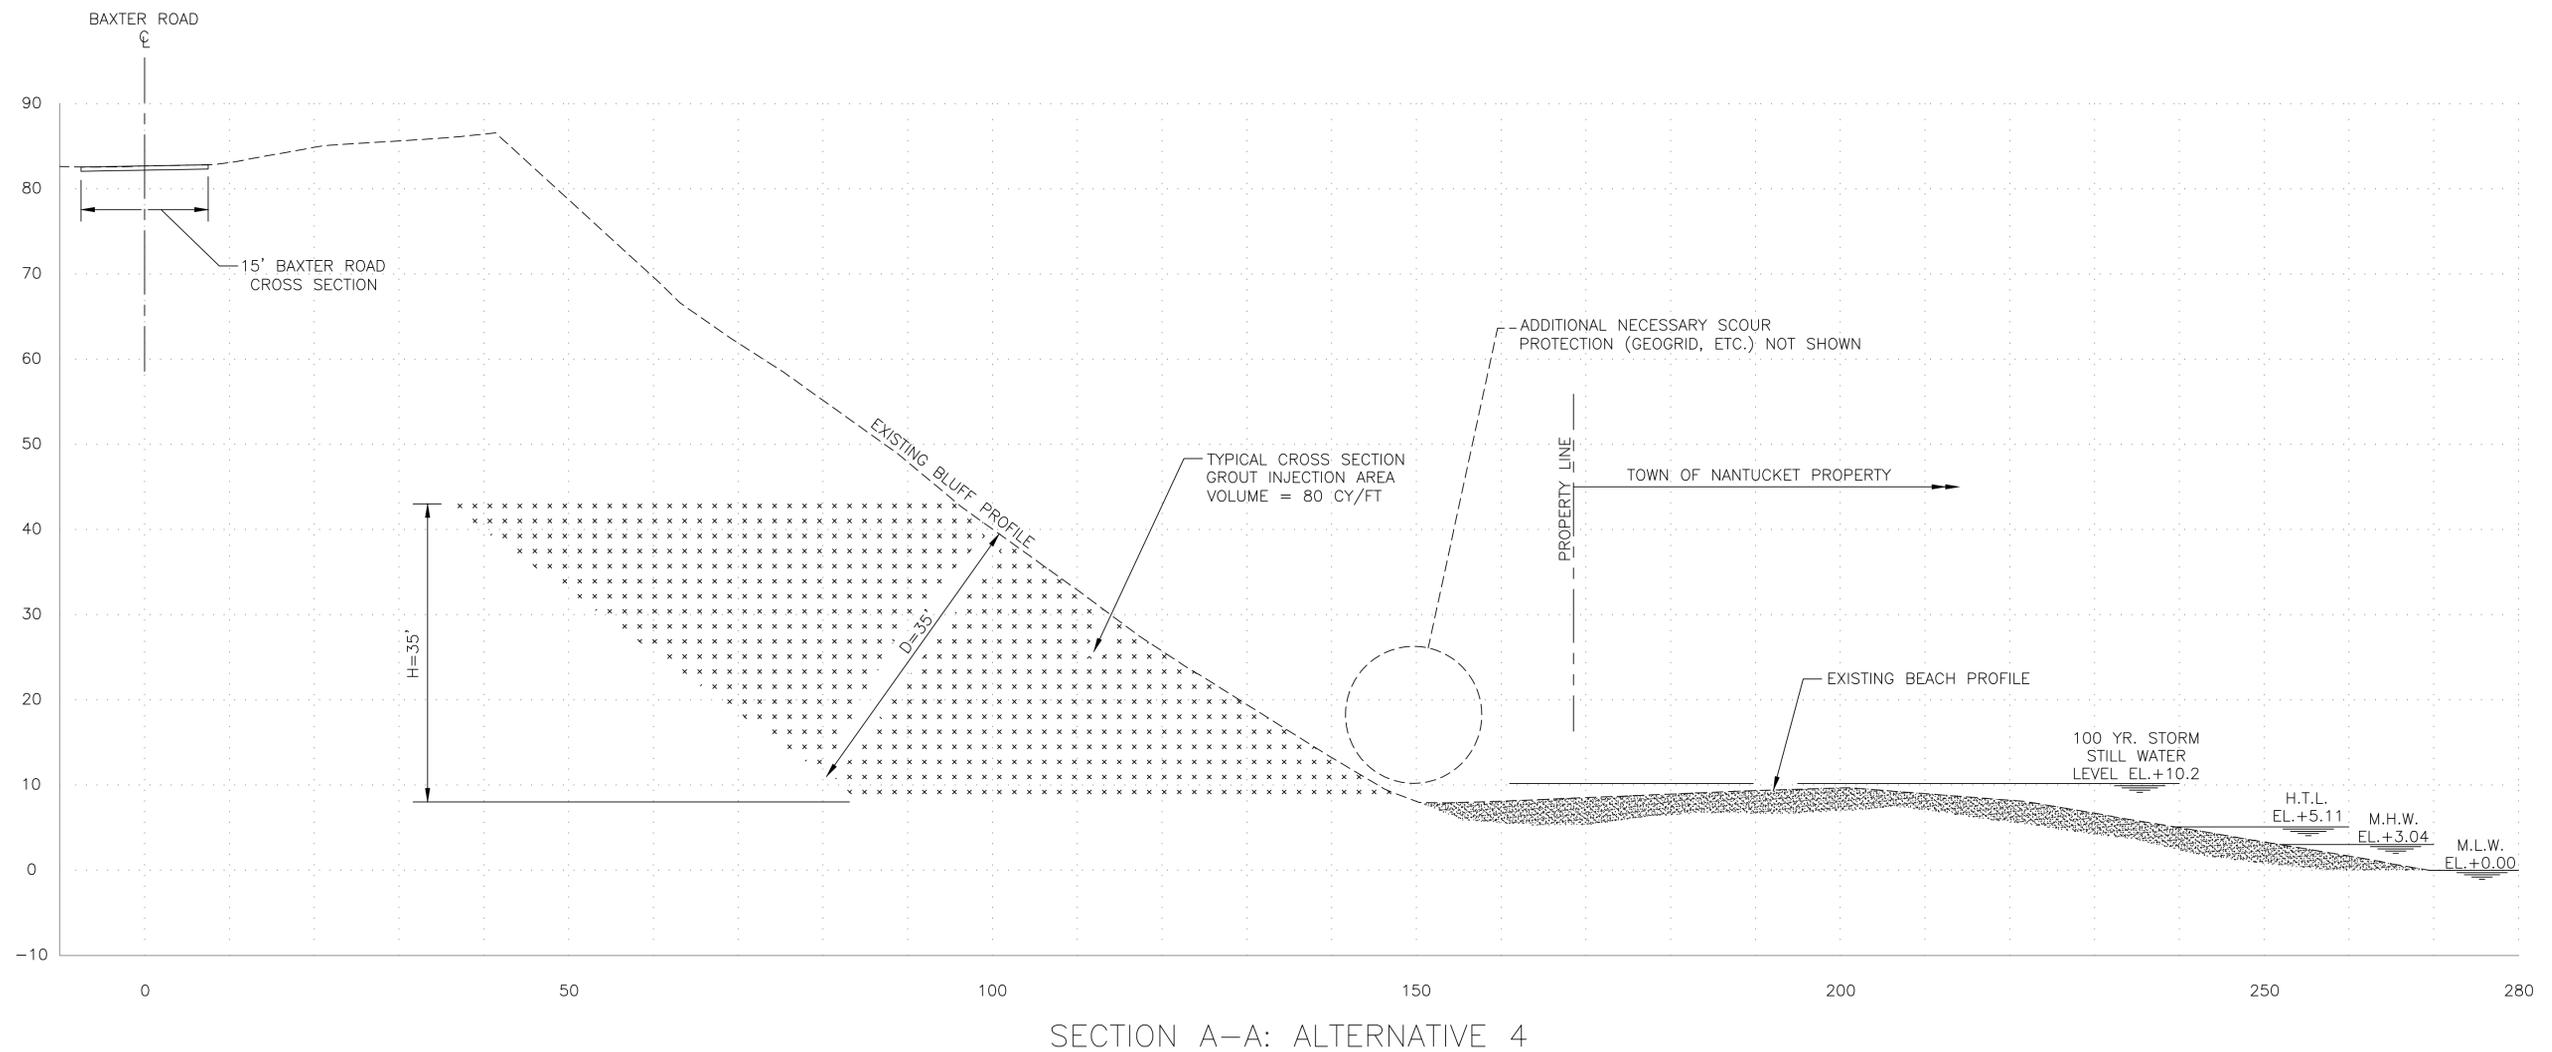
**ALT 4**

STABILIZATION ALTERNATIVE	DESCRIPTION	ALTERNATIVE ADVANTAGES	ALTERNATIVE DISADVANTAGES	APPROXIMATE CONSTRUCTION ESTIMATE	APPROXIMATE CONSTRUCTION DURATION
ALTERNATIVE #4 GROUT INJECTION	SHAFTS ARE DRILLED INTO THE SLOPE FROM THE TOE UPWARD, FOLLOWED BY PRESSURE INJECTION OF GROUT WHICH HARDENS/STRENGTHENS THE WEAK SAND AT THE BASE OF THE SLOPE.	WEAK SAND LAYER AT BASE OF BLUFF IS HARDENED, INCREASING ITS RESISTANCE TO EROSION DUE TO STORM WAVE ACTION. GROUTING CAN BE COMPLETED FROM THE BEACH, ELIMINATING POTENTIAL IMPACTS TO RESIDENTS. GROUT COMPOSITION DOES NOT CHANGE THE APPEARANCE OF SAND. GROUTED SECTION SHOULD NOT REQUIRE ANY MAINTENANCE.	TO ADEQUATELY STRENGTHEN THE SLOPE, GROUTING WOULD BE REQUIRED OVER A RELATIVELY LARGE AREA (35 FT HEIGHT X 35 FT DEPTH). SOIL GROUTING NEEDS TO BE USED IN TANDEM WITH ADDITIONAL SLOPE STABILIZATION TO PROTECT AGAINST WAVE SCOUR (E.G. GEOTUBE). MATERIAL/EQUIPMENT WILL NEED TO BE BARGED ONTO THE BEACH FOR INSTALLATION. GROUT COMPOSITION NEEDS TO BE CUSTOMIZED BASED ON EXISTING SOIL CONDITIONS, INCREASING LEAD TIME. ESTIMATED CONSTRUCTION DURATION IS EXCESSIVE BASED ON PROJECT NEEDS.	<u>GROUT INJECTION ESTIMATE</u> APPROXIMATE GROUT CROSS SECTIONAL VOLUME = 80 CY/FT TOTAL GROUTED SLOPE LENGTH = 1,220 FT UNIT PRICE = \$375/CY INSTALLED GROUTING COST = \$36,600,000 <u>GEOTUBE ESTIMATE</u> INSTALLED GEOTUBE COST (FROM ABOVE) = \$845,950 TOTAL ESTIMATED COST = <u>\$37,445,950</u>	ESTIMATED DAILY OUTPUT = 500 CY PER 8 HOUR DAY TOTAL GROUTED VOLUME = 97,600 CY ESTIMATED CONSTRUCTION DURATION = <u>196 WORK DAYS</u>

Alternative 4 was presented by Haley & Aldrich (H&A) in our discussions with them. The grout would be injected into the cohesionless sand layer at the toe of the slope and would serve to strengthen or enhance the properties of the otherwise weak soil. From our discussions with H&A and based on their previous findings in the field, the grouted sand layer would be approximately 35 feet thick. The weak sand layer is overlain by a thick glacial till. This material in itself can be stabilized under normal conditions, however given it is founded on the cohesionless underlying sand makes the glacial till susceptible to failure as has been the case. This alternative has the advantage of being low impact when compared to other options, particularly given the fact the grout will be 'invisible' from the surface following construction and restoration of the impacted areas. While this alternative may be cost prohibitive as a temporary solution, we are not dismissing this option and recommend it be studied further.

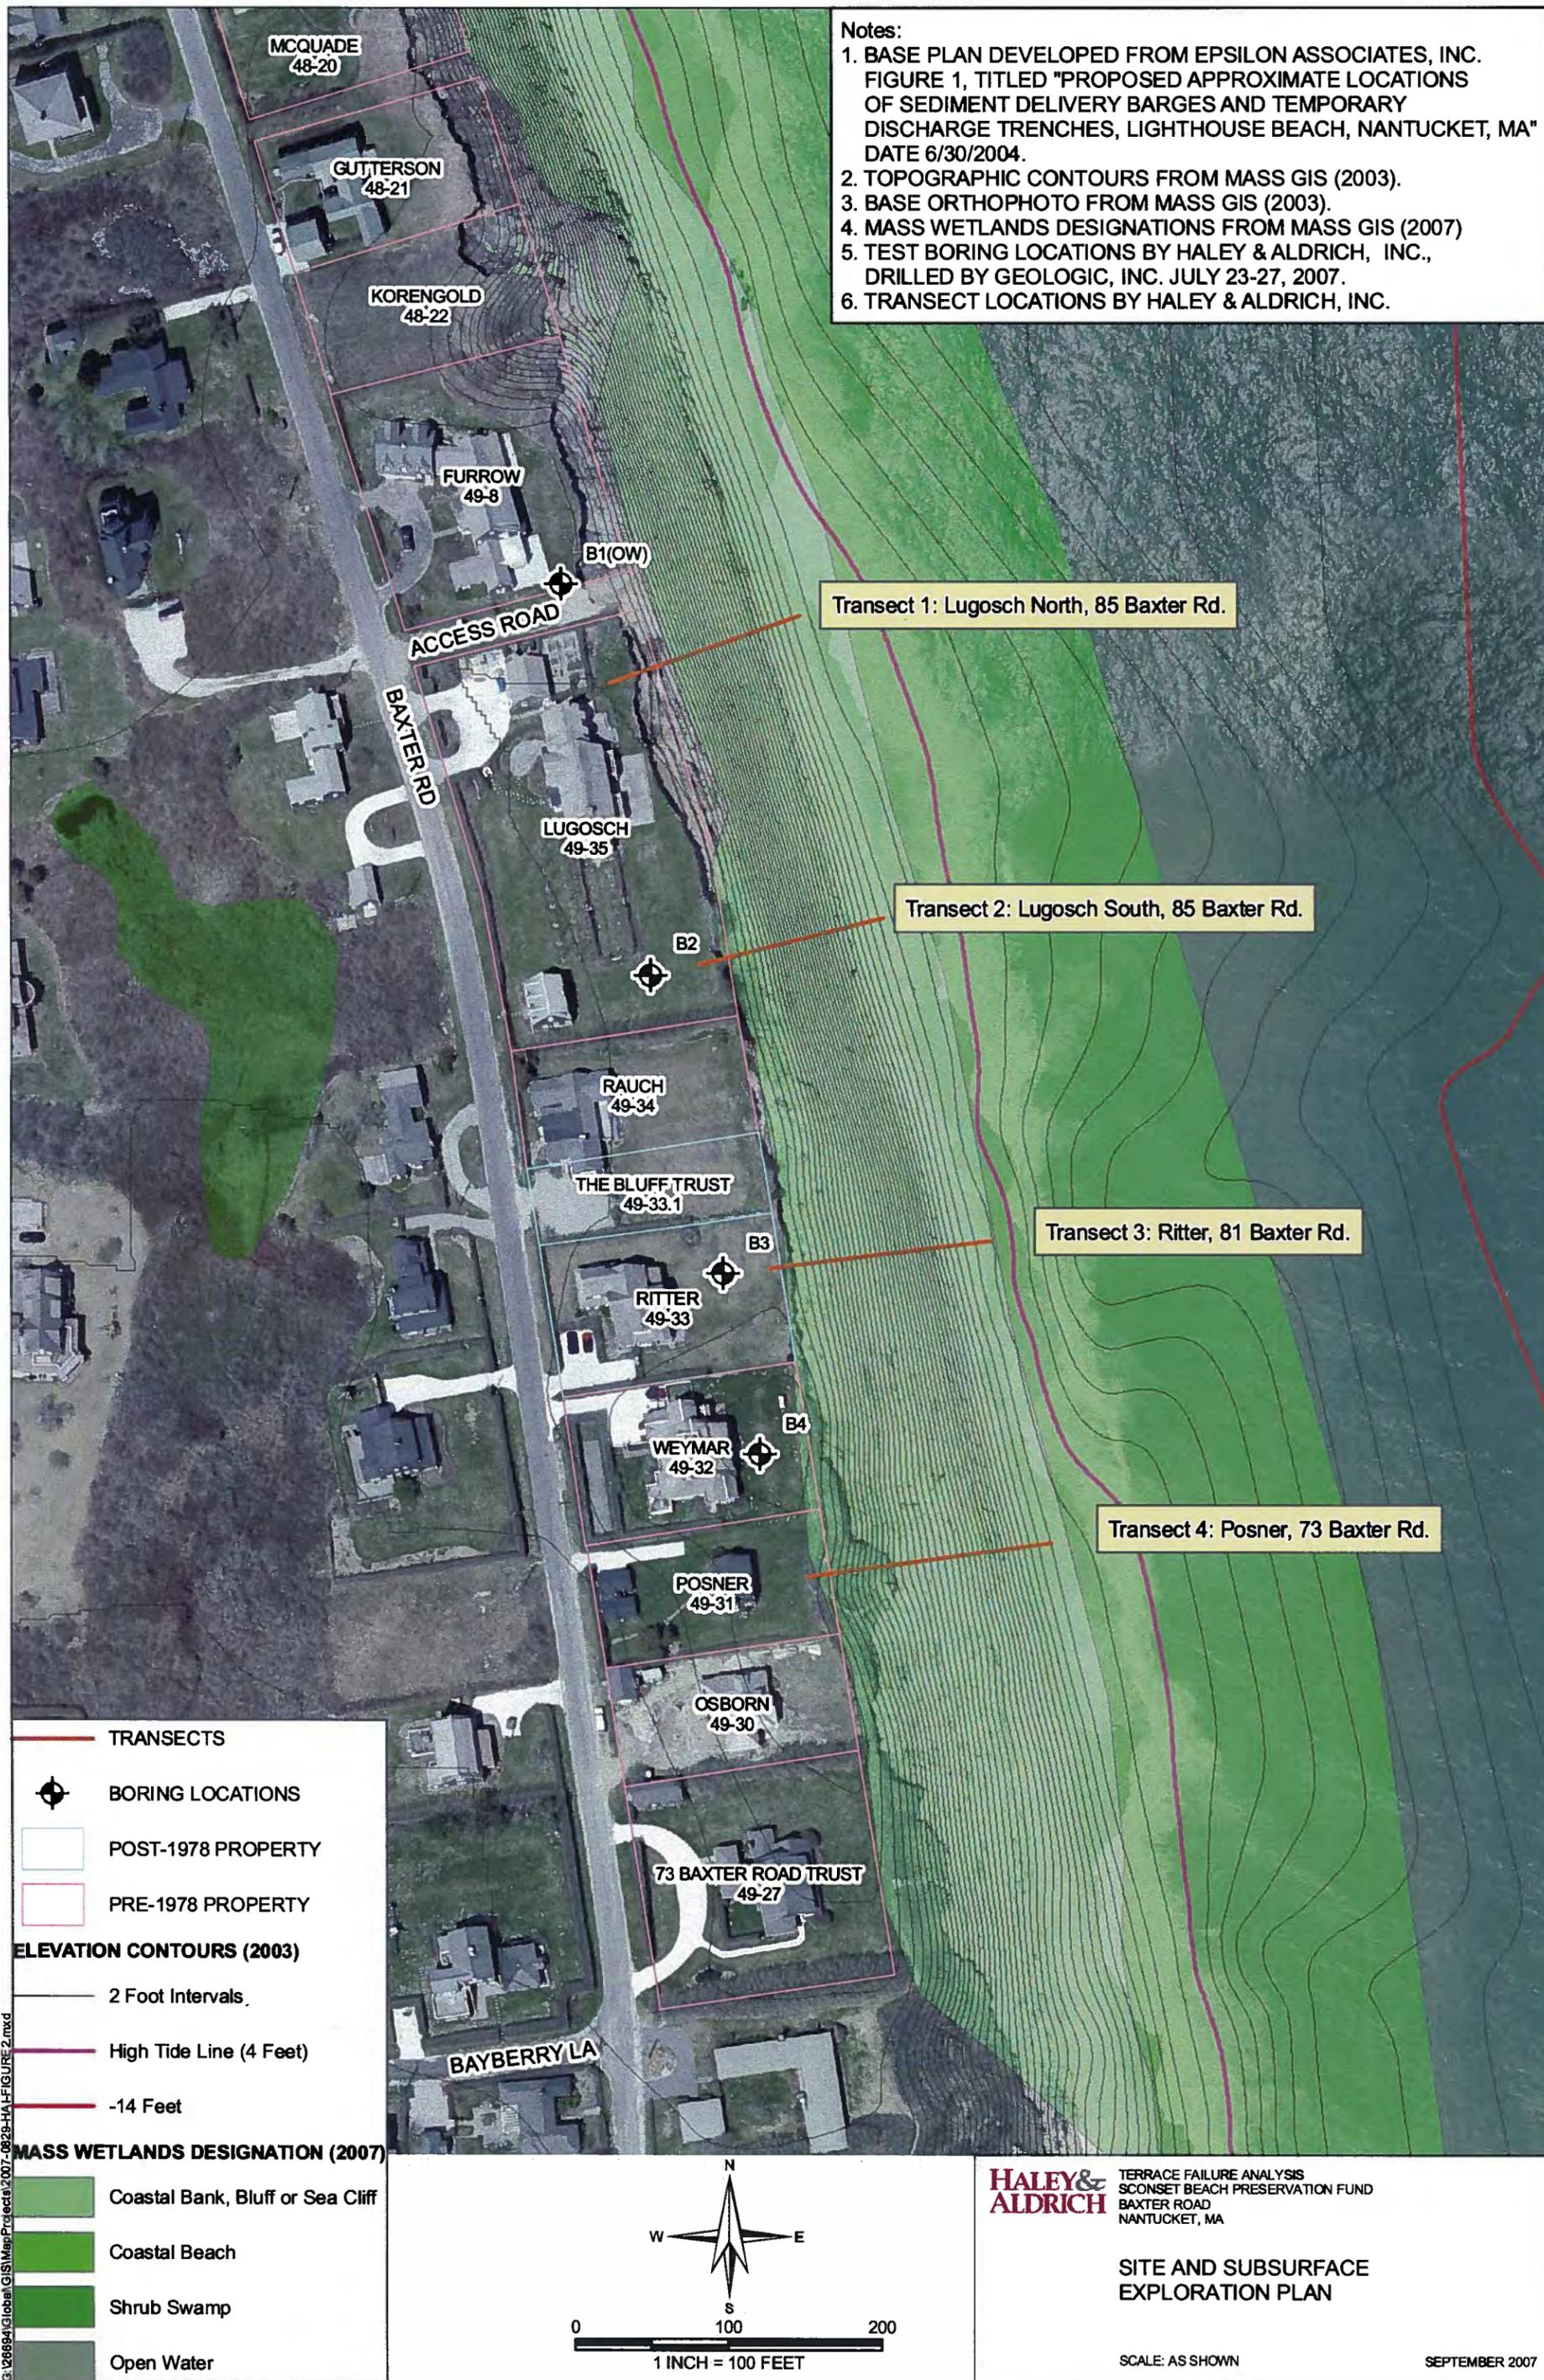
**Attachment B**  
**Boring Logs**

1. BASE PLAN DEVELOPED FROM EPSILON ASSOCIATES, INC. FIGURE 1, TITLED "PROPOSED APPROXIMATE LOCATIONS OF SEDIMENT DELIVERY BARGES AND TEMPORARY DISCHARGE TRENCHES, LIGHTHOUSE BEACH, NANTUCKET, MA" DATE 6/30/2004.
2. TOPOGRAPHIC CONTOURS FROM MASS GIS (2003).
3. BASE ORTHOPHOTO FROM MASS GIS (2003).
4. MASS WETLANDS DESIGNATIONS FROM MASS GIS (2007)
5. TEST BORING LOCATIONS BY HALEY & ALDRICH, INC., DRILLED BY GEOLOGIC, INC. JULY 23-27, 2007.
6. TRANSECT LOCATIONS BY HALEY & ALDRICH, INC.

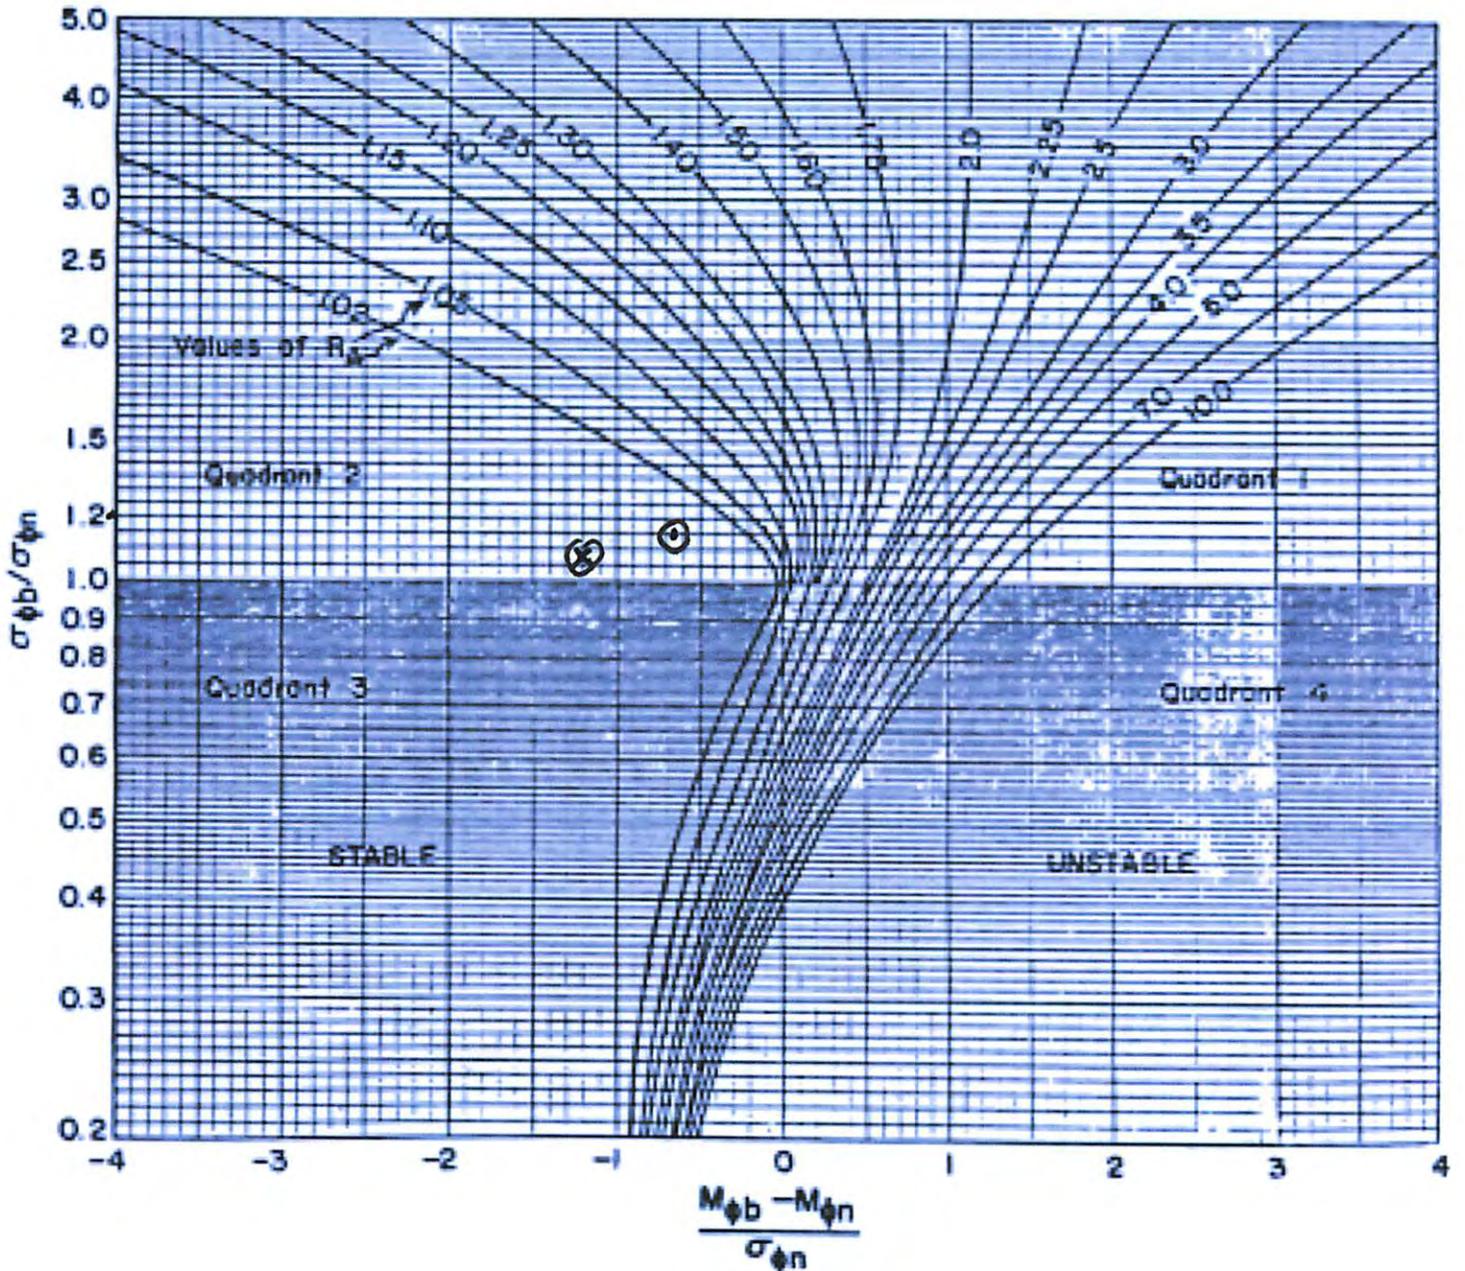
# JAMES OVERFILL FACTOR (RA)

'BEACH': 2006 BANK COMPOSITE  
FROM REVETMENT AREA.

Sconset Beach James Overfill Calculation Worksheet  
 Borrow area to bank comparisons
