TOWN OF NANTUCKET

Town of Nantucket
Capital Program Committee
www.nantucket-ma.gov

MINUTES

2015 NANTUCKET FACILITIES ASSESSMENT

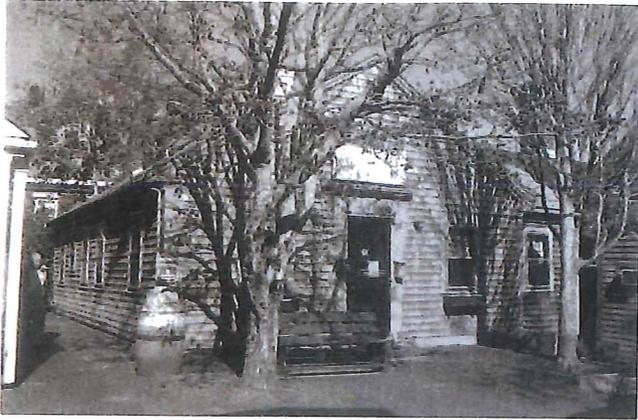
3 CHESTNUT ST.

B3010.10 Steep Slope Roofing: Active or inactive water infiltration evident

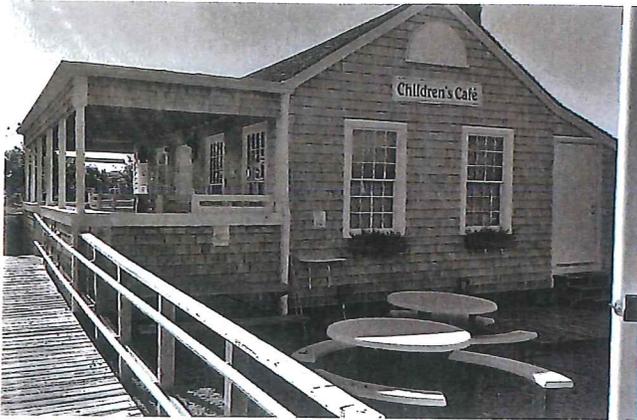
CHILDREN'S BEACH CONCESSIONS

B1080 Stairs: Egress stair appears non-compliant with current regulatory standards due to width, winders, riser height and /or tread depth..

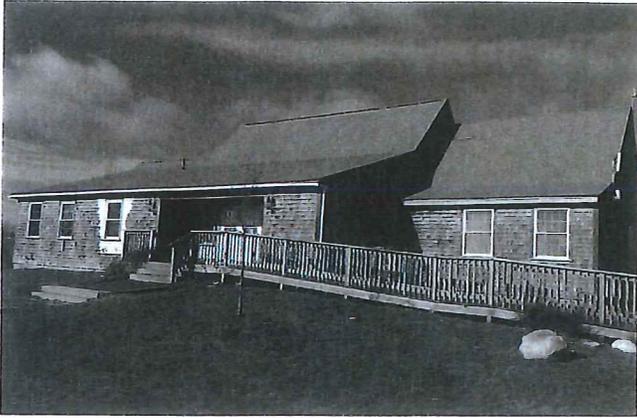
DPW ADMINISTRATION

B3010.10 Steep Slope Roofing: Aging shingles, shakes, and/or tiles suggest new roof replacement

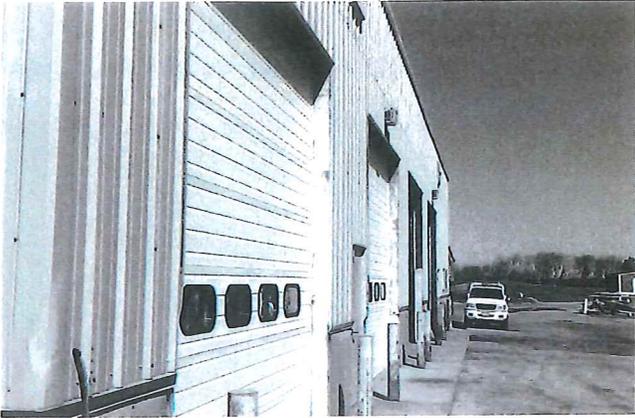
DPW FLEET GARAGE

B2010 Exterior Walls: Thermal resistance issues evident
