NANTUCKET FACILITIES ASSESSMENT

Town of Nantucket, MA
16 Broad St.
Nantucket, MA

10 June 2015

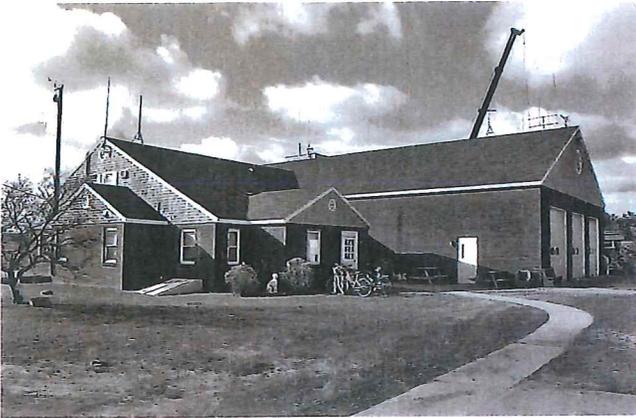
Two story, wood framed, slab on grade. Generally in fair condition with evidence of termite infestation and general deterioration.

The original Peerless oil fired boiler is rated 400 Mbh and (2) Taco hot water circulation pumps are beyond their useful life expectancy. In addition, the heating hot water distribution system, terminal components, ventilation and exhaust systems and controls should be replaced/upgraded.

B2010 Exterior Walls: System failure evident

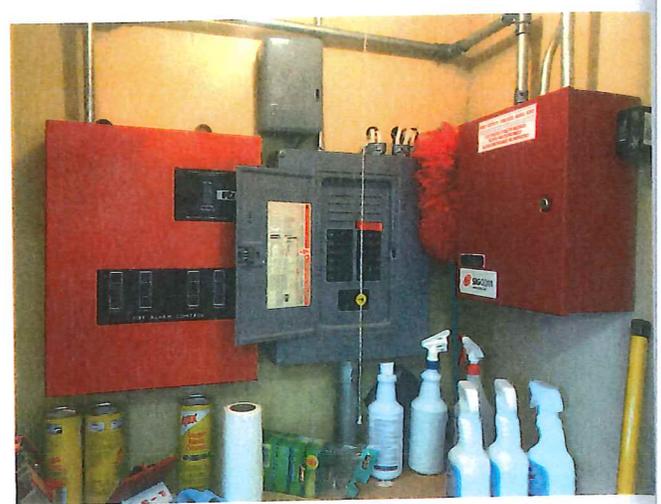
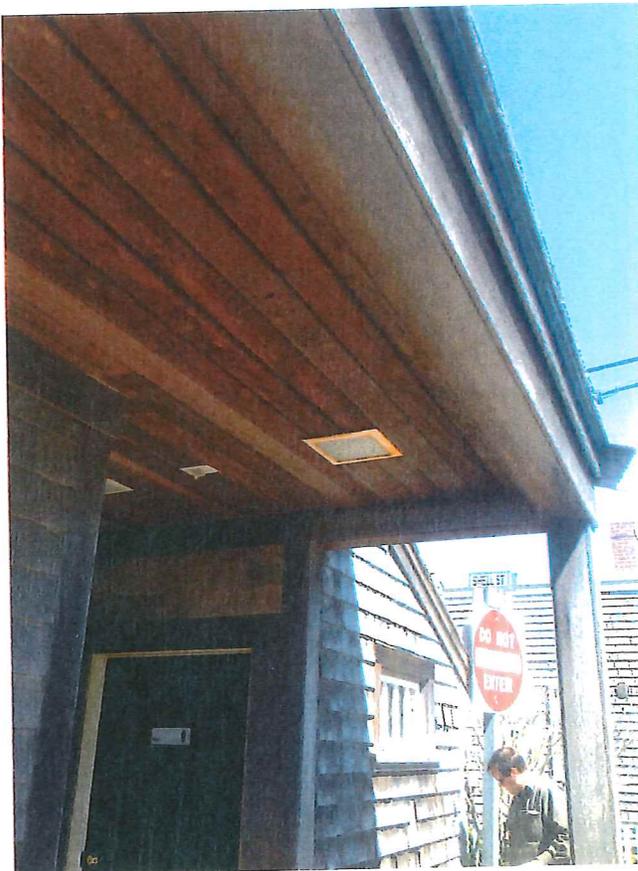
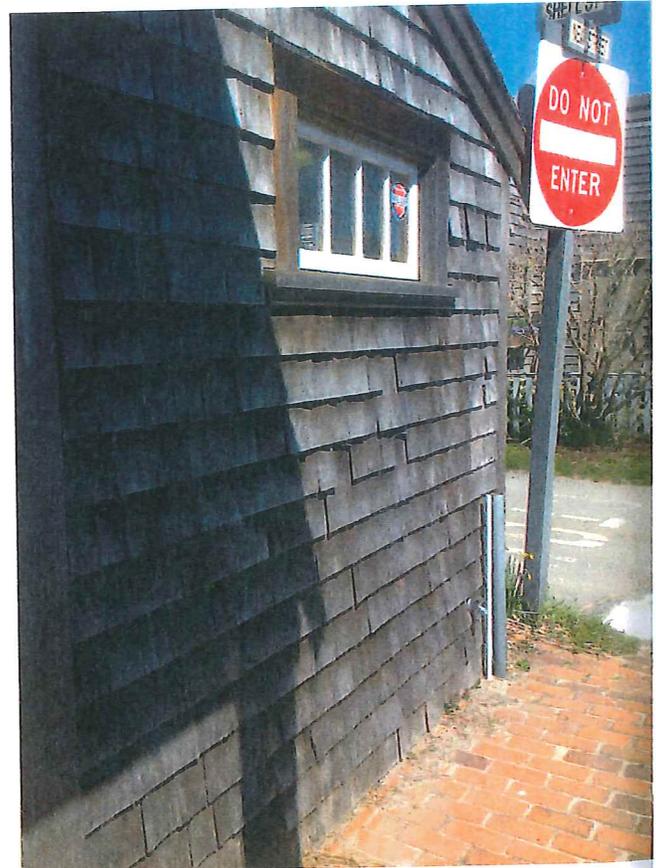
B1020 Roof Construction: Moisture, mildew, mold, and/or moss issues evident

B2010 Exterior Walls: System failure evident

B3010.10 Steep Slope Roofing: Aging shingles, shakes, and/or tiles suggest new roof replacement

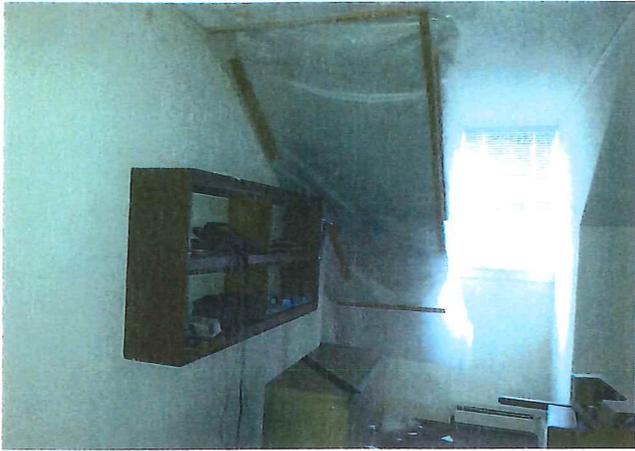
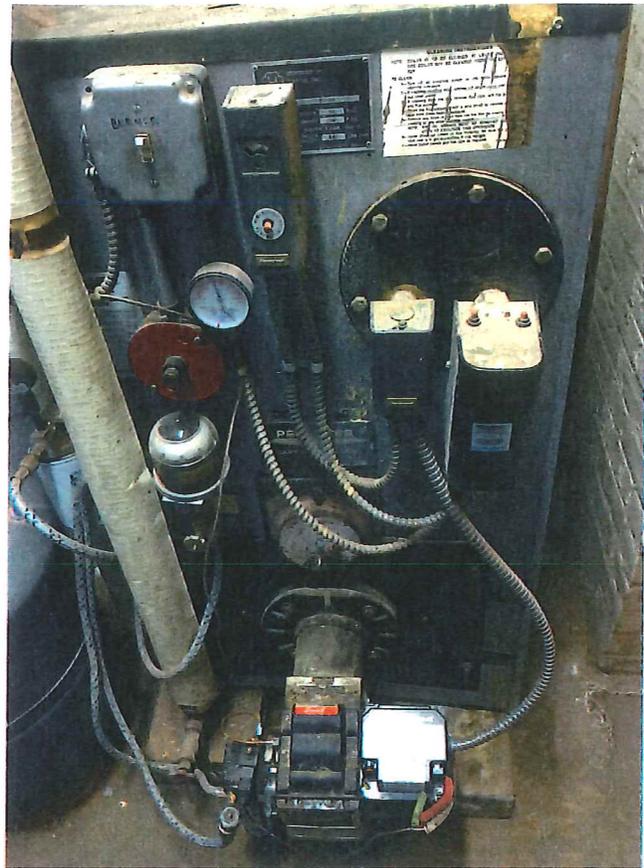
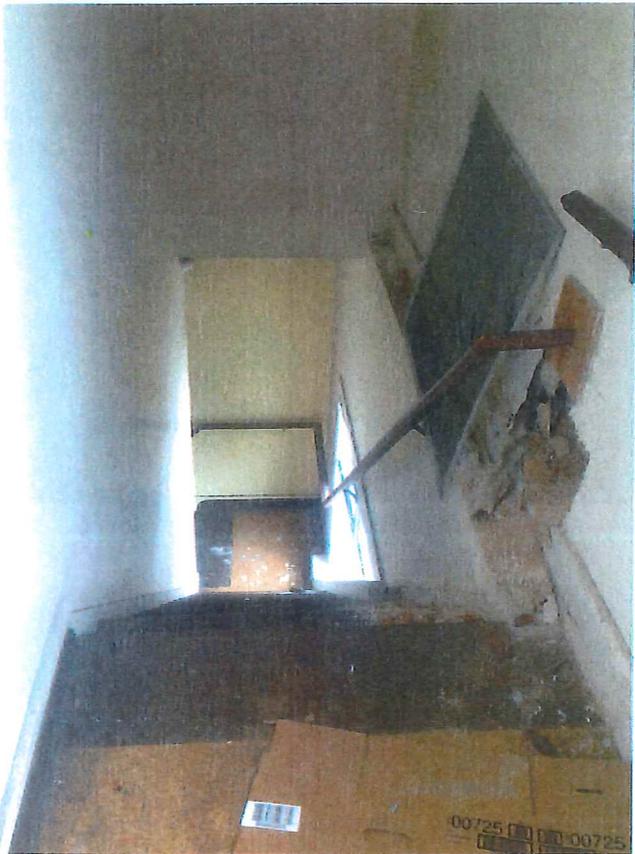
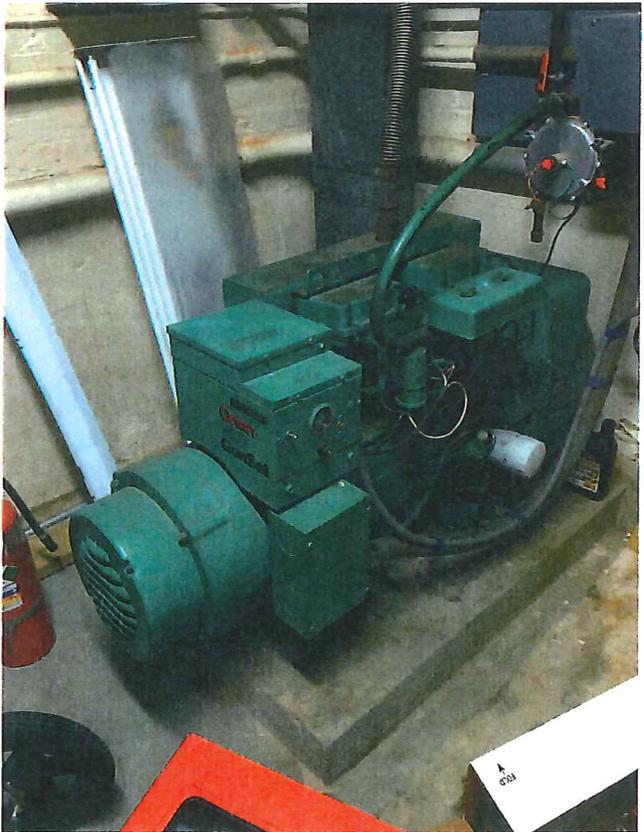
Appears to be generally sound and sturdy. Roof leaks both prior, and apparently, ongoing, raise concern for roof and some floor structure.

The building was re-roofed in 2013 after being subject to leakage for a number of years. The dormer siding was not replaced at the time the roofing was done, so the integrity of the step and counter flashings can not be positively confirmed.

The second floor is not currently in use. The plaster in many areas has suffered considerable damage from water infiltration incurred before the roof was replaced. These areas are damaged through to the base coat of plaster and will require skillful repair.

B2020 Exterior Windows: Thermal resistance issues evident

B1080.50 Stair Railings: Height lower than 42", is ladder type and/or baluster spacing exceeds 4"

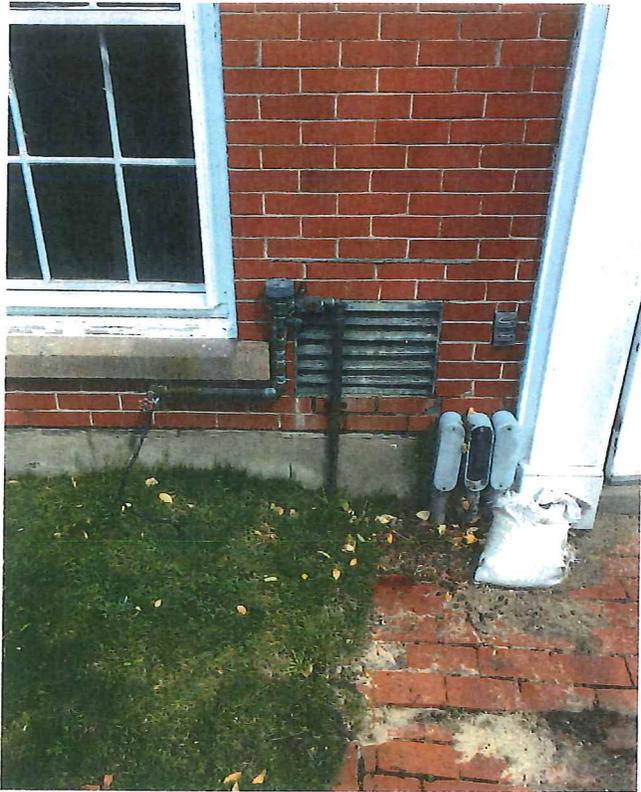
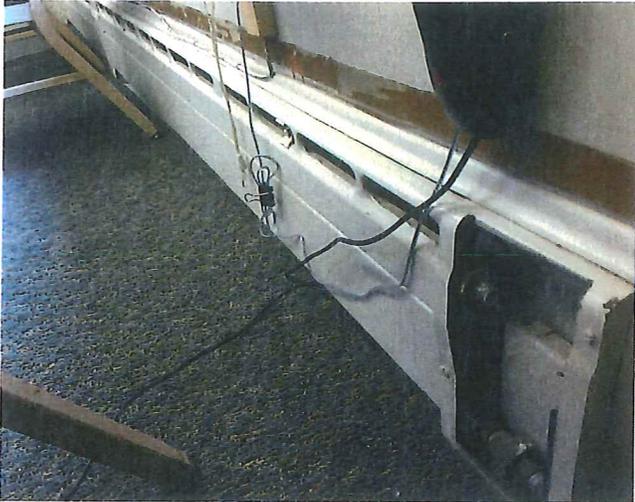
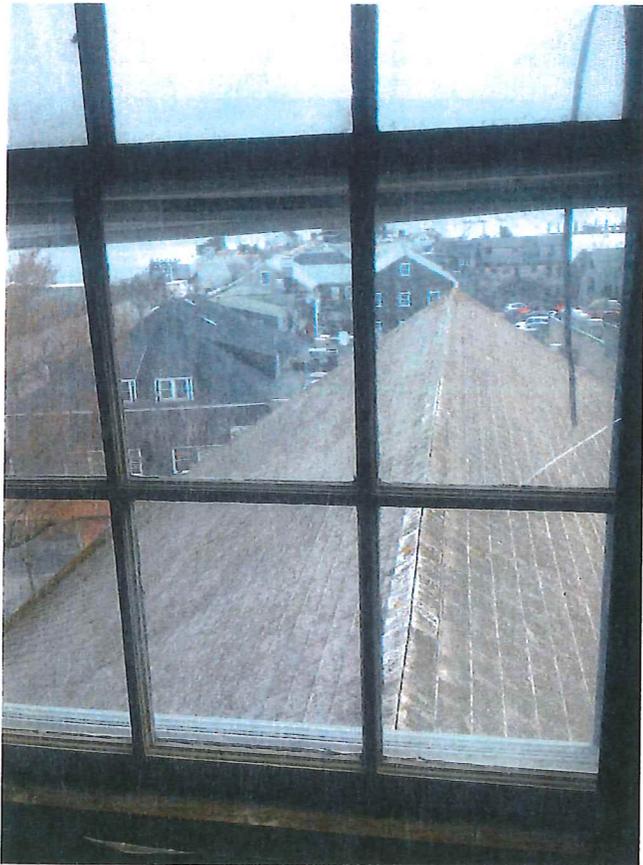
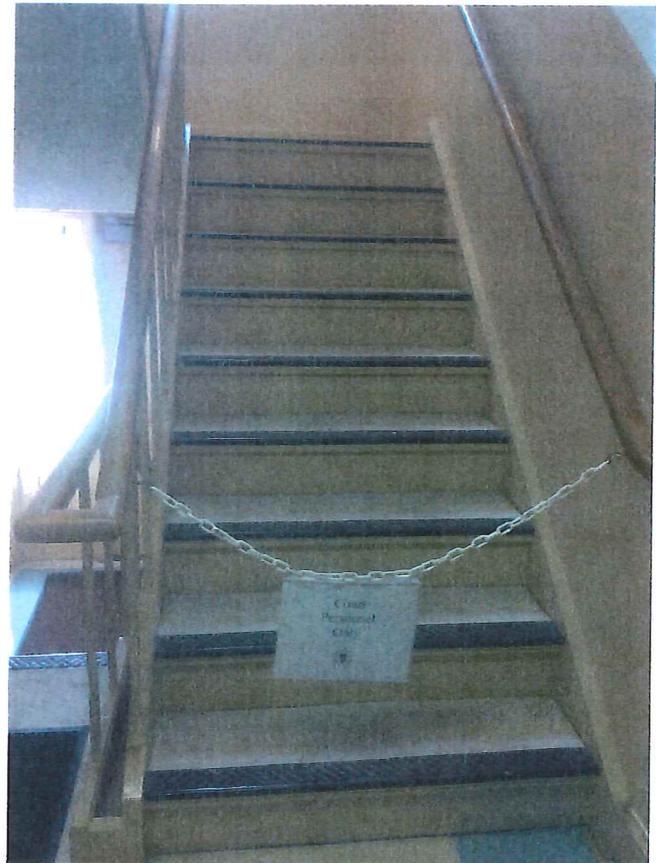
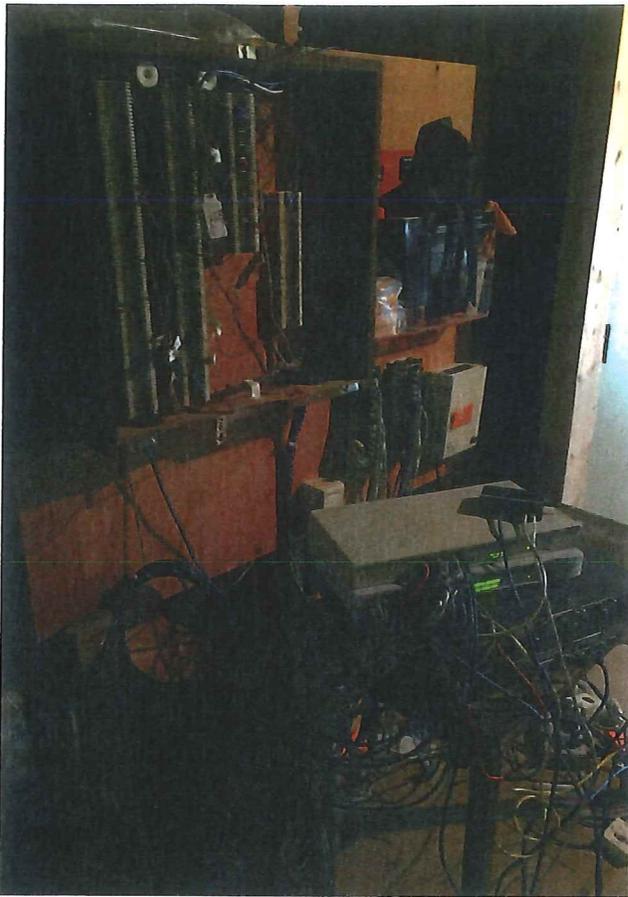
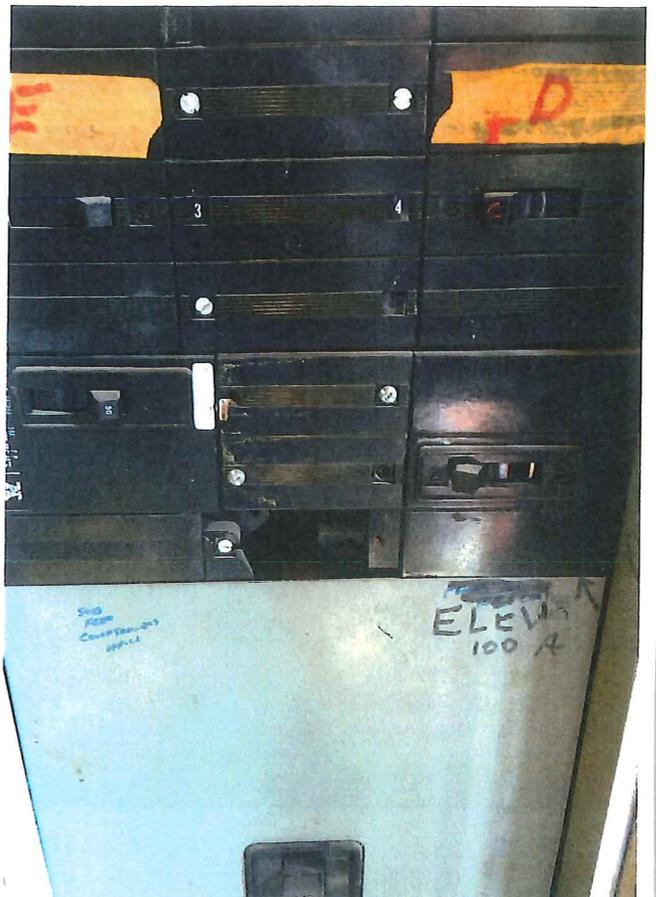
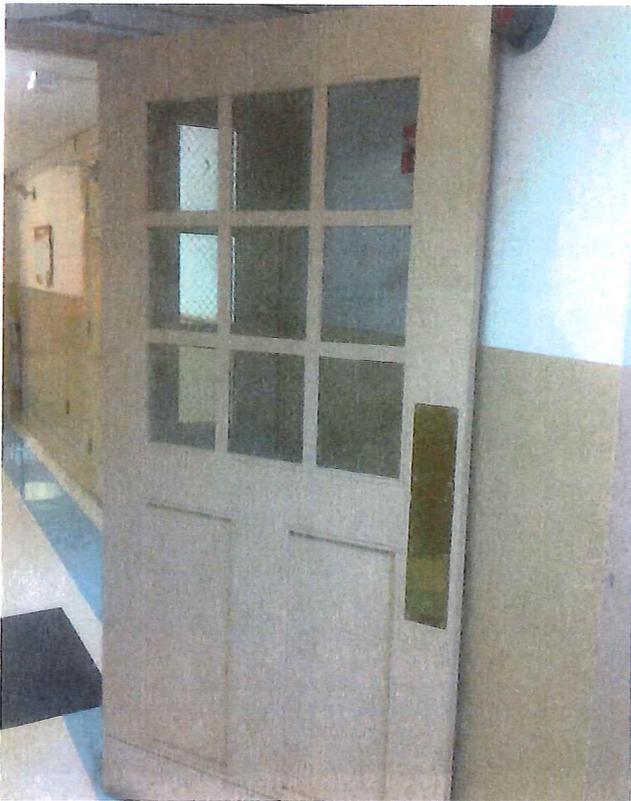
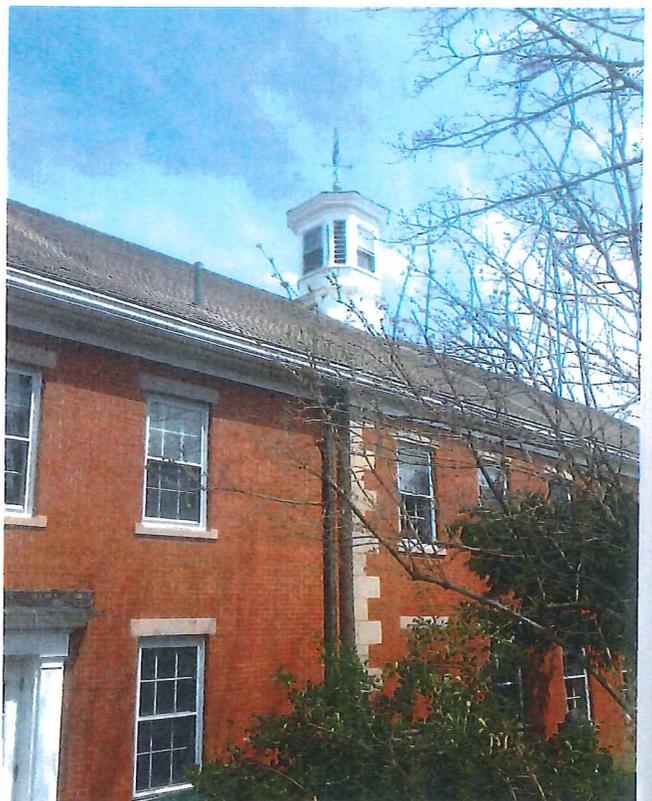
The building appears to be structurally sound, with the acknowledgement of a crack in the foundation and exterior brick facing on the south façade. This crack appears to be from differential settlement and was not apparent from within the building.

Windows are wood, single glazed, most with storm windows. About half of the windows show some degree of rot in the sill, in some cases the rot is quite extensive.

The gutters are wood and are in fair condition. Evidence of previous repairs can be seen and these repairs were done in sections, not through replacement of full runs.

A1010 Standard Foundations: Settlement evident

B3010.10 Steep Slope Roofing: Aging shingles, shakes, and/or tiles suggest new roof replacement

B1080 Stairs: All or portion of stair shaft in not in a rated assembly

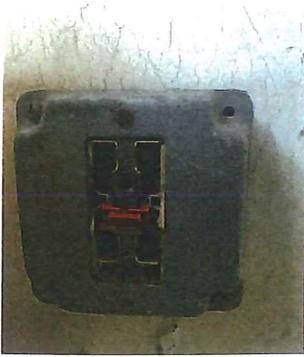
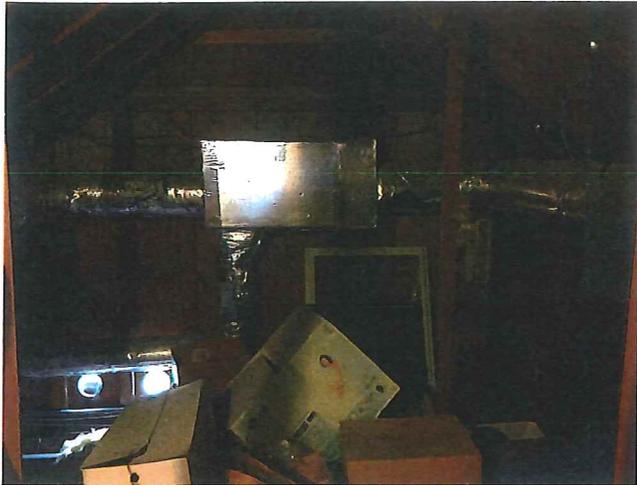
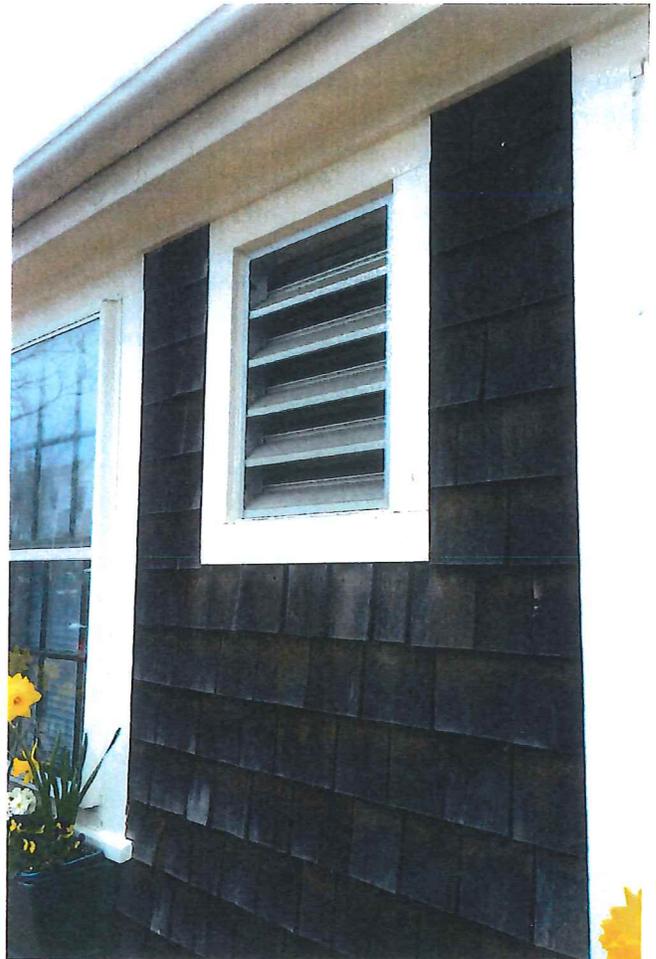
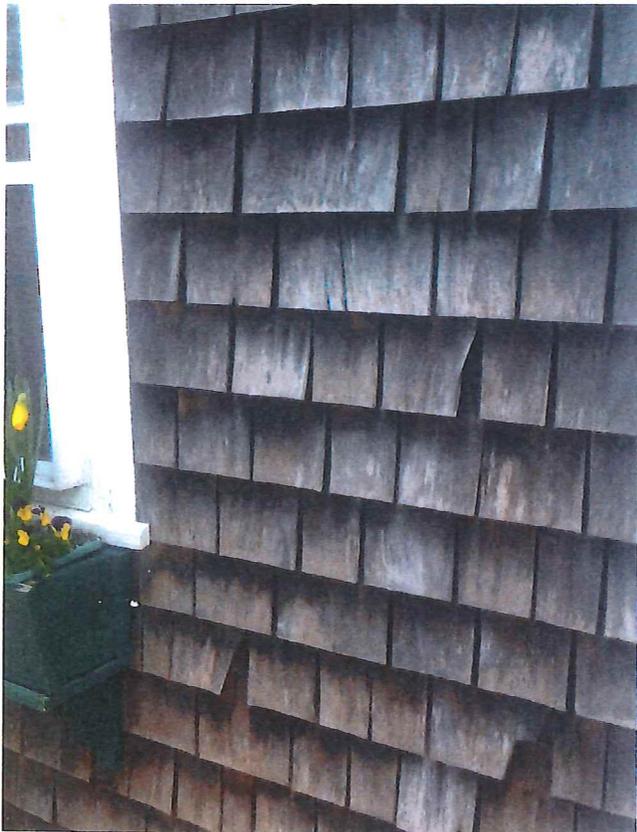
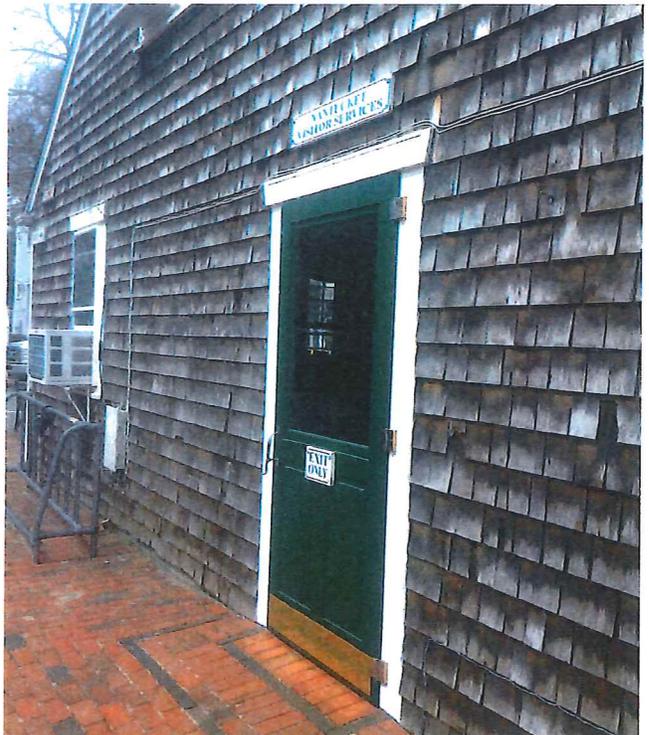
- A4010 Standard Slabs-on-Grade: Moisture, mildew, mold, and/or moss issues evident
- B2010 Exterior Walls: Moisture, mildew, mold, and/or moss issues evident
- B2010 Exterior Walls: Air infiltration issues evident
- B3010.10 Steep Slope Roofing: Aging shingles, shakes,
