Children's Beach Stormwater Pumping Station Evaluation

Public Meeting

Town of Nantucket

March 14, 2019

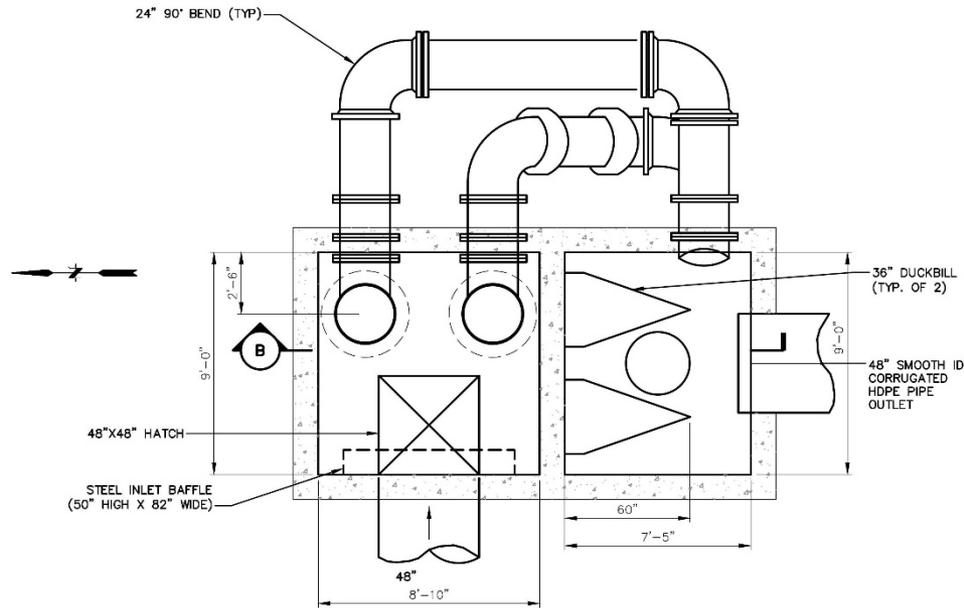
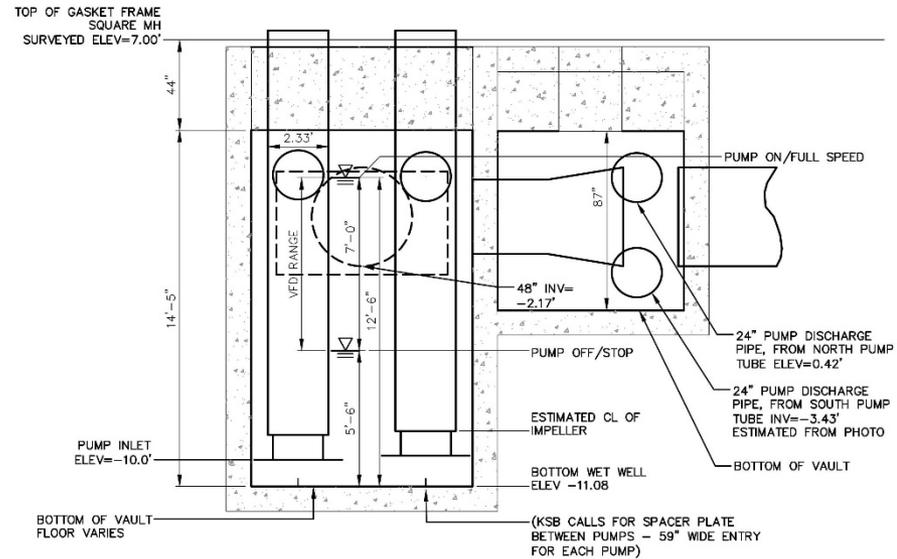
Background – Initial Pump Failure/Improvements

- Initial Failure Oct. 2009
- Hydraulic Evaluation 2011 Results
- Recommended 2011 Improvements
 - Improved Venting
 - Pump Repairs
 - VFDs

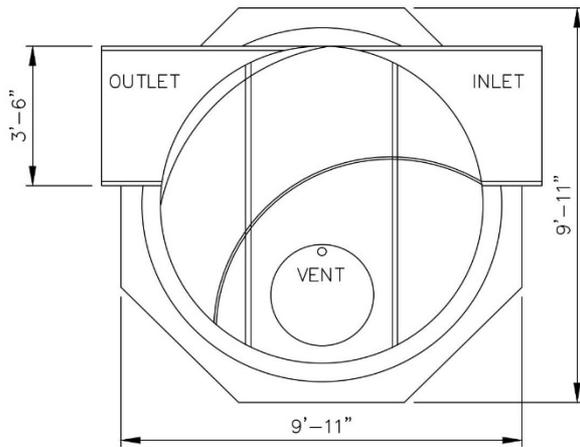
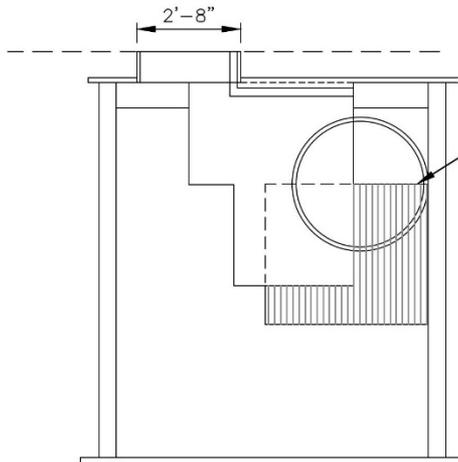
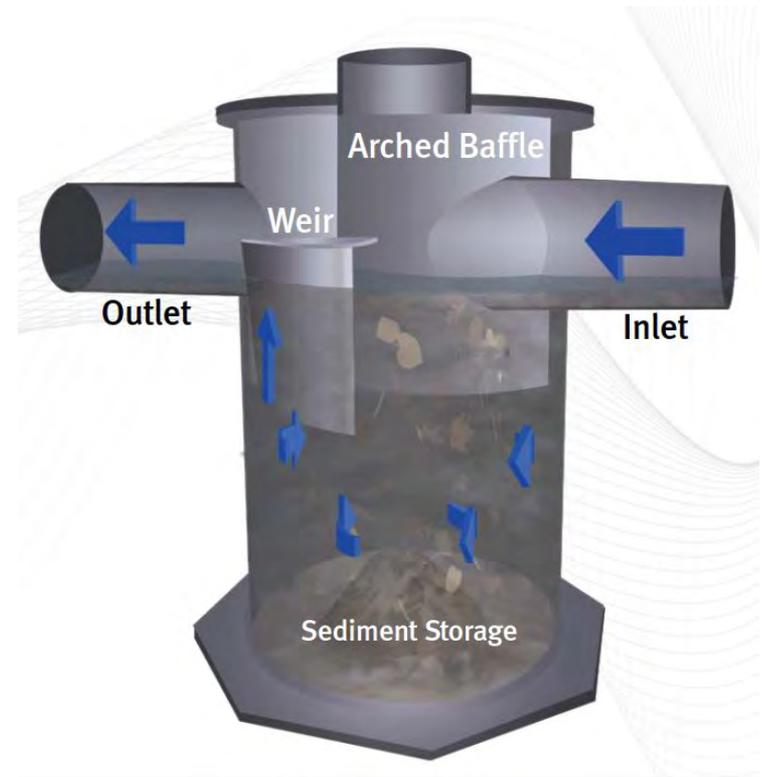
Existing Conditions – BMP Concentrator

- Aqua-Swirl Model AS-8 Units (removes solids)
 - Two Installed Upstream of Children’s Beach Pumping Station

—————	GRADE 2.96'
—————	ELEV 2.29'
—————	ELEV -2.13 (INV OUT DRAWN/SHOWN AT -2.13' TO HAVE WATER FLOWING DOWNHILL FROM AQUASWIRL INTO WETWELL.)
—————	ELEV -7.80'

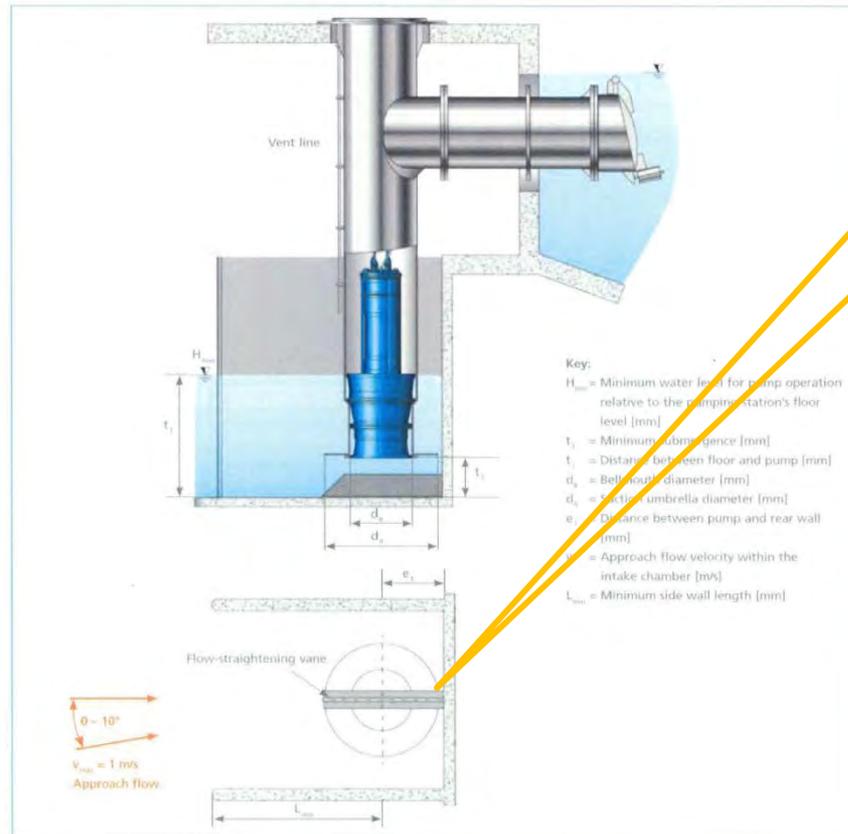
Flow
Straightening
Vane

If a check of the minimum water level in the pump sump establishes that this is insufficient, another chamber variant without corner fillets in combination with a suction umbrella fitted at the discharge tube's inlet may provide sufficient submergence to prevent air-entraining vortices. This allows the pump to operate at a lower suction-side minimum water level t_1 with the same pump size and the same operating point.

Fig. 23. Open intake chamber with suction umbrella (see the type series booklet or selection software for the actual dimensions)

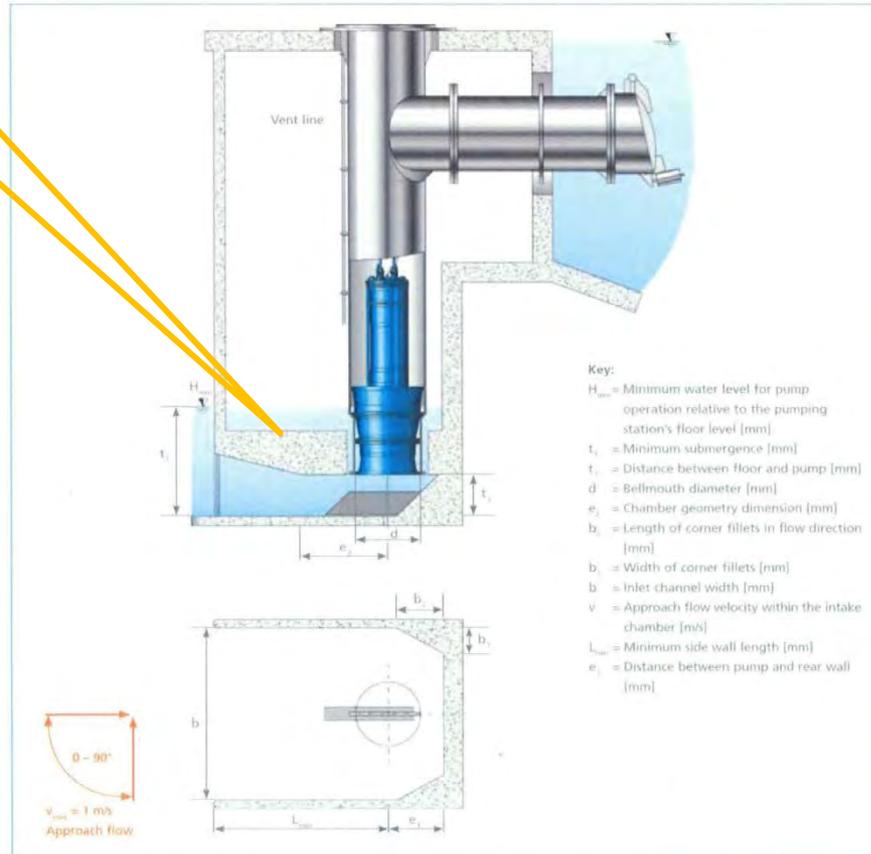
Formed Inlet

A special type of chamber is the covered intake chamber. It allows the lowest minimum water levels without the occurrence of air-entraining surface vortices and can accommodate flows approaching at an angle of 0 to 90 degrees at 1 m/s max.

However, this variant involves higher construction costs than the chamber types previously described. This type of chamber has more than proved its worth under unfavourable approach flow conditions and low water levels.

Fig. 24: Covered intake chamber (see the type series booklet or selection software for the actual dimensions)

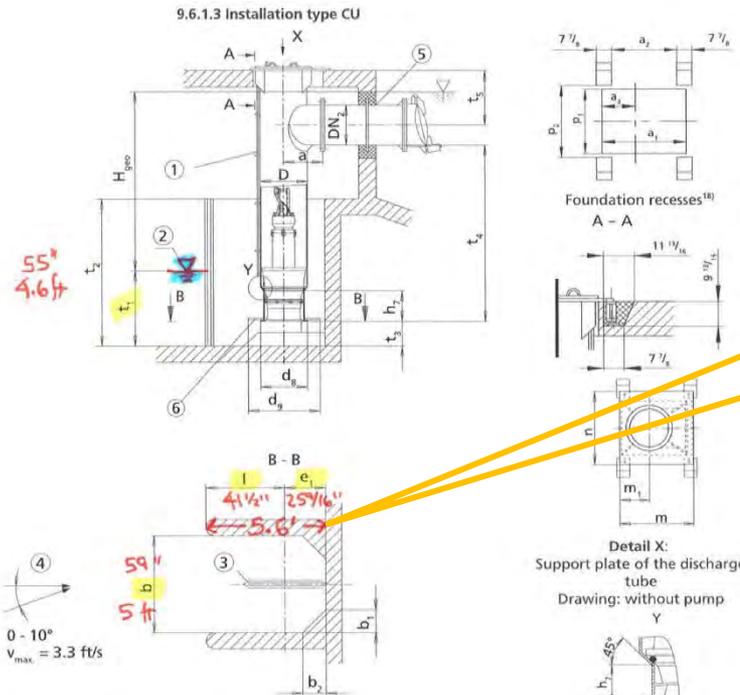
Minimum Dimensions for Children's Beach PS*

* Dimensions presented are part of the required design parameters but not the only requirements

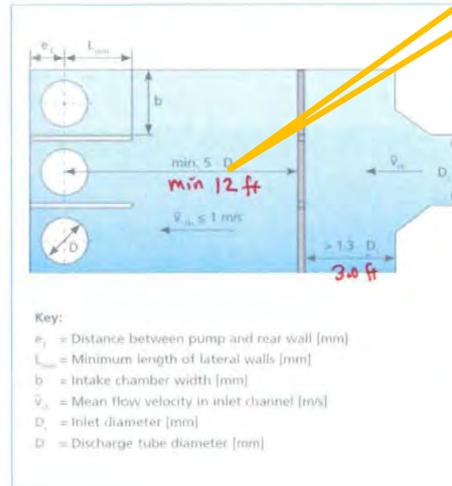
Fig. 39: Solution, Variant 4.2

**Minimum Wet Well Length
Approx. 18 FT for
Children's
Beach PS***

Each pump is to be provided with a complete intake chamber sized to match the respective pump (see the type series booklet or selection software). The intake chambers are installed facing the inlet in the opposite sump wall. A curtain wall with openings near the floor should be installed across the entire width of the pump sump upstream of the intake chambers. This prevents the pumps from influencing each other during pumping and ensures an even approach flow.
