Temporary Baxter Road Stabilization Project
Supplemental Information for 4/30/14 Hearing
Siasconset Beach Preservation Fund
and
Town of Nantucket

Engineering Basis of Design

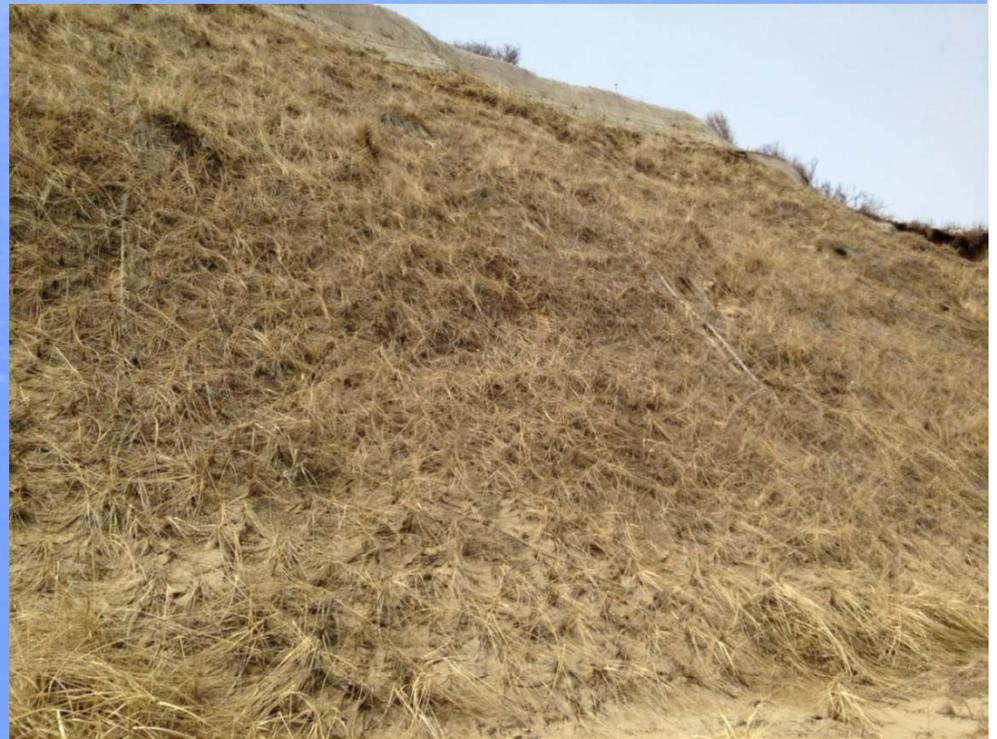
Planting Plan

American beachgrass will be planted first.

Upper 5 to 7 feet will be reserved for swallows.

Minor addition of sand needed at 93 and 97 Baxter Road (areas outside of sand delivery locations) to prepare a planting bed for the American beachgrass by smoothing deeper rills and gullies.

Use of erosion control blanket or jute netting proposed.

No equipment on beach needed; access will be from the top.

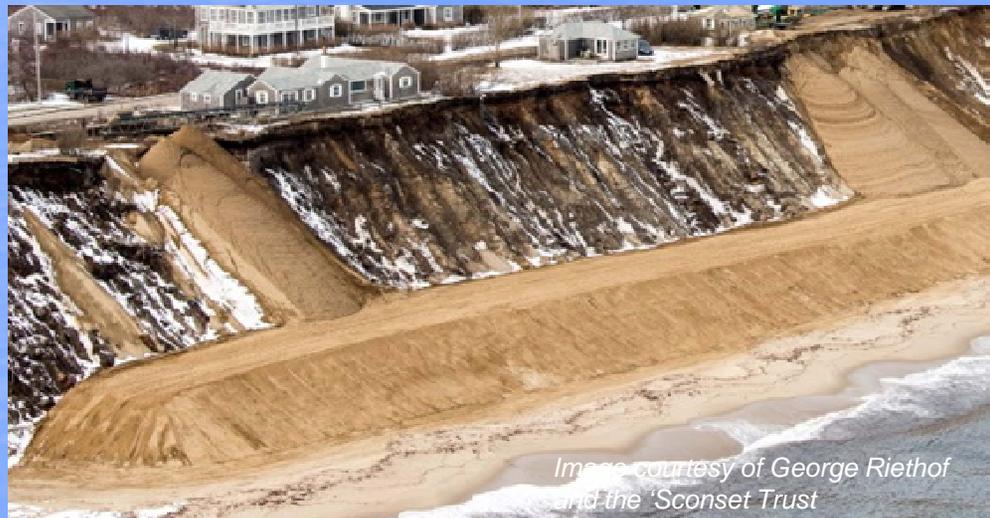
Construction Narrative

Returns: 15-foot circumference geotextile, jute, or coir tubes will be field-fitted at a 45 degree angle between the geotubes and the bluff. No excavation into bluff proposed. Bottom elevation of +3 to +4 MLW to avoid need for shoring; top equal to height of third geotube if project is limited to 3 tubes currently in place. Constructed via skid steer (and possibly excavator) using dry pit sand (no slurry).

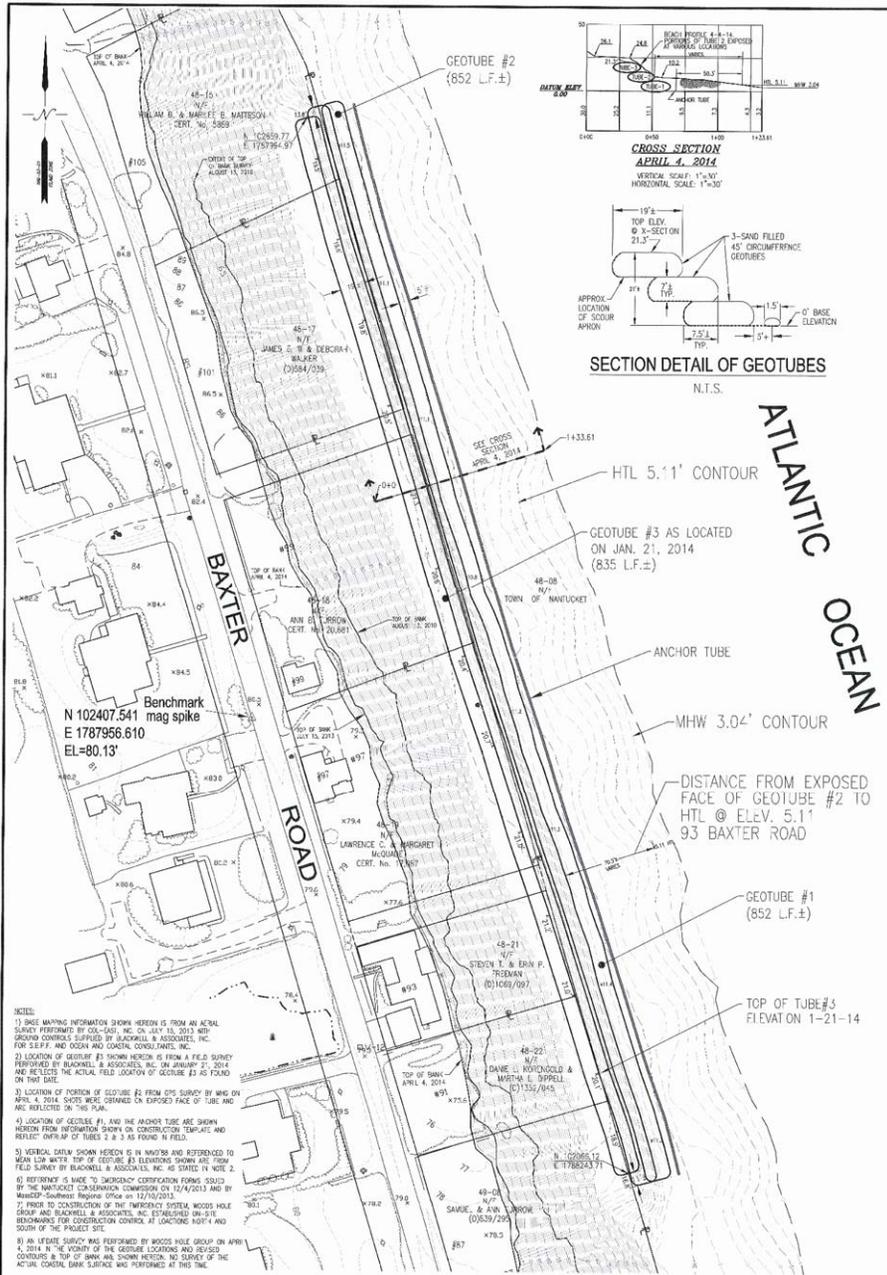
RECORD DRAWING
EMERGENCY INSTALLATION OF
SAND FILLED GEOTUBES
PREPARED FOR: SAUGOSET BEACH PRESERVATION FUND
1 BEACH - 30 FEET - JANUARY 27, 2014
SHEET 1 OF 1 B-7275

- 2) LOCATION OF GEOTUBE #1 FROM HEREON IS FROM A FIELD SURVEY PERFORMED BY BLACKWELL & ASSOCIATES, INC. ON JANUARY 21, 2014 AND REFLECTS THE ACTUAL FIELD LOCATION OF GEOTUBE #1 AS FOUND ON THAT DATE.

- 3) LOCATION OF PORTION OF GEOTUBE #2 FROM THIS SURVEY BY MHO ON APRIL 4, 2014 SHOWN HEREON IS ON EXPOSED FACE OF TUBE AND ARE REFLECTED ON THIS PLAN.

- 4) LOCATION OF GEOTUBE #3 AND THE ANCHOR TUBE ARE SHOWN HEREON FROM INFORMATION SHOWN ON CONSTRUCTION TEMPLATE AND RELATED OVERLAP OF TUBES 1 & 2 AS FOUND IN FIELD.

- 8) AN URGENT SURVEY WAS PERFORMED BY WOODS HOLE GROUP ON APRIL 4, 2014 IN THE VICINITY OF THE GEOTUBE LOCATIONS AND BEACH CONTOURS & TOP OF BANK ARE SHOWN HEREON. NO SURVEY OF THE ACTUAL BEACH SURFACE WAS PERFORMED AT THIS TIME.

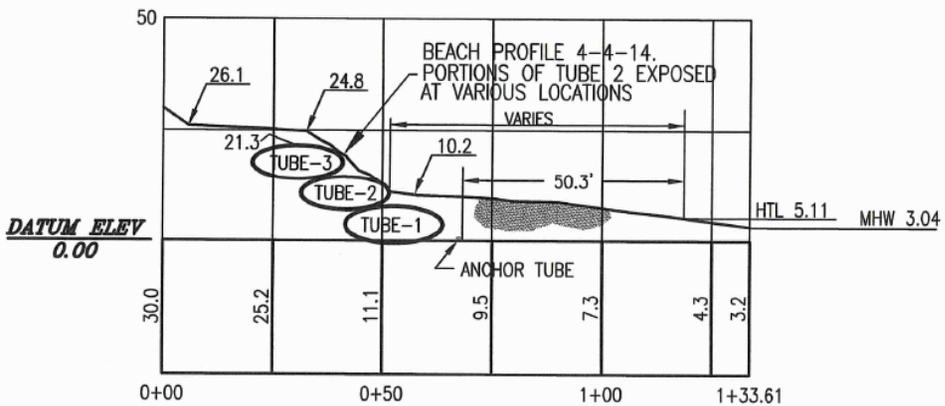
CROSS SECTION
APRIL 4, 2014

VERTICAL SCALE: 1"=30'
HORIZONTAL SCALE: 1"=30'

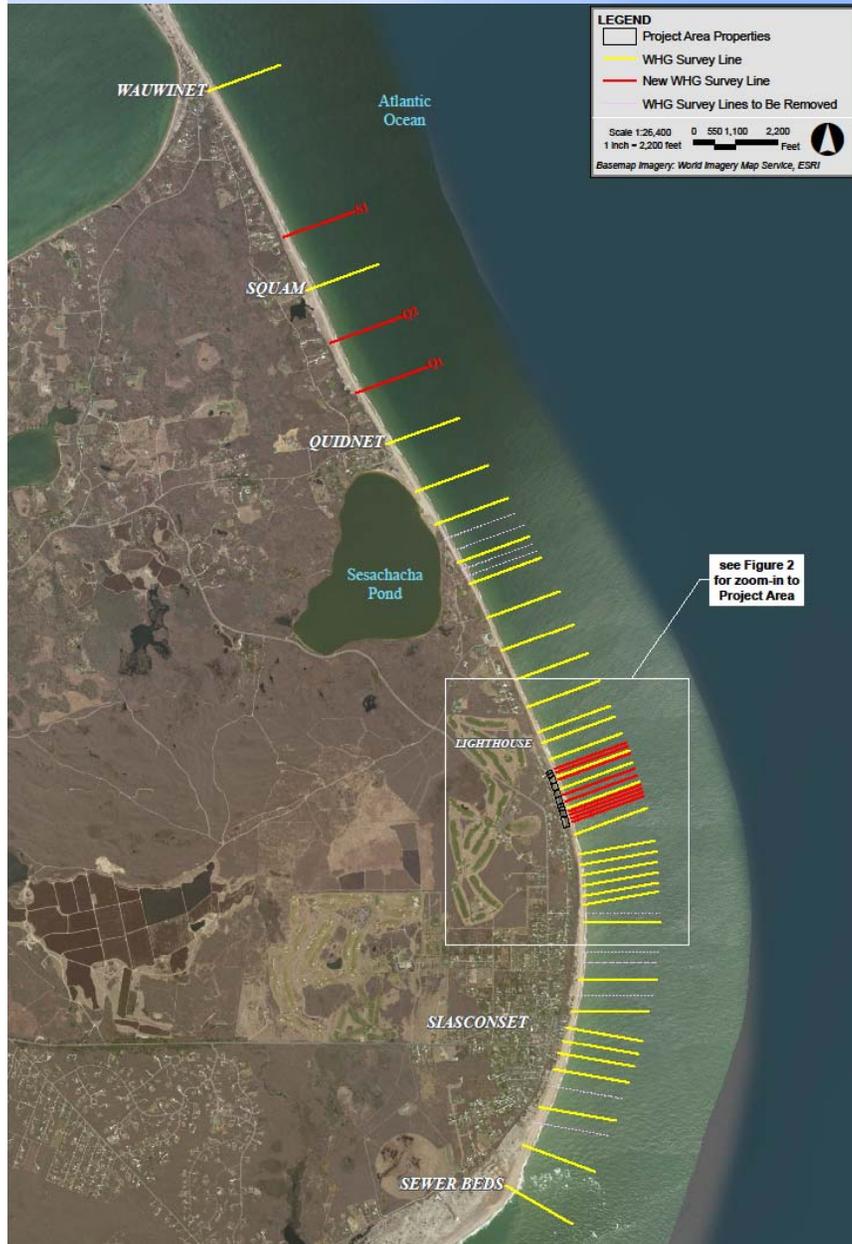
Shoreline Monitoring Program

- Spring surveys (toe of bank to -5 MLW)
- Fall surveys (toe of bank to ~3,000 feet offshore or -25ft to -35ft contour, whichever is less)
- Top of bank monitored along profiles in project area and w/in 300' of ends

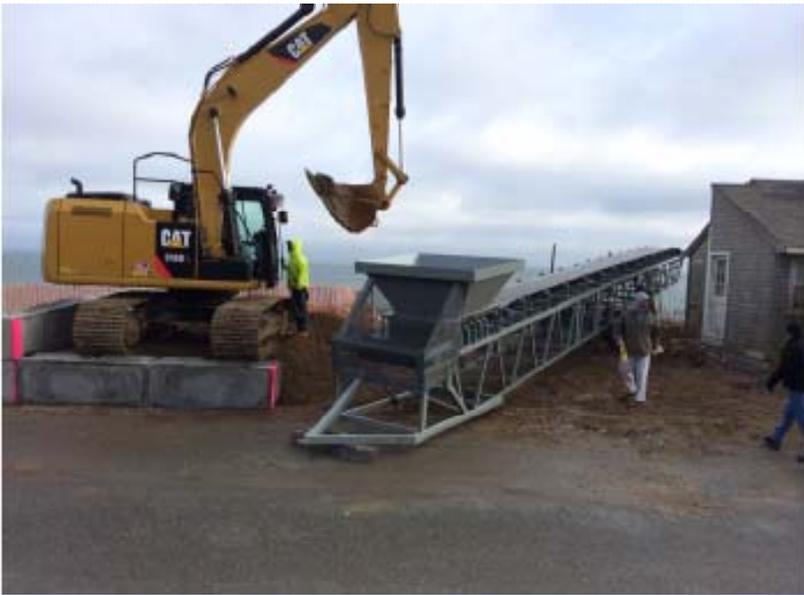
Sand Nourishment Program

- Provide the initial cover of 22 cy/lf during and/or immediately following construction.
- Annually in April starting in 2014: Provide additional sand and/or adjust the existing template sand to obtain a minimum of 2' cover over the geotubes to protect them from UV degradation. The volume of any sand placed in April will be recorded and counted towards the annual 22 cy/lf requirement.

- Annually in November starting in 2014: Place an additional volume of sand to ensure a substantial sand cover (10-15 cy/lf) is available at the onset of the winter storm season. Throughout the winter, place additional sand on an as-needed basis (when half the vertical height of the lowest geotube is exposed.) If the balance of the 22 cy/lf volume is not placed in its entirety during the 2014-2015 winter, the balance of the sand will be placed by March 31, 2015.

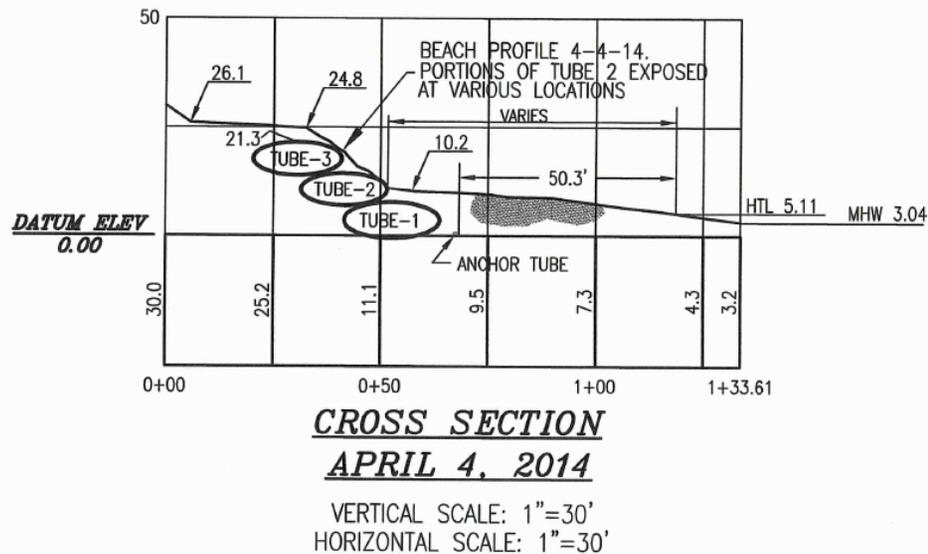
Sand Nourishment Program

Sand Template is expected to be available to the littoral system.

- Sand template is located seaward of the toe and is more available during lower wave energy events.
- Sand cover is loose sand that is more erodible than native sand in the coastal bank.

During March 26, 2014 storm, ~1.5-2.5 cy/lf contributed by sand cover.

Terraces contributed only 0.25 cy/lf.

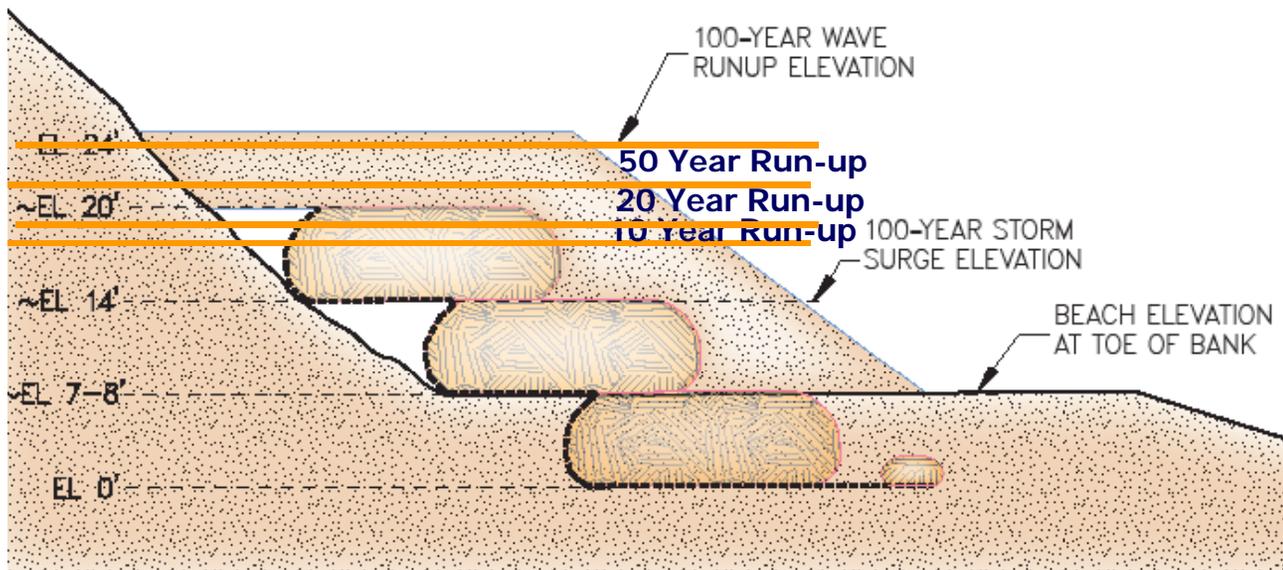
Wave runup will be higher in larger storms.

Post-storm reports will estimate sand contribution from the project area vs. unprotected areas and indicate if template needs to be adjusted.
